Occupational Radiation Protection during High Exposure Operations

Lessons Learnt from Occupational Radiation Protection in Past Accidents

Nuclear Accidents – Fukushima Accident –

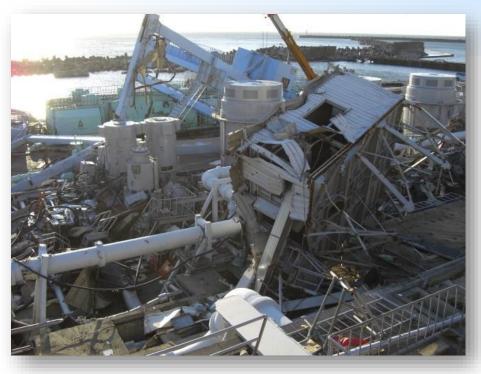
Afterward the wave by Tsunami flooded and damaged the unhoused seawater pumps and motors of all six units at the seawater intake locations on the shoreline, resulting in loss of ultimate heat sink events for all units

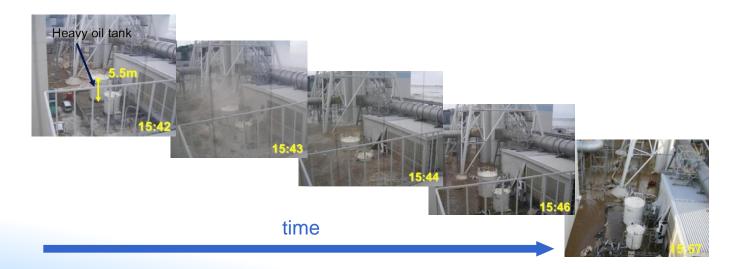
Water entered and flooded all the reactor and turbine buildings, the common spent fuel storage building and diesel generator building, which damaged the buildings and the electrical and mechanical equipment inside at ground level and on the lower floors

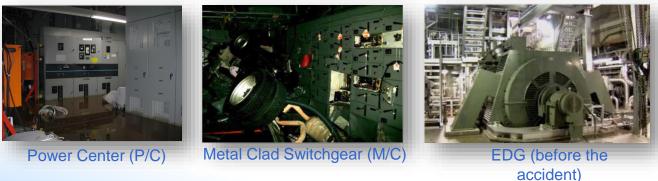
- The damaged equipment included the EDGs or their associated power connections, power distribution panels and switchgear equipment, which resulted in the loss of emergency AC power
- 13 EDGs were unusable except one of the air cooled EDGs that of Unit 6, which was continuing to supply emergency AC power to the Unit 6 safety systems and allowing cooling of the reactor of Unit 6 and 5 by the power interchange

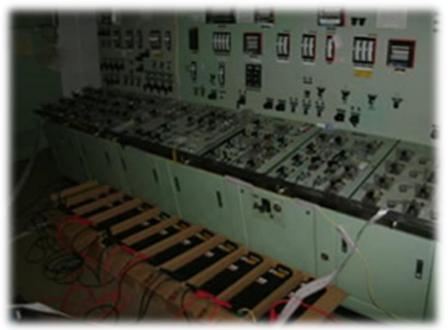
The operators removed batteries from abandoned cars in the darkness,

and connected them as a power supply for the instrumentation and control.

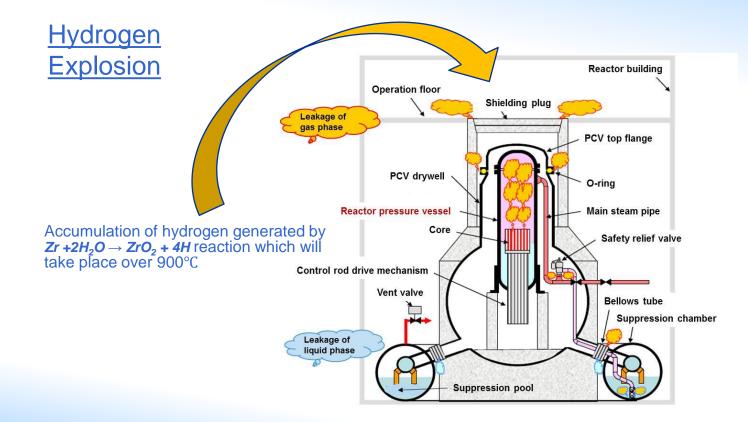
- Because the DC batteries escaped from flooding, driving and the control of RCIC and the high-pressure core injection system (HPCI) were able to be continued
- After 14 hours of continued operation of the HPCI, the Unit 3 operators decided to manually stop it and instead use the alternative means of injection at low pressure, concerning about the reliability and possible failure of the HPCI
- The Unit 3 HPCI was therefore turned off by the operators, who then proceeded to open the Safety Relief Valves (SRVs)
- However, all attempts to open the SRVs failed, and reactor pressure quickly increased above the level at which the DDFP could inject, stopping the cooling of the Unit 3 core about 35 hours after the SBO
- At 11:01 on 14 March, an explosion occurred in Unit 3

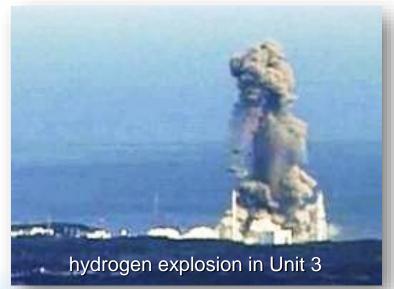
- By the loss of cooling measures the core meltdown in Unit 1 to 3 occurred
- As the result, radioactive material were released into out of reactor buildings and also environment of wide spread area
- Also hydrogen explosion were caused
