# Occupational Radiation Protection during High Exposure Operations

Lessons Learnt from Occupational Radiation Protection  
in Past Accidents

Nuclear Accidents – Fukushima Accident –

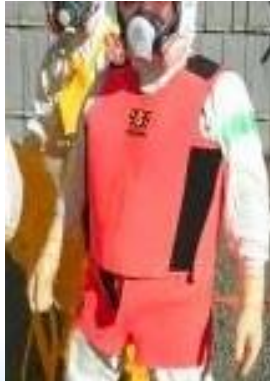
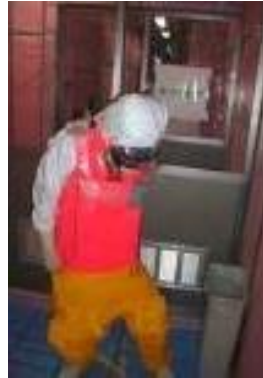
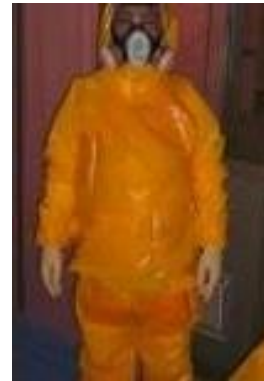
- The APD was set the outside and inside of the protective suit
- worker A : outside 0.22mSv,    inside 0.17mSv,    (22% shielded)
- worker B : outside 0.24mSv,    inside 0.16mSv,    (33% shielded)
- Shielding effect strongly depends upon the environmental photon spectrum

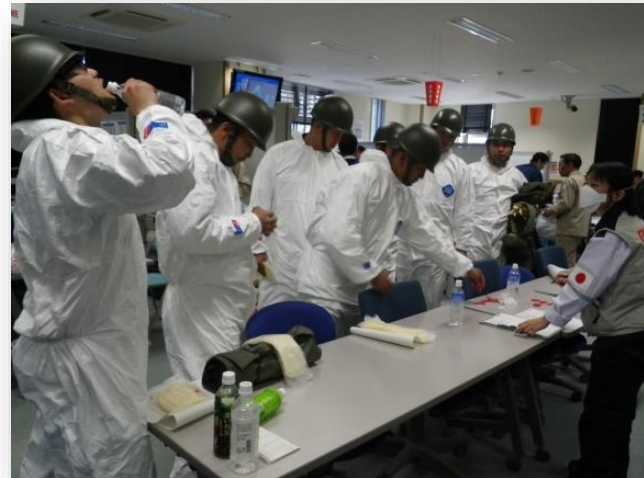
- On 14 March 2011, six military personnel encountered the hydrogen explosion just in front of Unit 3
- 90 minutes before hydrogen explosion they took potassium iodine (130mg)
- The blast of the hydrogen explosion directly pierced through their Tyvek® suit and battle suit.
- Surface contamination level was 1 mSv/h at 10cm distance when they escaped from the site

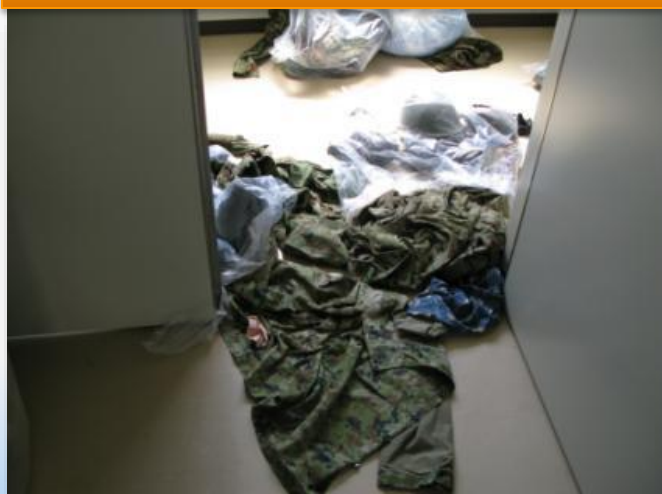
Measured on 16 Mar. 2011

- As soon as the heavy contamination was confirmed, their Tyvek suit and battle suit were cut and removed immediately
- The activity of the clothes was too high to analyze the spectrum on the day
- Two days later radio nuclides were detected from their battle suits

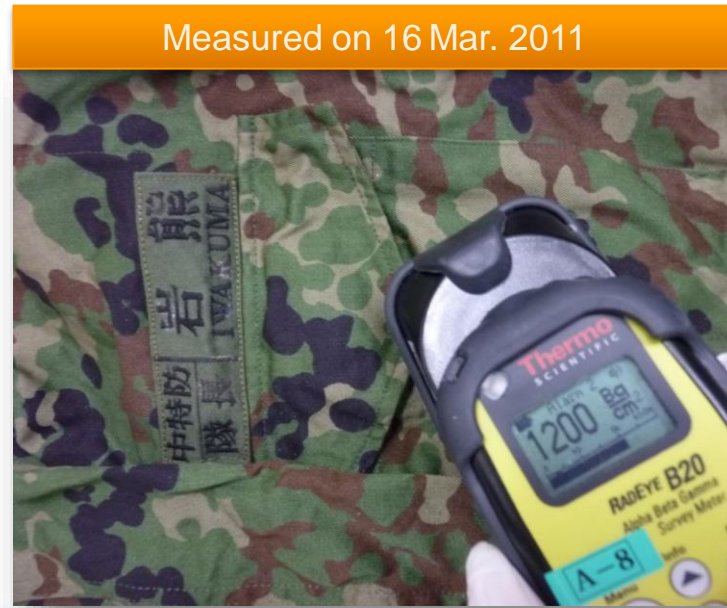
6 months later, the surface contamination of the battle suit was reduced to 1/20 of the initial level because of the half life of Tellurium and Iodine, but was still 30 times of legal regulation

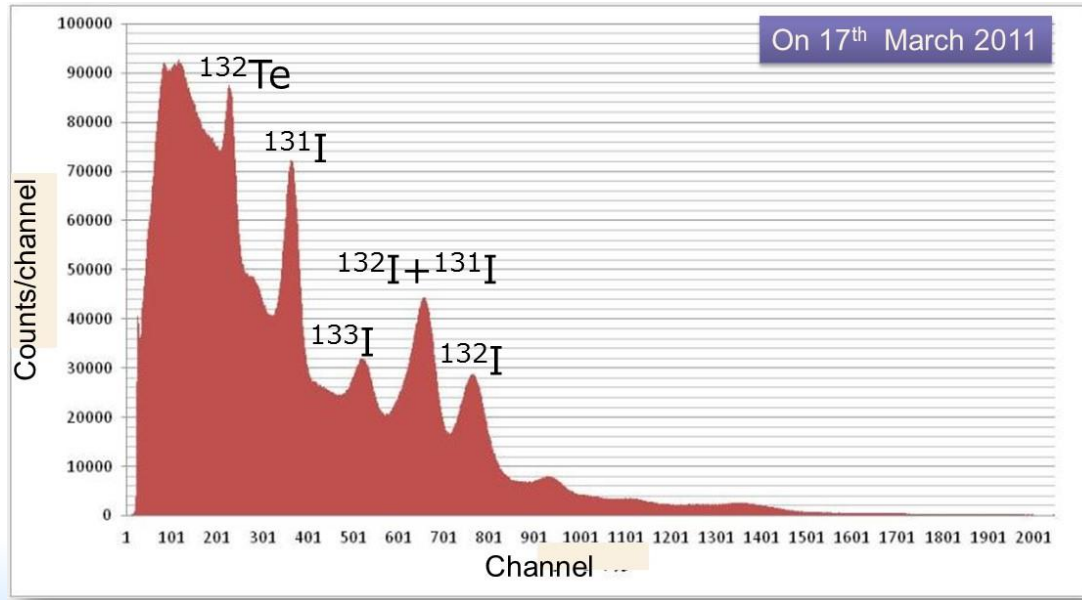
- On 15 Mar. one injured soldier who suffered injury was carried to NIRS
- It was impossible to measure his internal contamination on the day because of the saturation of the WBC (NaI(Tl)-8"Φx4)
- Two days later the in-vivo measurement was carried out as below

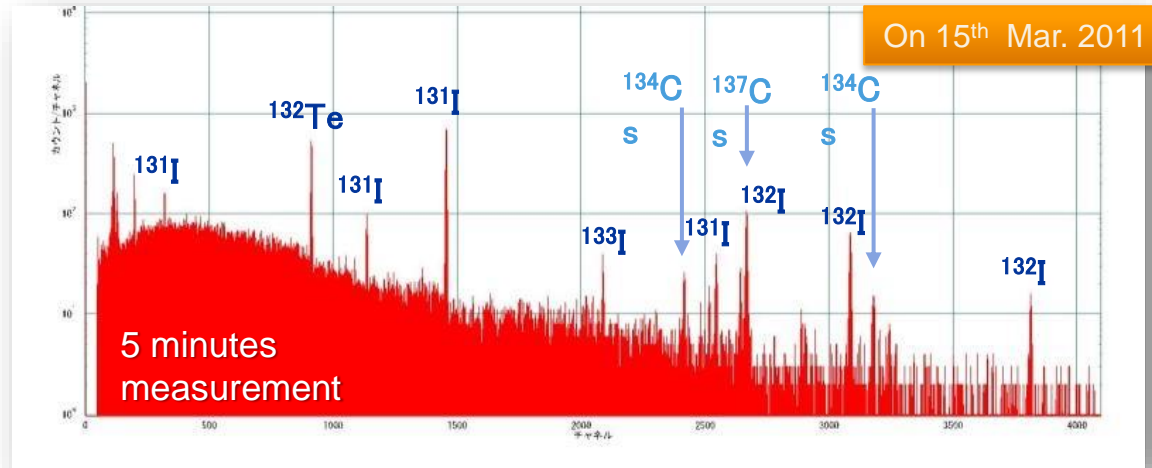
- There was an incorporation to the thyroid gland though the overall mask had been worn based upon the measurement by Ge thyroid monitor
- It was thought that not only  $I_2$  and CsI but a large amount of methyl iodide were existing
- Considering the collection efficiency of the iodine filter and specific activity it may be reasonable to assume the penetration of some methyl iodide.

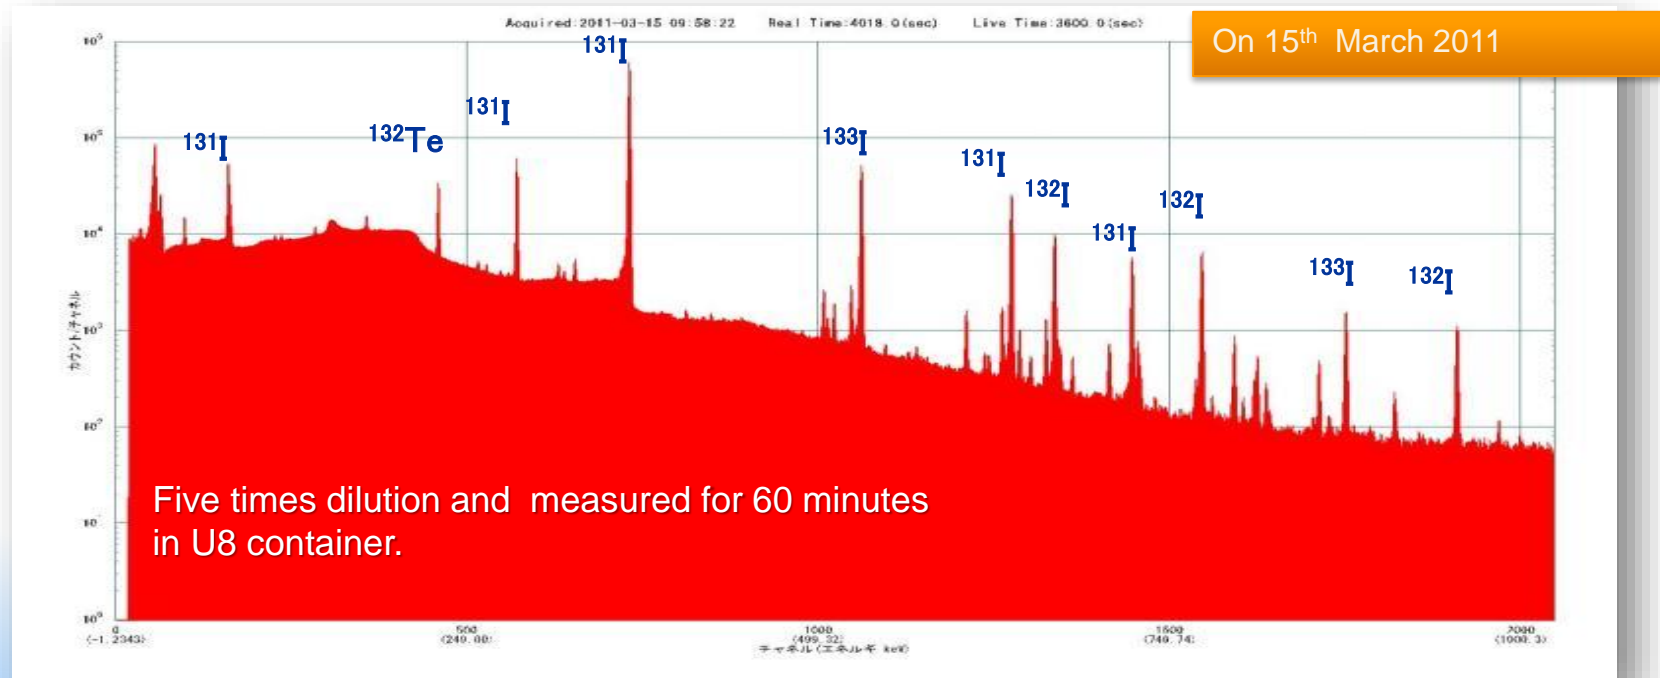
- Nuclide observed in urine
- A large amount of iodine shows the blocking effect by the iodine tablet
