Analysis of the TEPCO Fukushima Daiichi NPS Accident

Interim Report
(Provisional Translation)

October 2014

Nuclear Regulation Authority, Japan

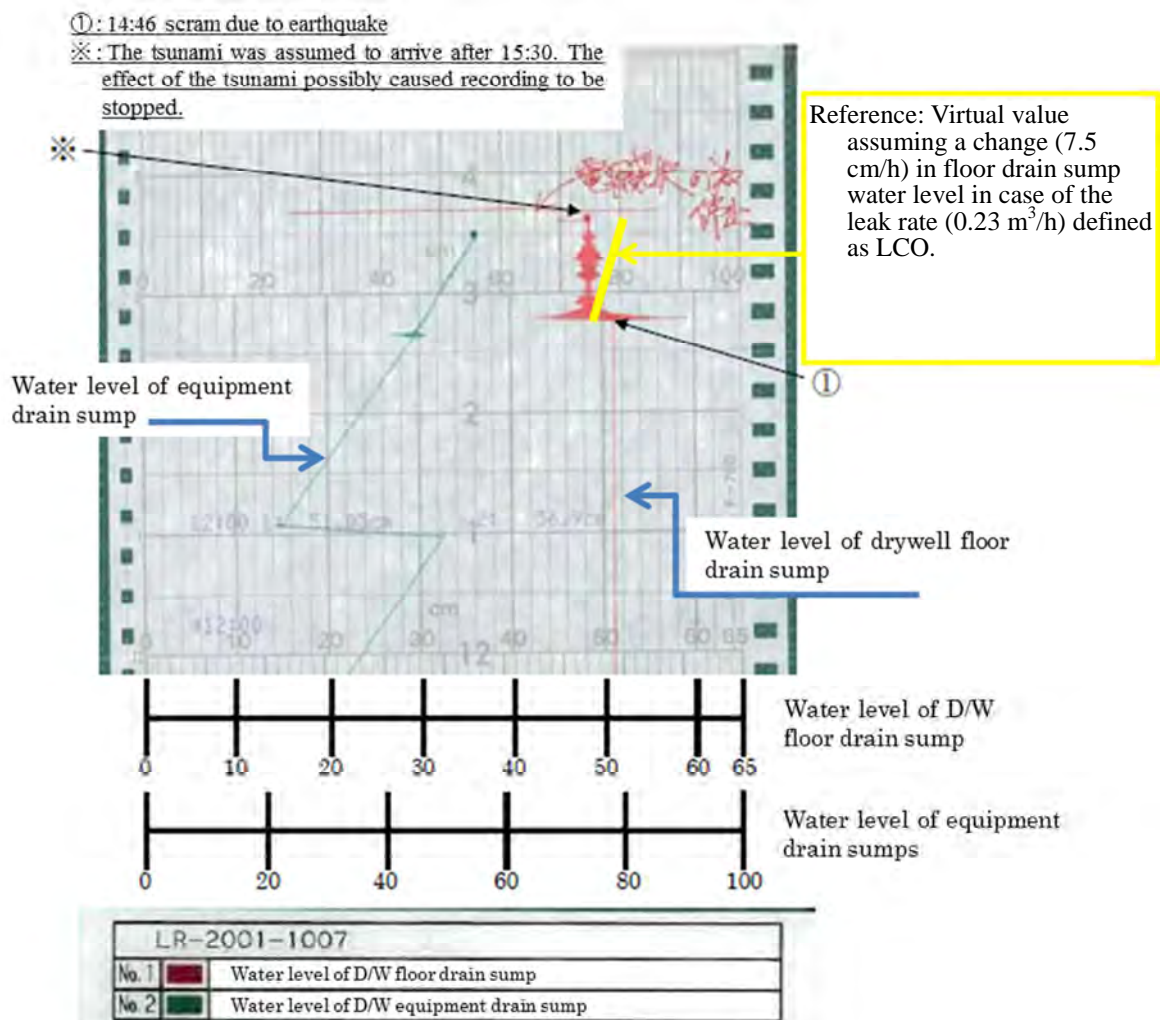
Figure 1.3 Water Levels of Drywell Floor Drain Sumps and Equipment Drain Sumps ⁵

From these findings, the NRA estimated that there was no such coolant leak that could change the water level of the drain sump from the RPV in that time period. However, if a very small amount of coolant leaking from the liquid phase fully evaporated and did not flow as liquid into the drain sump, a leak might not be detected. If gaseous coolant (i.e. steam evaporated from the liquid phase or steam from the gas phase) leaked from the RPV, it might increase the PCV pressure. The NRA analyzed further this point in the next Item (3) PCV pressure.

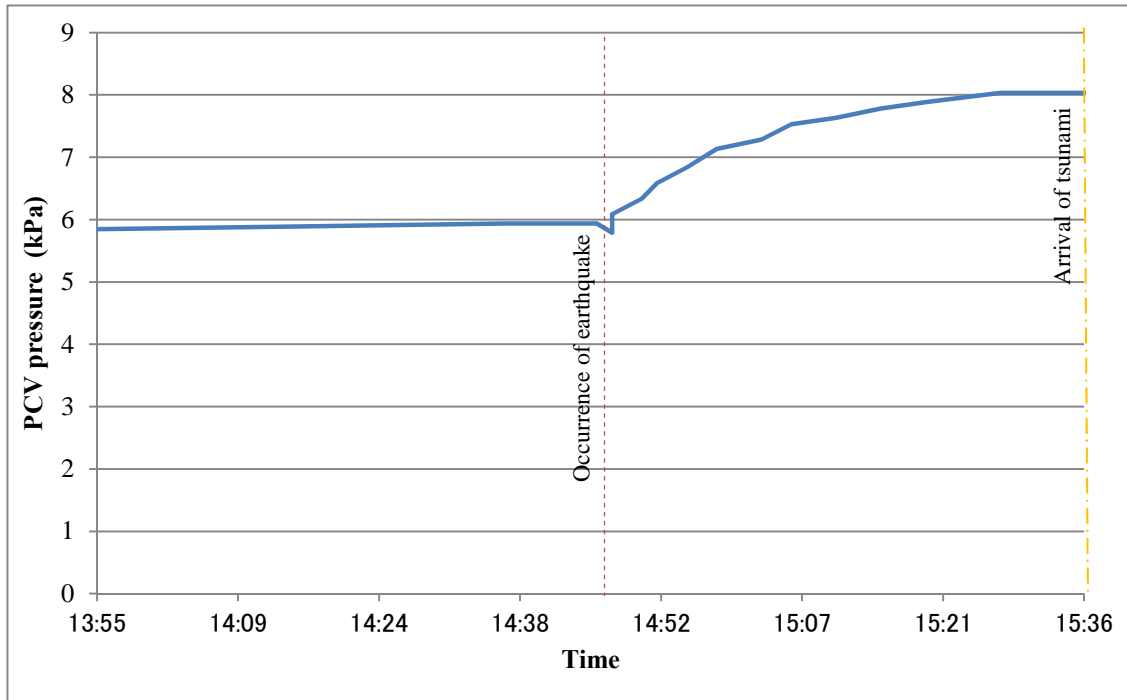
Figure 1.4 Behavior of PCV Pressure

The measured PCV pressure had increased about 2.0 kPa from the earthquake occurrence to the tsunami arrival (Fig. 1.4). In addition, the "High PCV pressure (13.7 kPa)" alarm was not generated.⁶

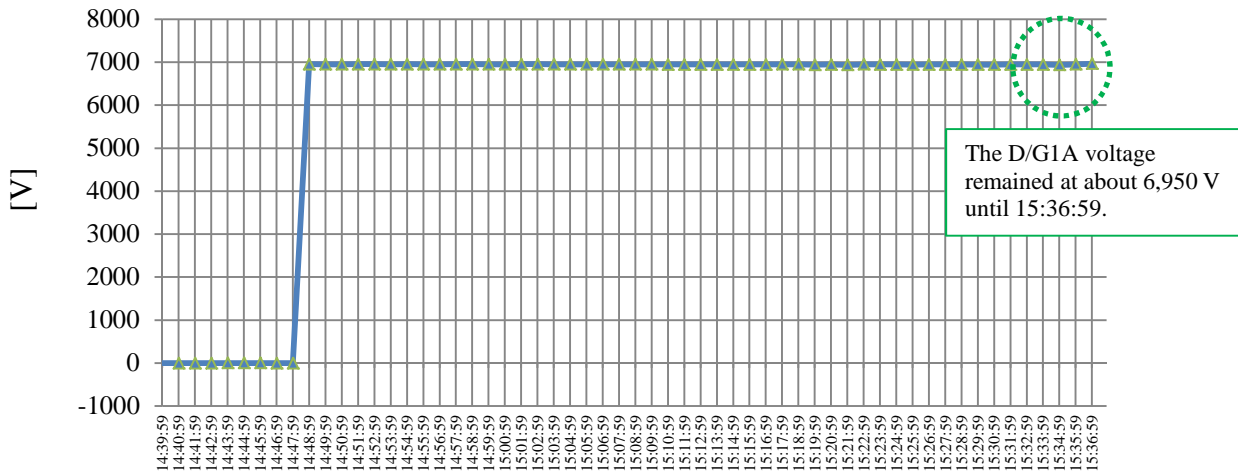
Figure 2.4 Behavior of D/G1A Voltage Value

With the aid of the newly provided data of the transient phenomena recorder, the NRA found that D/G1A remained at about 6,950 V until 15:36:59 (data collecting time just before data measurement stopped) (Fig. 2.4). Conversely, M/C1C connected to D/G1A dropped its voltage to almost 0 V between 15:35:59 and 15:36:59, and was subsequently disabled to supply power (Fig. 2.5).

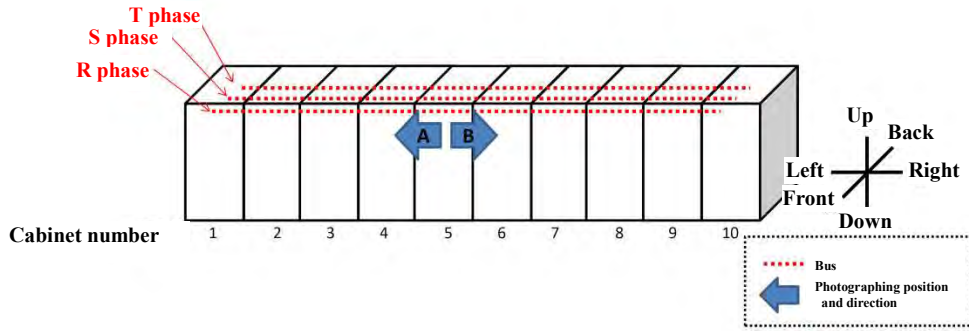
Figure 2.8 Buses and Bus-supporting Insulators inside M/C1C

The NRA therefore estimated that M/C1C did not cause such outages due to the effects of the earthquake, as was pointed out in the National Diet Investigation Commission report.

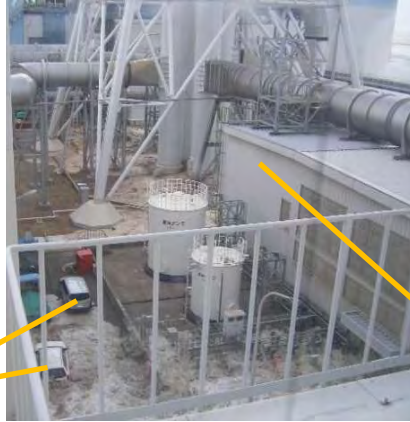
Photo 3 (Tsunami 2-2 caused large-scale flooding on the premises (height: O.P.+ 10 m).)

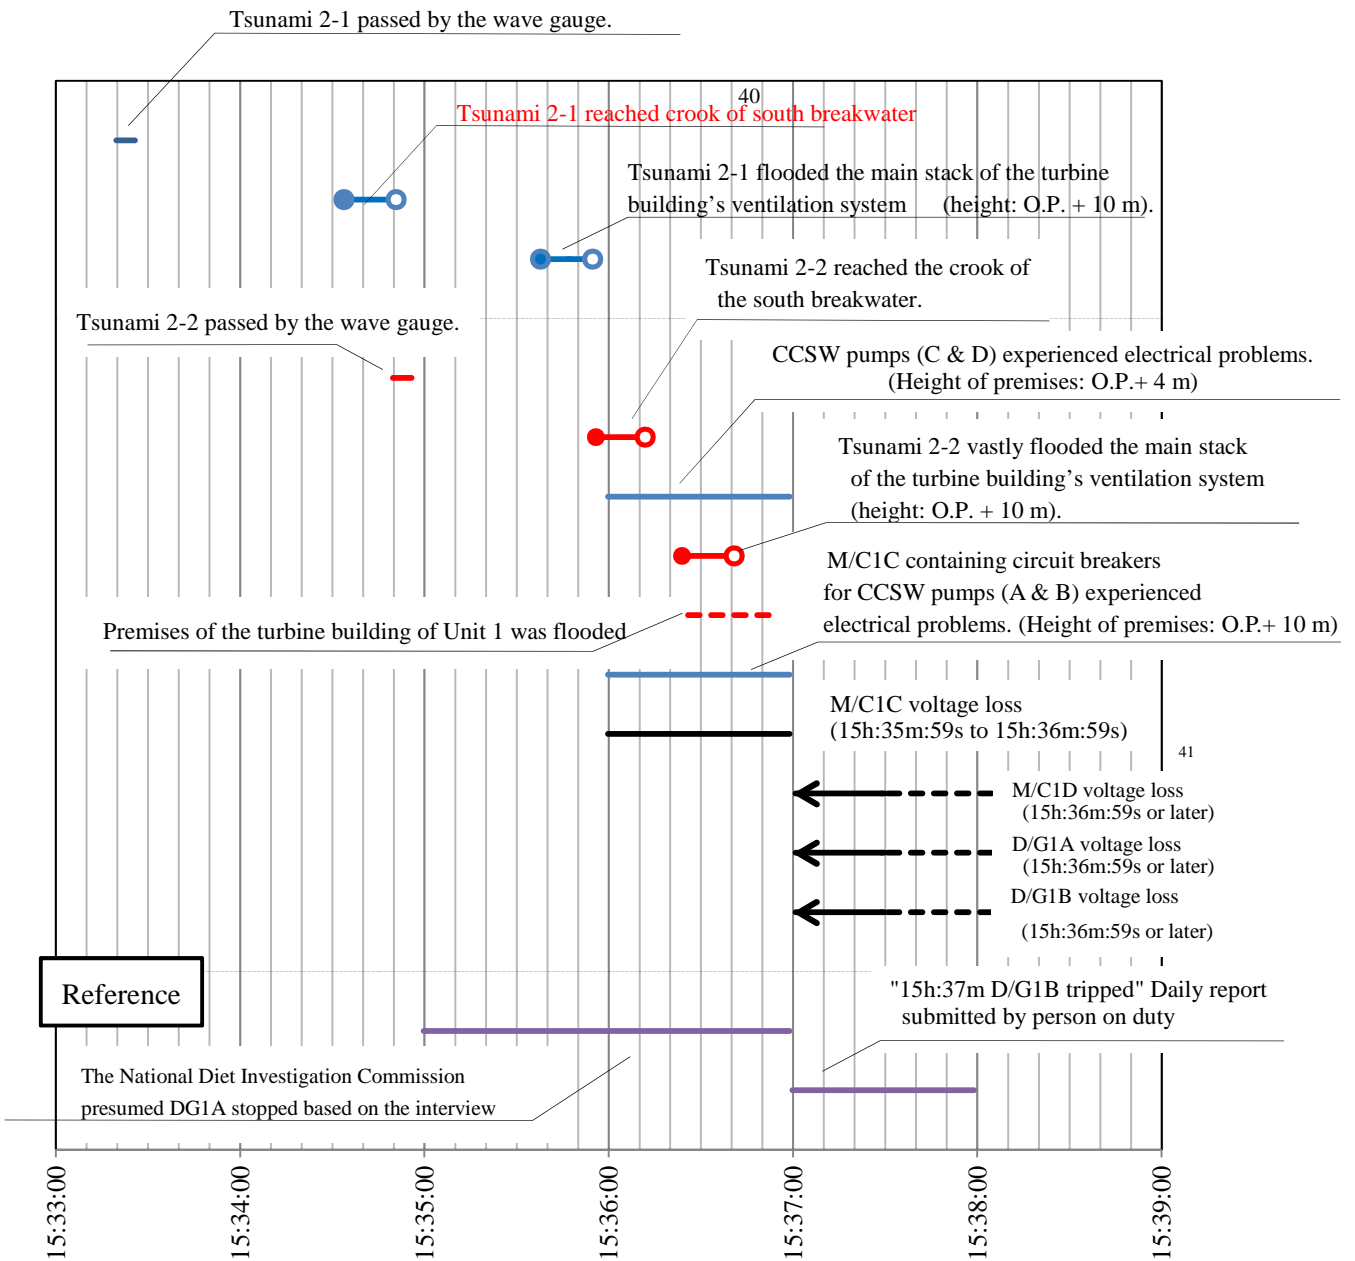
Figure 2.25 Time-series Arrangement of Wave Gauge Record Data, Photos, and Transient Phenomena Recorder Data (Unit 1)

Judging from Fig. 2.25, the NRA estimated that M/C1C, M/C1D, D/G1A and D/G1B lost their voltages after the premises of the turbine building of Unit 1 (containing this equipment) were assumed to be flooded and also that this situation is roughly correspond to the tsunami inundation.

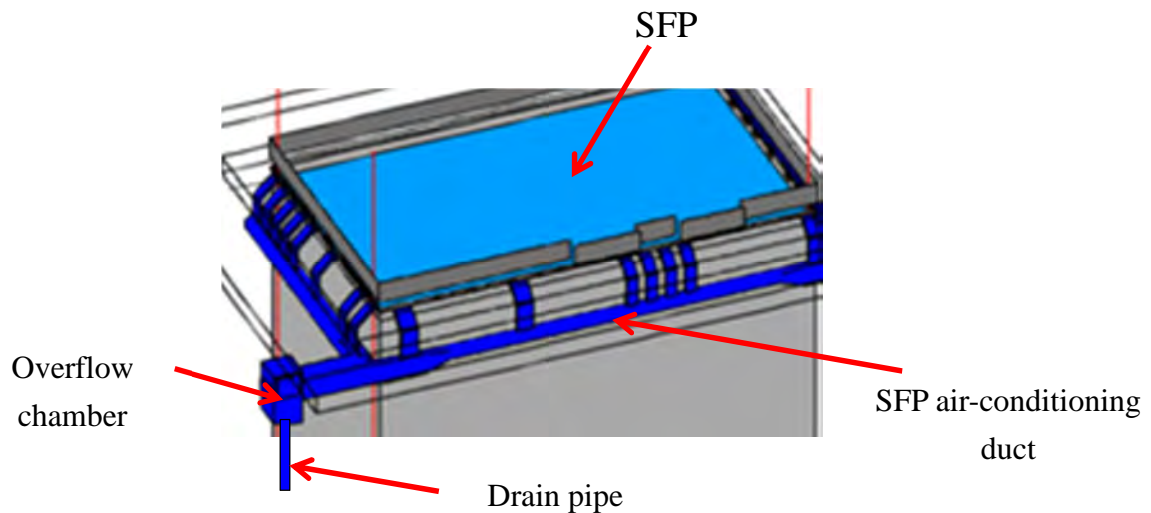
Figure 3.5 Location of the SFP, SFP duct, and Overflow Chamber (image diagram)

- Result of assessment: The NRA estimated that water in the SFP possibly overflowed and then flowed into the overflow chamber through a duct inlet provided on the side of the SFP, due to the sloshing caused when the earthquake occurred. This overflowing water apparently caused the water leaking point.

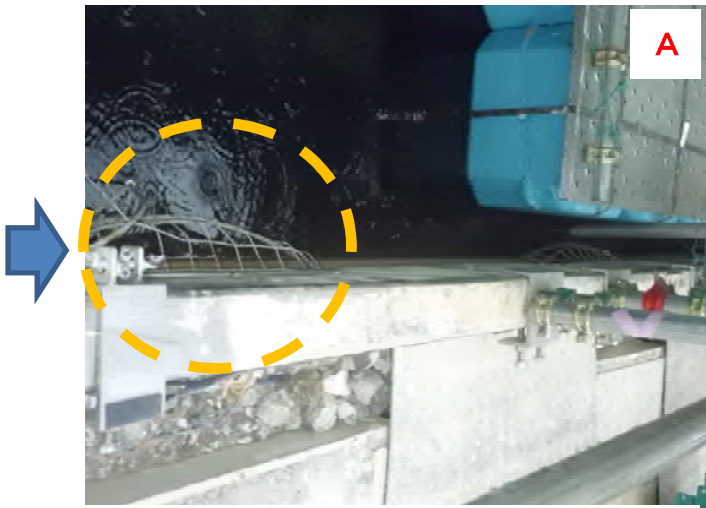
Deformation of the exhaust port net of the exhaust duct above the SFP on the 5th floor (deformed outward)
(photographed by TEPCO on November 8, 2011)

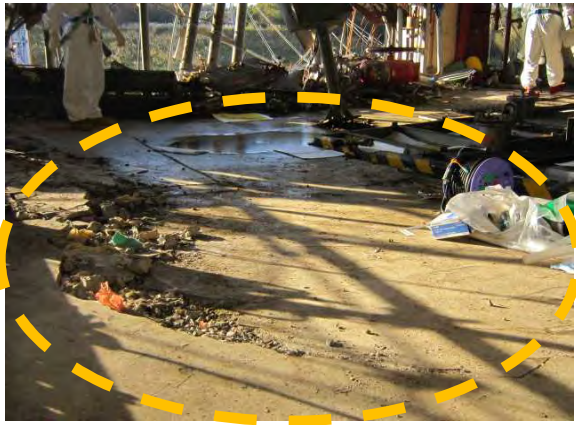
Photographed by TEPCO on November 8, 2011
Floor damage in the southwest area of the 4th floor

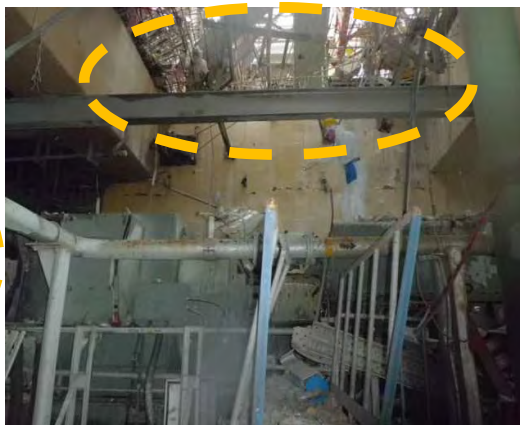
Photographed by TEPCO on November 8, 2011
Ceiling damage in the southwest area of the 4th floor

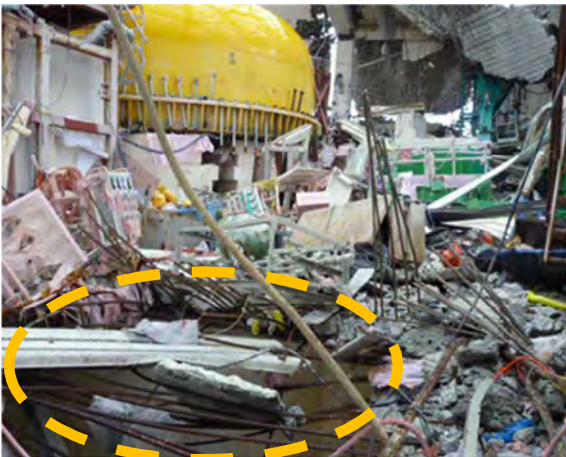
Photographed by TEPCO on October 5, 2011
Floor damage in the southwest area of the 5th floor

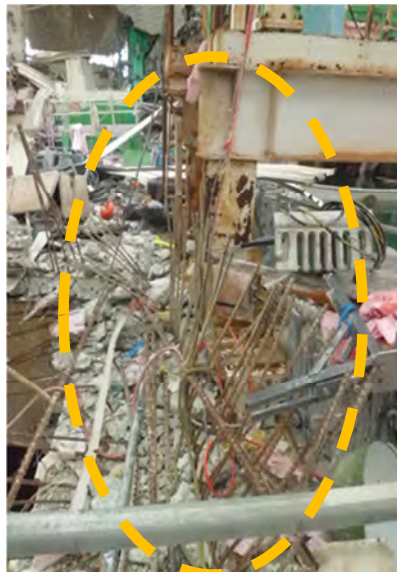
Photographed by TEPCO on October 5, 2011
Floor damage in the southwest area of the 5th floor (upward-vent reinforcing bars)

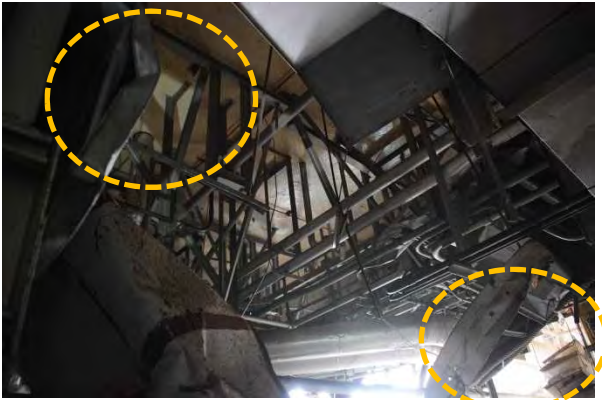
Photographed by the NRA on July 12, 2013
Ceiling damage in the northwest area of the 3rd floor (duct damage)

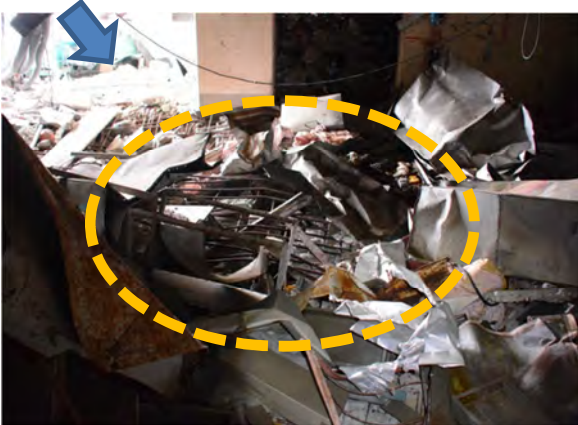
Photographed by the NRA on July 12, 2013
Floor damage in the northwest area of the 3rd floor

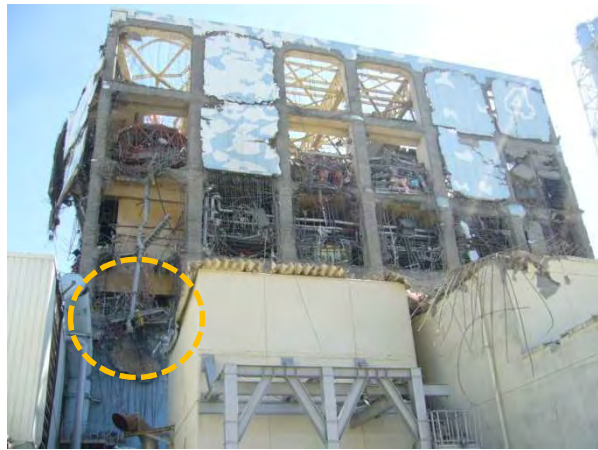
Photographed by TEPCO on March 18, 2011
Complete destruction of the wall west of the staircase in the northwest area of the 3rd floor

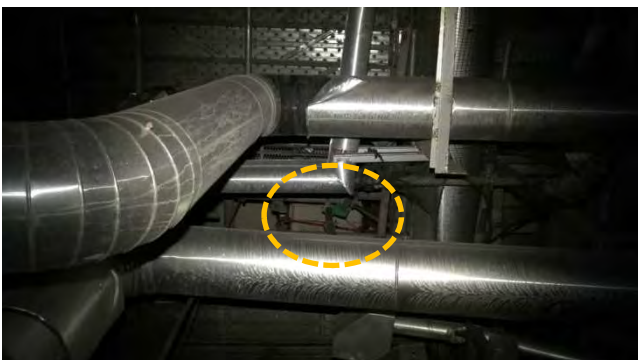
Photographed by the NRA on February 6, 2014
 Ceiling penetration
Ceiling damage in the northwest area of the 2nd floor (directly under the damaged floor in the northwest area of the 3rd floor)

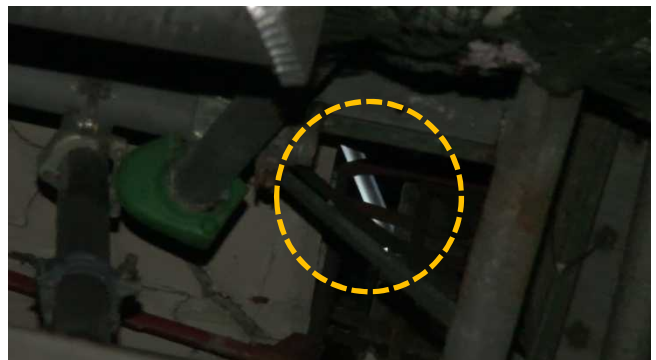
Photographed by the NRA on February 6, 2014
 Magnified penetration view (of materials on the 3rd floor that the NRA visually recognized)

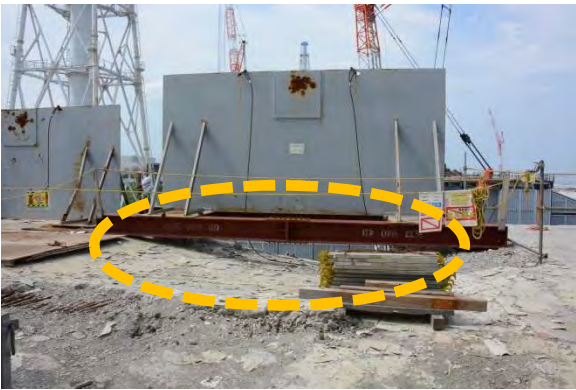
Photographed by the NRA on July 11, 2013
Downward deformation in the north area of the 5th floor
