**IAEA MISSION TO ONAGAWA
NUCLEAR POWER STATION TO
EXAMINE THE PERFORMANCE OF
SYSTEMS, STRUCTURES AND
COMPONENTS FOLLOWING THE
GREAT EAST JAPANESE
EARTHQUAKE AND TSUNAMI**

Onagawa and Tokyo, Japan

30 July - 11 August 2012

IAEA MISSION REPORT

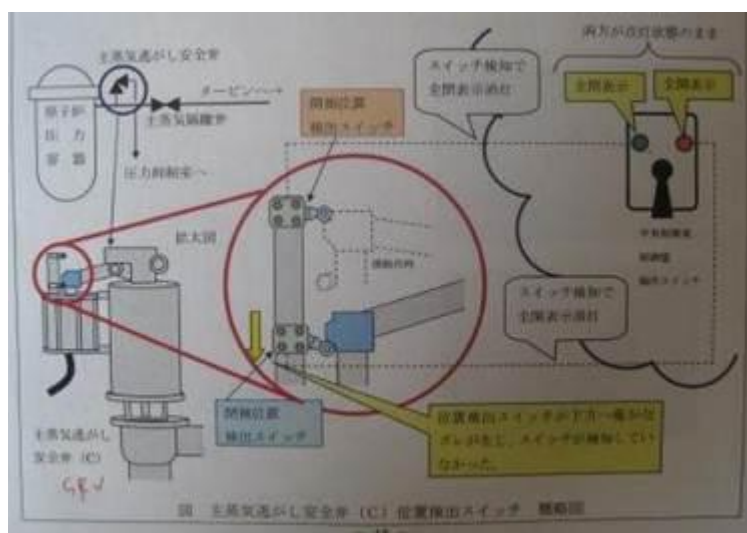
A false indication was displayed in the Unit 1 control room showing that the main steam pressure relief Valve C was both open and closed. Apparently vibration of the lever atop the piston actuator slightly moved the close-side switch downward, which caused the switch unable to detect proper close position of the valve and to indicate both an open and closed position for the valve on the main control room panel. But the operator easily confirmed that the steam relief valve actually remained closed according to the trends of the exhaust pipe temperature and reactor pressure vessel's pressure. Later maintenance engineer confirmed its relocation issue, see **Figure 7-8**.

Figure 7-8 The piston actuator linkage atop the main steam safety relief valve

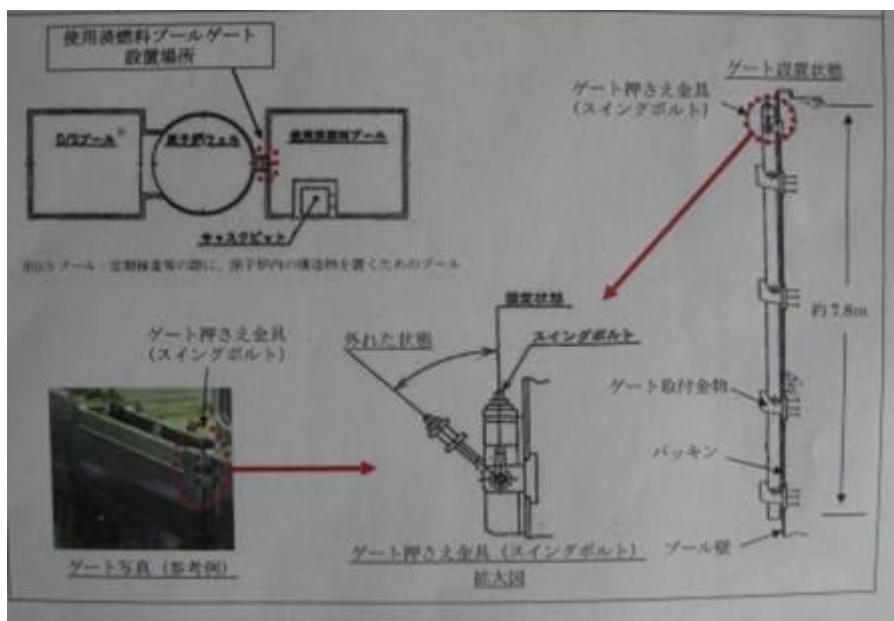
On the refueling floor of the Unit 3 reactor building, an anomaly was observed in the vertical stainless steel watertight gates that form a lock between the spent fuel pool water and the normally dry canal to the reactor well, and to the spent fuel cask pit (see illustration below). According to the maintenance engineers' explanation, a set of large bolts is screwed down against the top of the gate, to prevent lift of the gates by buoyancy when the both side of gates were filled with water. At the two locations the tightening bolt atop the gate was found to have loosened, but the gate was still in proper position by the L-shape retainers welded on the pool wall and the cylindrical bars welded on right and left sides of the gate at 4 elevations. The bolts were found tilted to one side on their swivel attachment. In neither case was the bolt or its attachment to the gate noticeably damaged, nor was the gate seal leaking. The drawing of the gate attachment to the fuel pool side in the illustration shows a series of hooked-shaped supports for the gate that push the gate against its lift from the proper position as the bolt is tightened down - see **Figure 7-9**.

Figure 7-9 Gate of the spent fuel pool

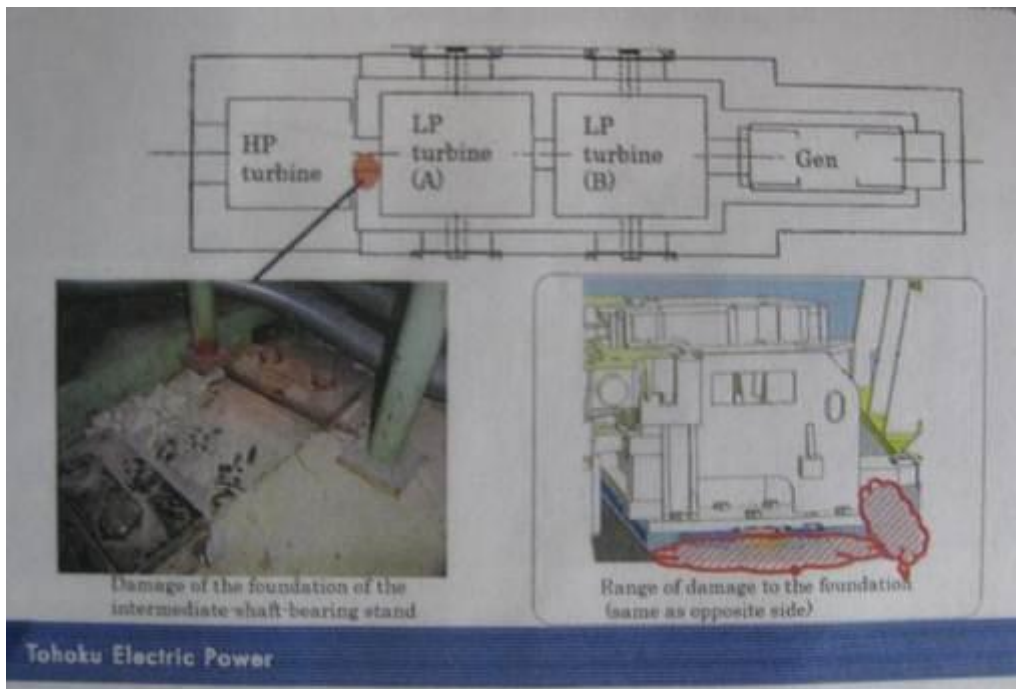
The Unit 2 turbine generator was rotated at low speed by turning gear in preparation for startup at the time of the earthquake. The spinning turbine rotor essentially floats on a film of oil while spinning. After earthquake Intermediate bearing (thrust bearing) were dismantled to be inspected and renovated at the factory. Axial bearings were reported as showing wear but did not require replacement. At the base of Intermediate bearing housing between the high pressure and low pressure turbine A, the concrete surface (grout) of the base spalled, but steel bar reinforced concrete (strength member) showed no damage at all according to the inspection after the grout removed. Bolts securing the base plate of the bearing housing were also slightly bent. Scoring was noticed where the rotor blades contacted the surrounding nozzles on the low pressure turbines. The contact damage did not require blade or nozzle replacement on the Unit 2 turbine.

Figure 7-11 Spalled Concrete Grout Under Intermediate Shaft Bearing Base Plate Unit 2

The drawing shows the location of spalled concrete at the base of the Unit 2 bearing housing between the high pressure and first stage low pressure turbine see Figure 7-11.

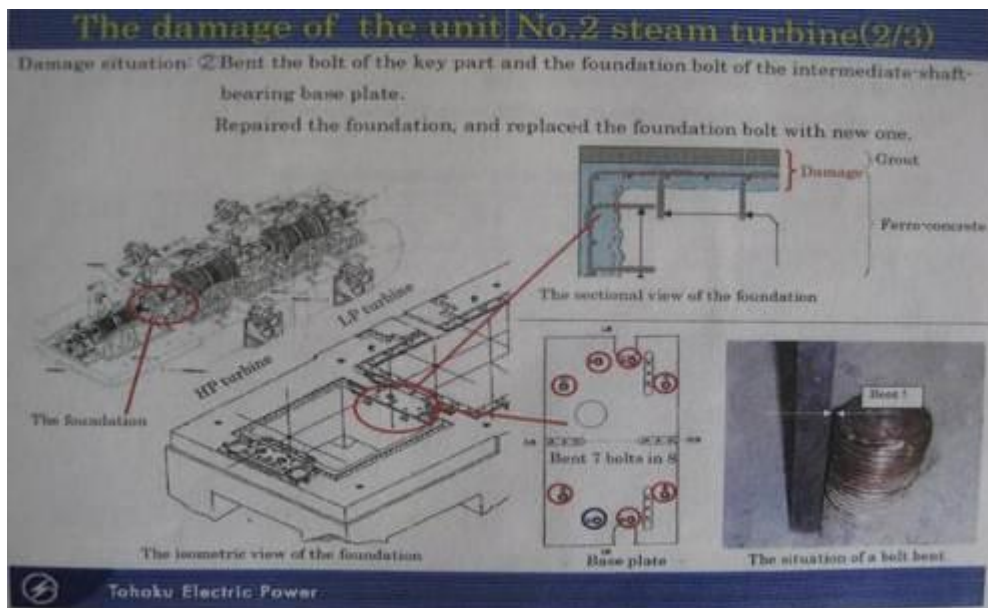
Figure 7-12 Slightly Bent Bolts of Intermediate Bearing Base Plate Unit 2

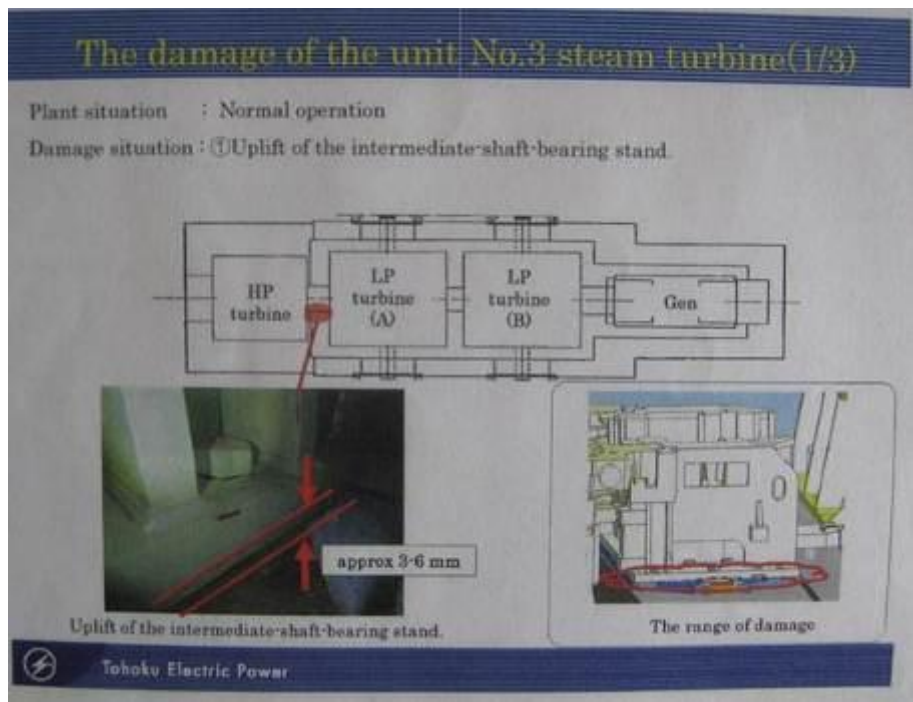
Figure 7-13 Uplift of Base Plate of Bearing Housing Unit 3

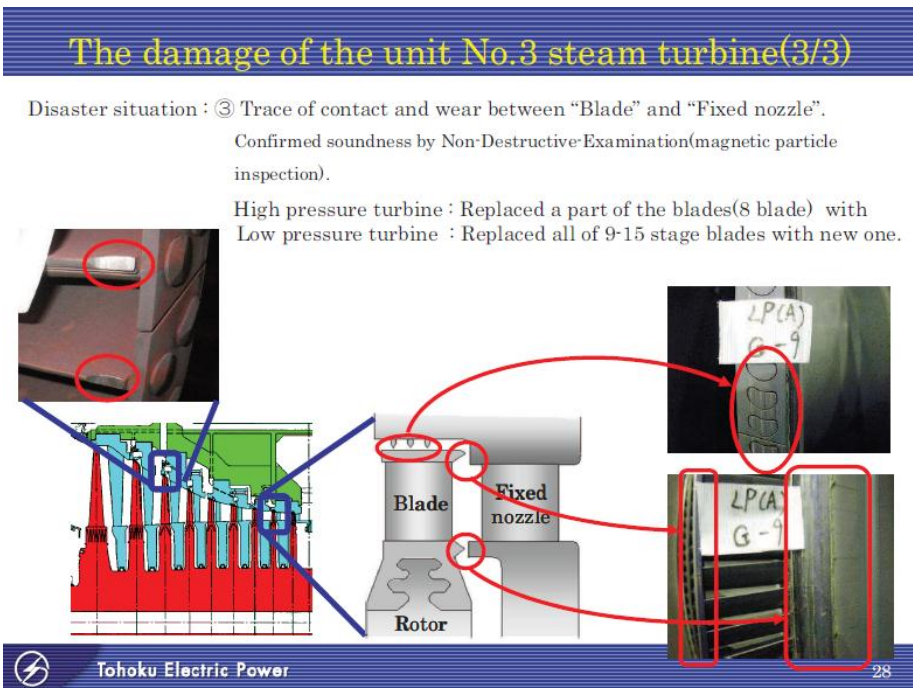
Figure 7-14 Wears on the Unit 3 steam turbine blades

efficiency (thermal efficiency), considered necessary period for the seismic resistance improvement work and the blade replacement work, a part of turbine blades were decided to be replaced.

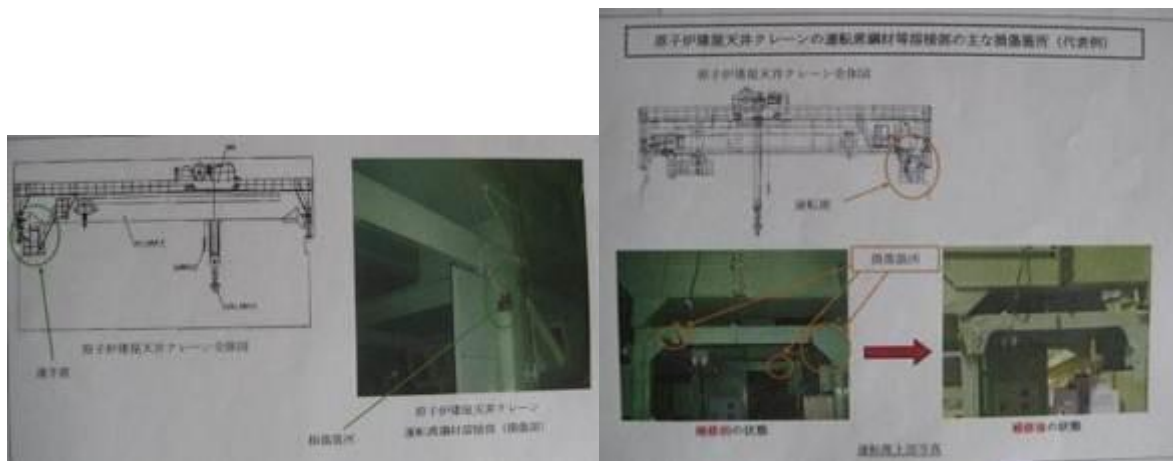
Figure 7-15 Overhead Bridge Cranes

Yielding and cracking occurred in the part of the steel support frame supporting the operator's cab on the Unit 1 and on the Unit 2 reactor building overhead bridge cranes. At both locations the cab (or cockpit) is cantilevered beneath the frame. The level of motion at the crane rail level apparently incurred sufficient cantilever sway in the cab to initiate cracking in the steel. Had failure in the support frame reached the point of cab detachment, the falling cab could have been a serious interaction hazard for the refueling floor fixtures, therefore Tohoku EPCo considers the countermeasures, such as frame reinforcement below see **Figure 7-15**.

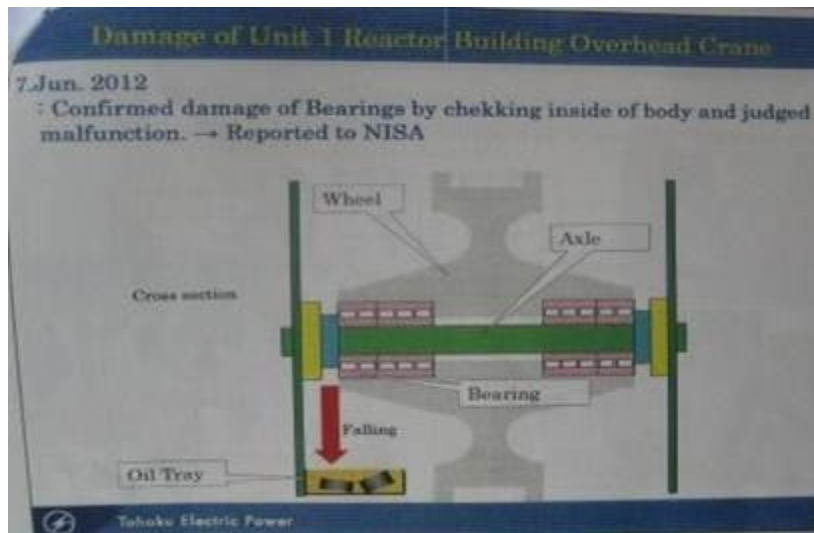
After the earthquake Unit 1 reactor building overhead bridge crane was found to be squeaking on its moving of the bridge. But this June one of 4 driving shaft bearings in the gear drives for the crane wheels was found to be broken. Crushed bearing debris was found in the oil tray within the crane wheel housing as illustrated in the drawing see **Figure 7-16**.

Figure 7-16 Crushed bearing debris were found in the oil tray of the rail wheel assembly of the Unit 1 overhead bridge crane.

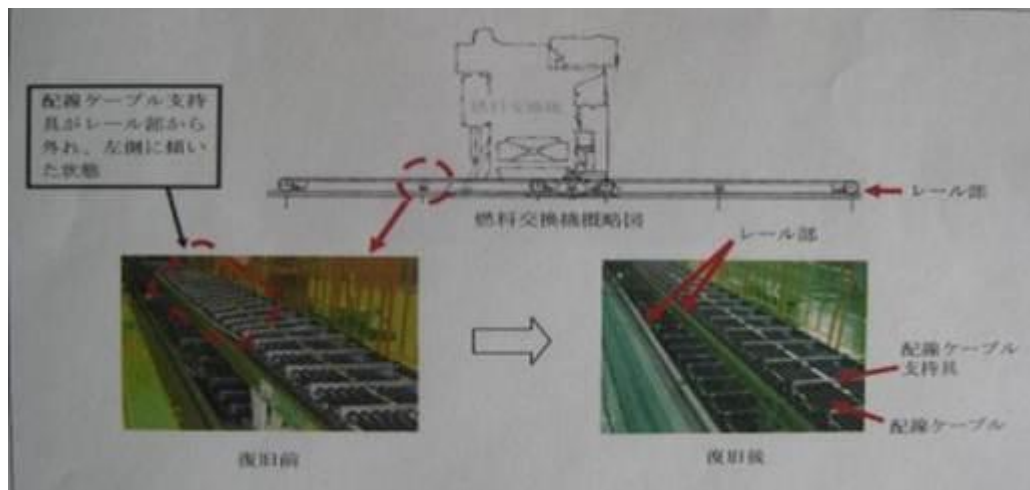
A caterpillar for holding cables of the Unit 3 reactor building refueling machine dislodged from the rails, presumably due to transverse torsion of the cable holding caterpillar see **Figure 7-17**.

Figure 7-17 A cable holding caterpillar dislodged from the rail of the Unit 3 refueling machine

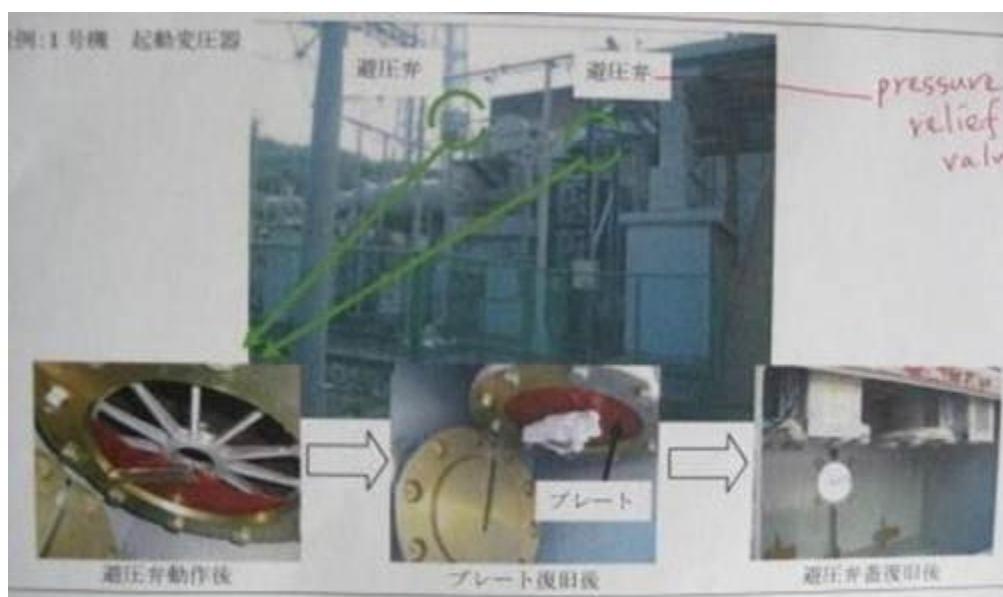
At the time of the March 11 earthquake, main transformers for all three units, startup transformers for Unit 1 & 2, house & auxiliary boiler transformers for Unit 2 experienced oil pressure relief valve actuations and corresponding over-pressure alarms due to sloshing of insulating oil in the transformer tanks. At the time of the biggest aftershock on April 7, main & house transformers for all three units, startup, auxiliary boiler & exciter transformers for Unit 2 experienced the same events as above. Activation of pressure switches in oil-insulated transformers due to sloshing is a common earthquake effect.

Figure 7-18 Activated pressure relief valves for unit 1 start-up transformer (example)

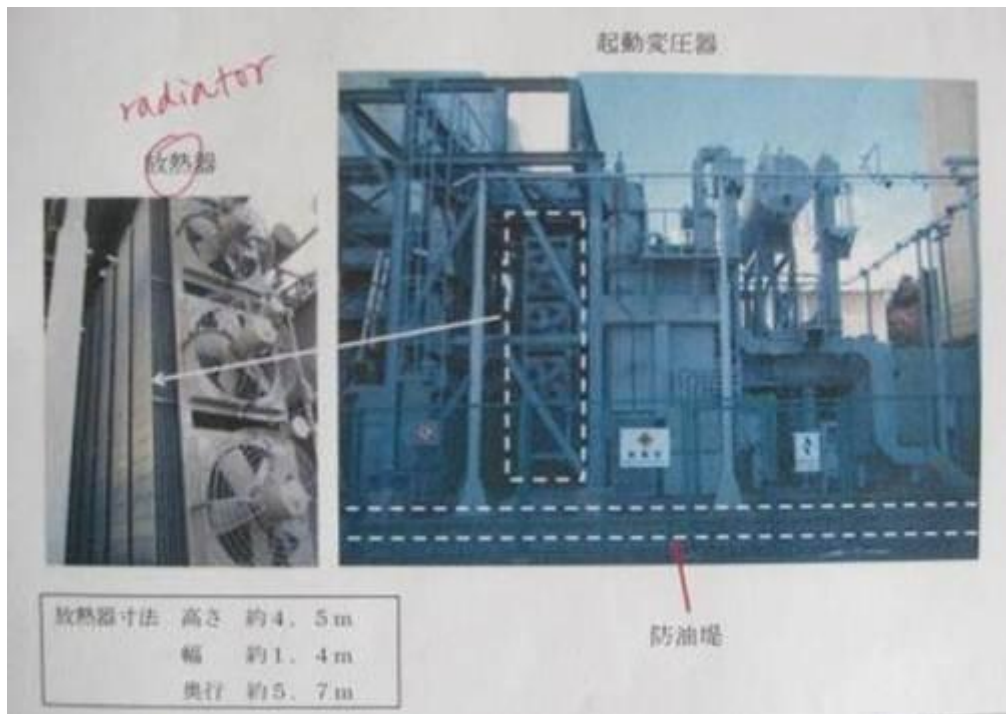
A crack occurred in a fin of the radiator for the Unit 2 startup transformer, leaking a small amount of oil. Oil leaks are common in transformer radiators, but usually occurring at the flanged connection of the cantilevered radiator mass. The fact that the leak occurred in a fin rather than the radiator pipe attachment may indicate an impact of the radiator against adjacent steel see **Figure 7-19**.

Figure 7-19 the radiator fin of the Unit 2 startup transformer

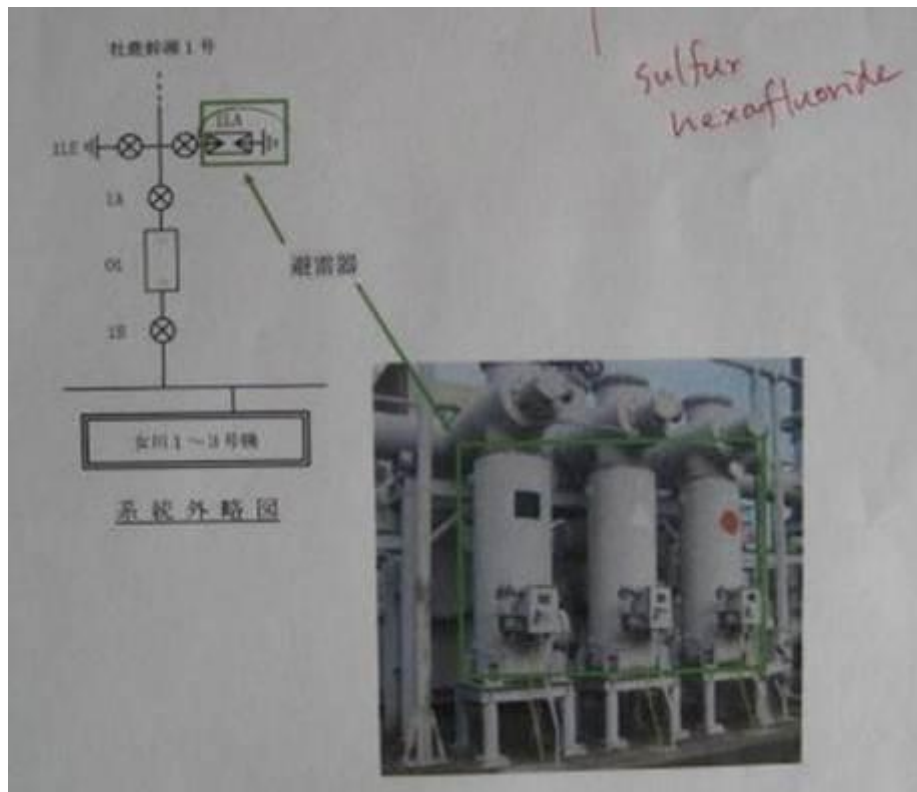
Partially burnout occurred in two over-current surge (lightening) arrestors in the sulfur-hexafluoride (SF-6) switchgear on the 275-kilovolt lines. The sudden over-current was apparently caused by reduction of insulating gap between an energized part, voltage distribution shield, and arrestor elements, zinc oxide, due to sway of lightning arrestors connected to the two Oshika lines. The surge arrestors have since been replaced by seismic resistance improved model that have a less moment arm and rigid seismic supports, see **Figure 7 20**.

Figure 7-20 Simplified diagram and photo of the surge arrestors in the SF-6 system for the 275-kV lines

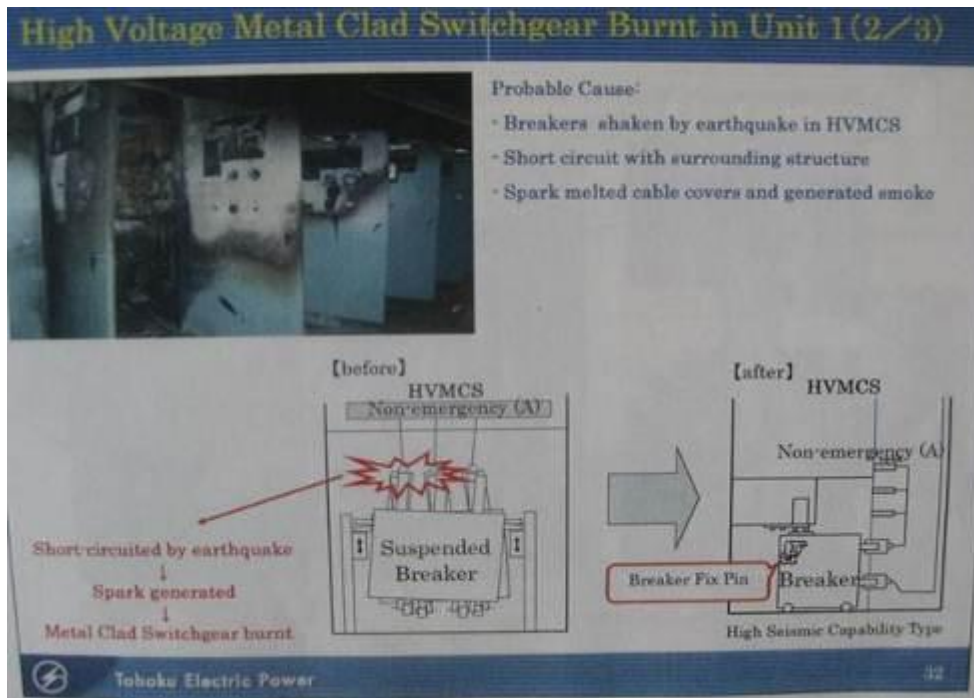
The Unit 1 power train at 6.9-kilovolts (the voltage for large motors) includes five switchgear assemblies (refer to the one-line diagram below for all three units). The Unit 1 non-safety-related power supply Train A consists of vertically-racked circuit breakers, unlike the horizontally-racked breakers in safety-related switchgear. Rocking of a vertically-racked breaker apparently fractured the insulators enclosing the bus clamps at the top of the breaker, allowing bus contact with the cabinet sheet metal. The resulting ground fault and short circuit flash started a small fire in the cabinet, consuming the cable insulation and the few other flammable materials in the cabinet. The arc and fire damage took the A switchgear assembly out of service. The activation of the protecting relay for start-up transformer caused the loss of offsite power in Unit 1 see **Figure 7-21.**, **Figure 7-22.** and **Figure 7-23.**

Figure 7-23 Photos & illustrations of the ground fault damaged vertically racked breaker provided by Tohoku EPCo

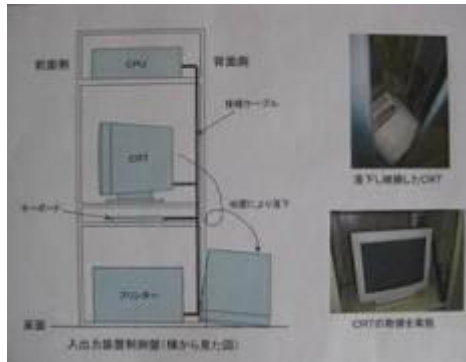
In the Unit 2 main control one unanchored CRT monitor toppled from the main control board. Soon after an operator re-stand it, using this monitor operators witnessed tsunami scenery at the port area. An unanchored CRT monitor toppled from a rack in the refueling-crane-mounted control room of Unit 1, see Figure 7-24. An unanchored programmable logic controller module toppled from a desk in the refueling control room of the Unit 3 reactor building.

Figure 7-24 Unanchored desk or rack-mounted equipment

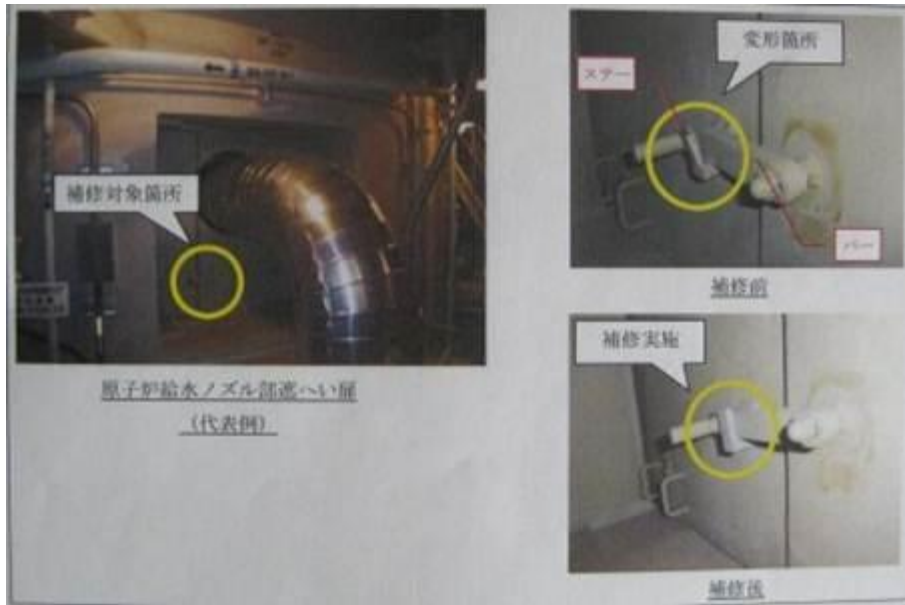
At seven doors in the three reactor buildings, yielding was observed in the steel latches for hatches. Locations where hatch latch yielding was observed were inspection hatches, which include for a penetration for a feedwater line, through the reactor thermal shield walls of Units 2 & 3 see Figure 7-26.

Figure 7-26 Yielding in the steel latches for hatches

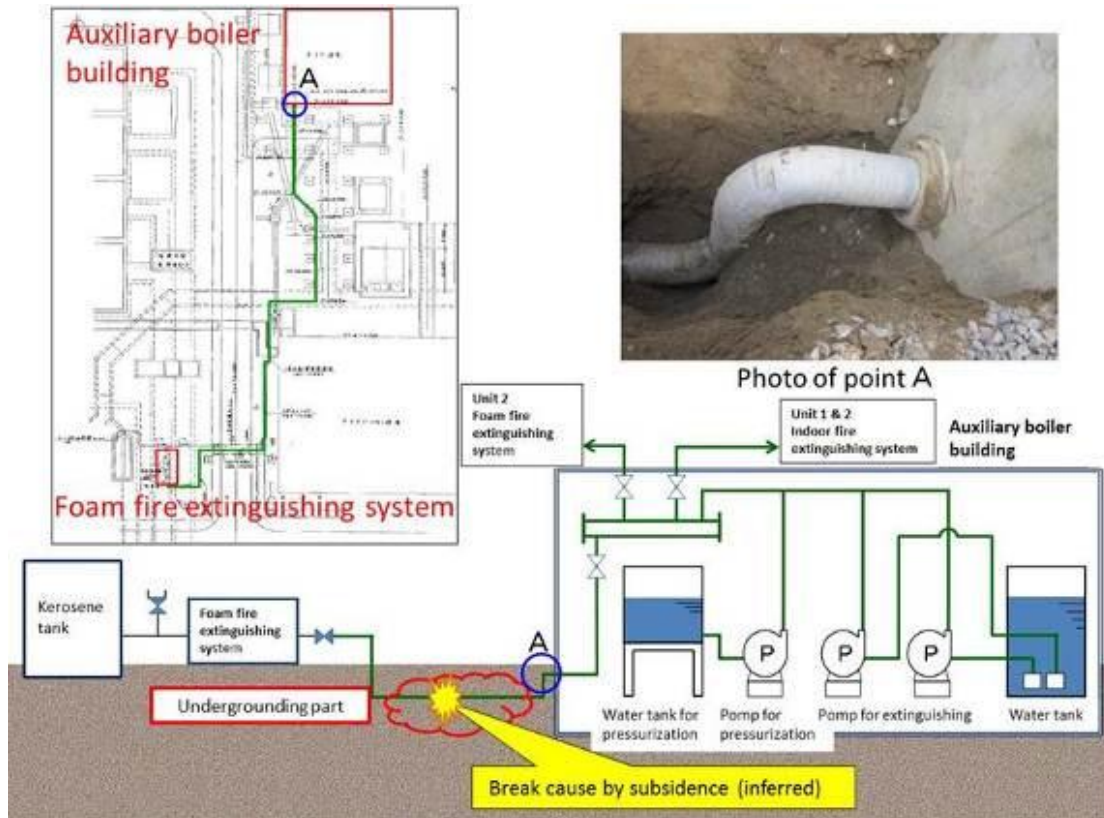
The only instance of a reported pipe failure was in a section of buried Unit 1 fire protection pipe shown below see Figure 7-28. The failure is believed to be due to soil settlement which was significant around the site. All the safety related pipes are in concrete channels preventing failure.

Figure 7-28 Pipe failure in a section of fire protection

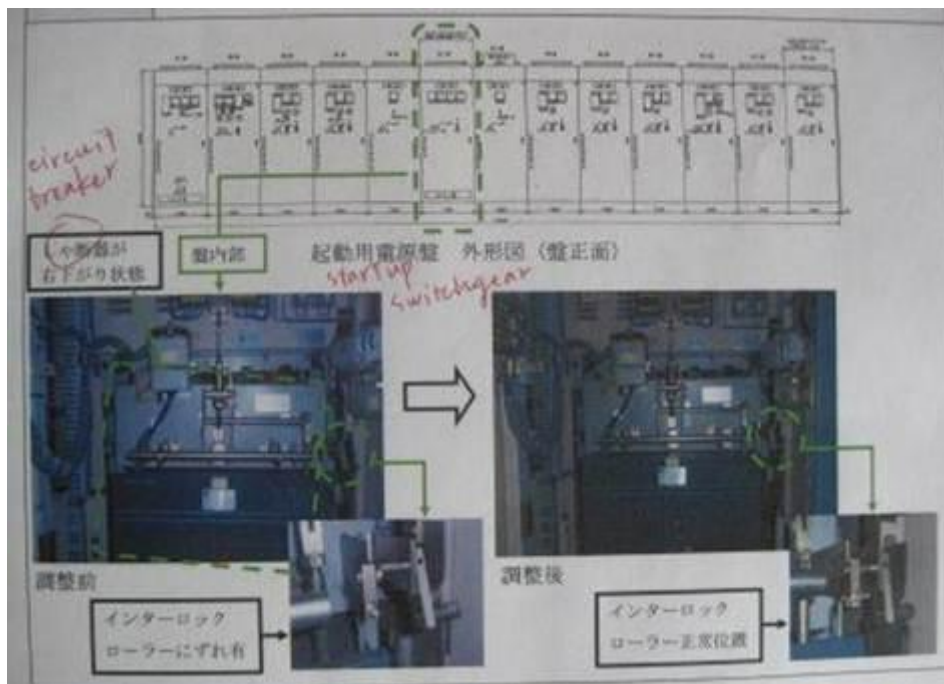
Figure 7-29 Dislocated interlock roller that push the switch for connecting circuit breaker(left), aligned interlock roller(right)

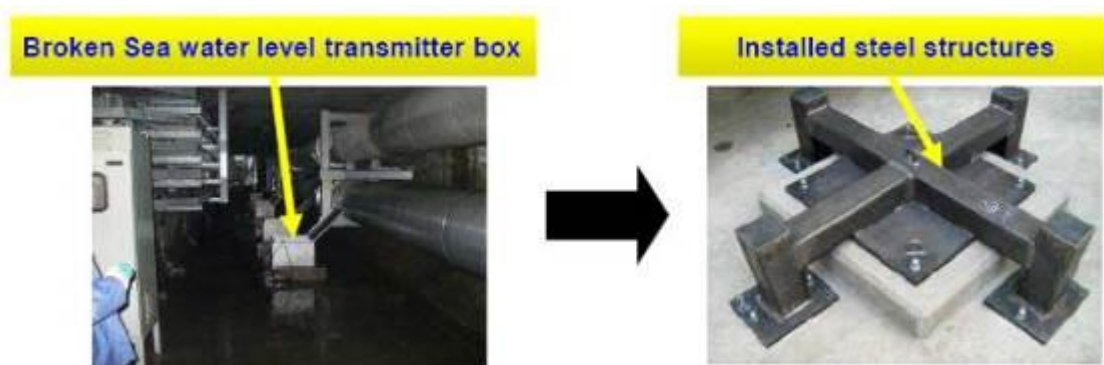
Figure 7-33 Broken sea water level transmitter box and the new type of transmitter box lid at Unit 2

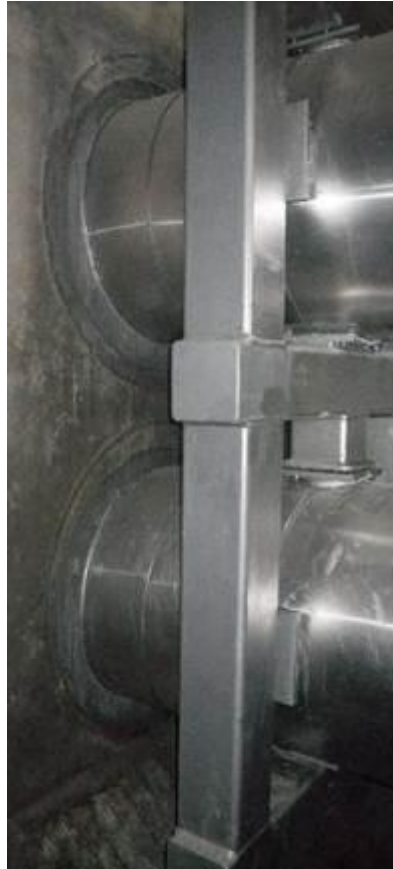
Figure 7-35 Pipe penetration from the RSW pit to the RSW trench
The resin sealant (dark gray rings between wall penetrations and RSW pipes) is installed after
March 11 Tsunami at Unit 2.
