MISSION REPORT

IAEA MISSION ON PARTIAL COLLAPSE OF TURBINE HALL ROOF OF UNIT 4

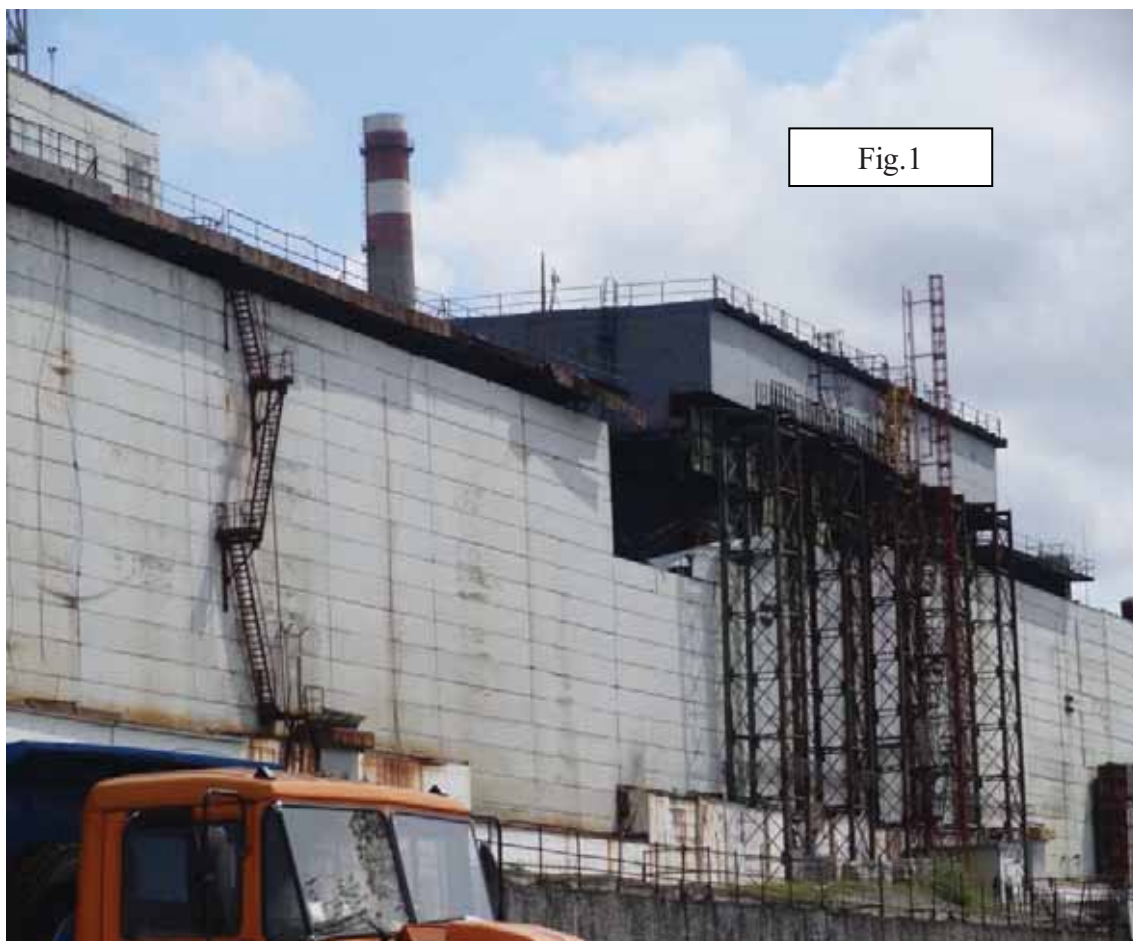
Figure 1 Turbine Building outside view of area of collapsed wall and roof section

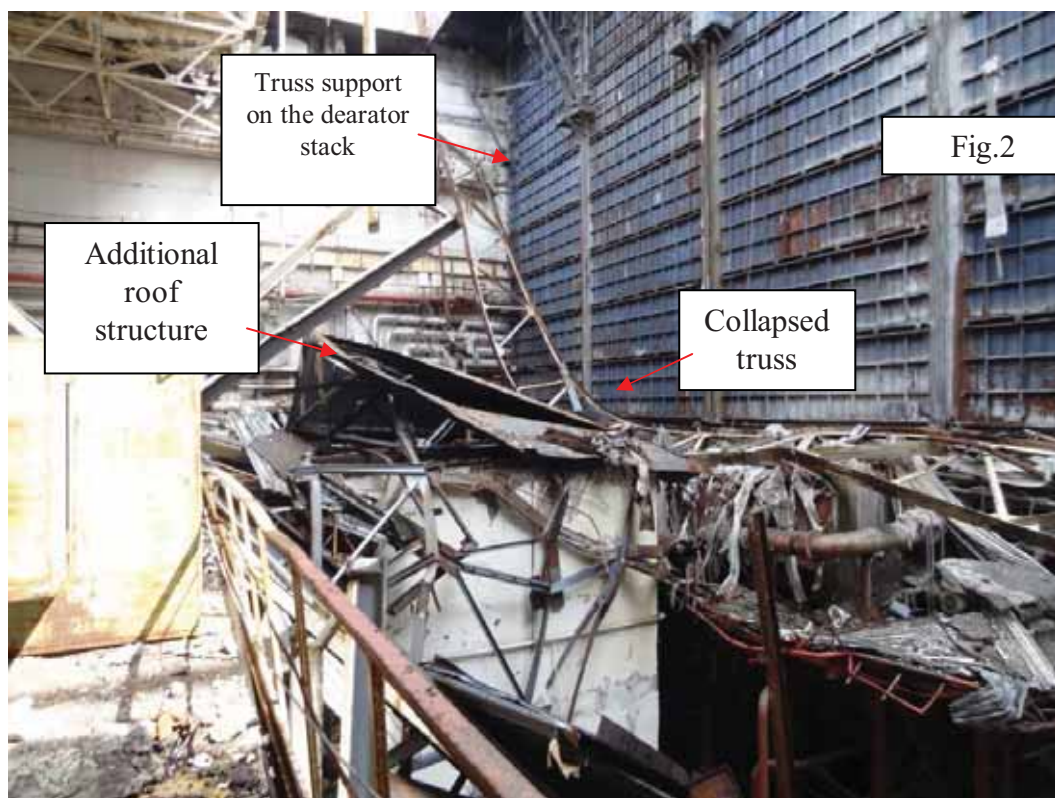
Figure 2 Turbine Building inside view of main floor area under collapsed roof section

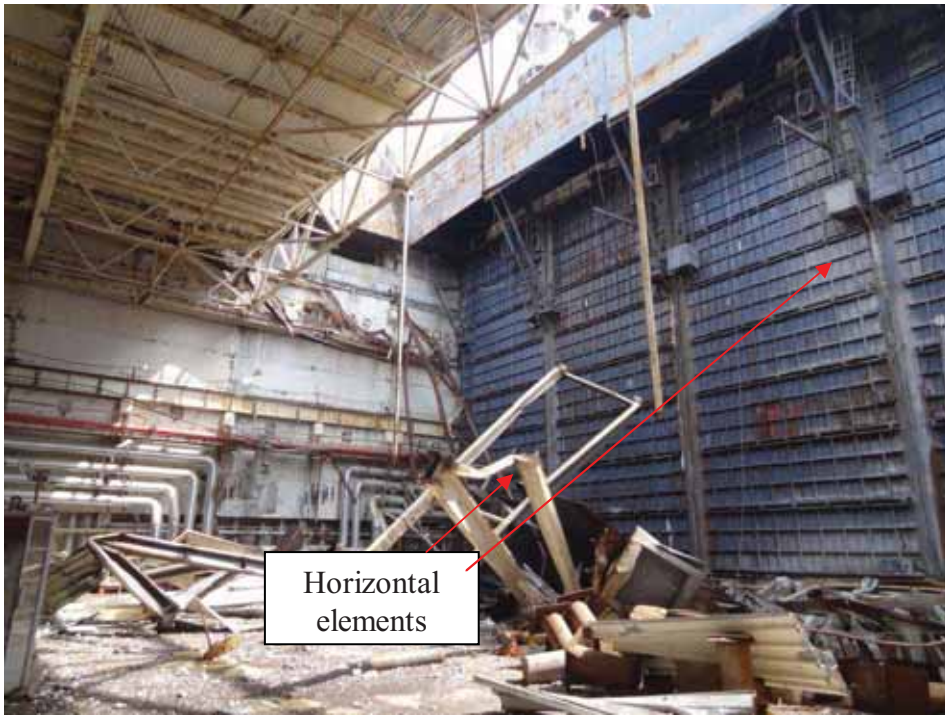
Figure 3 Turbine Building view of area of collapsed roof section

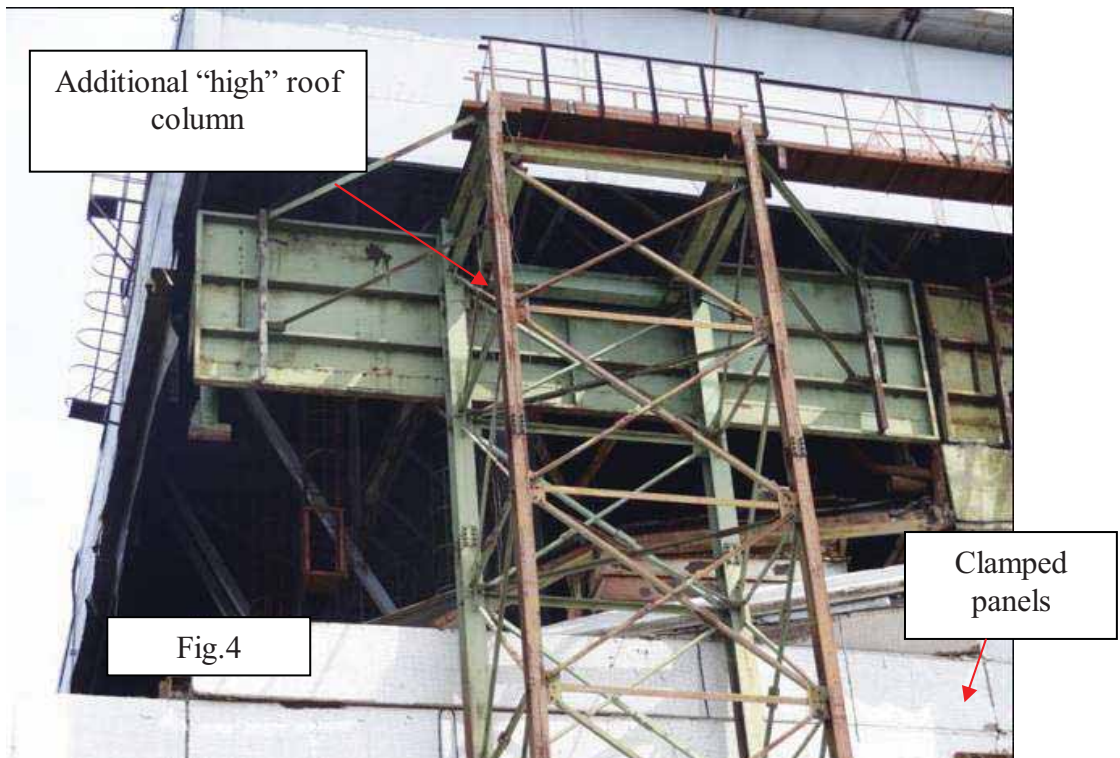
Figure 4 Turbine Building view from outside of wall panel failure in “high” roof zone next to gridline 50

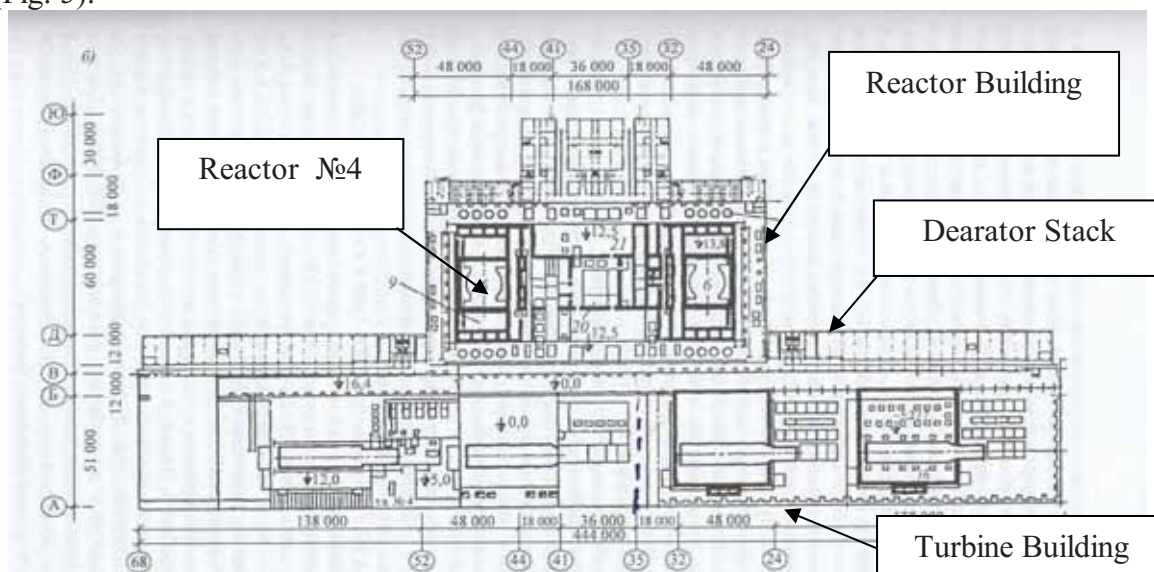
Figure 5 Plan view ChNPP main structures, part II (Units 3 and 4)

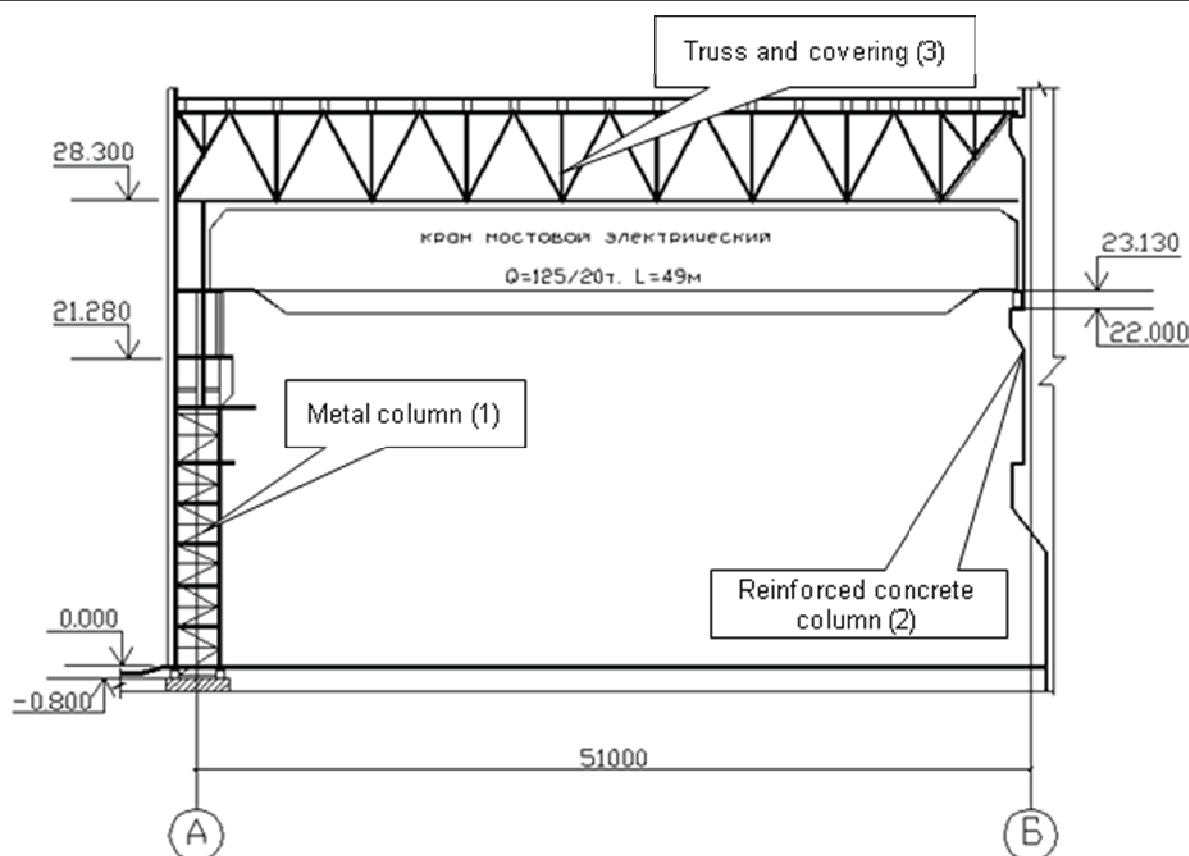
Figure 6 Section of ChNPP part II (Units 3 and 4) Turbine Building

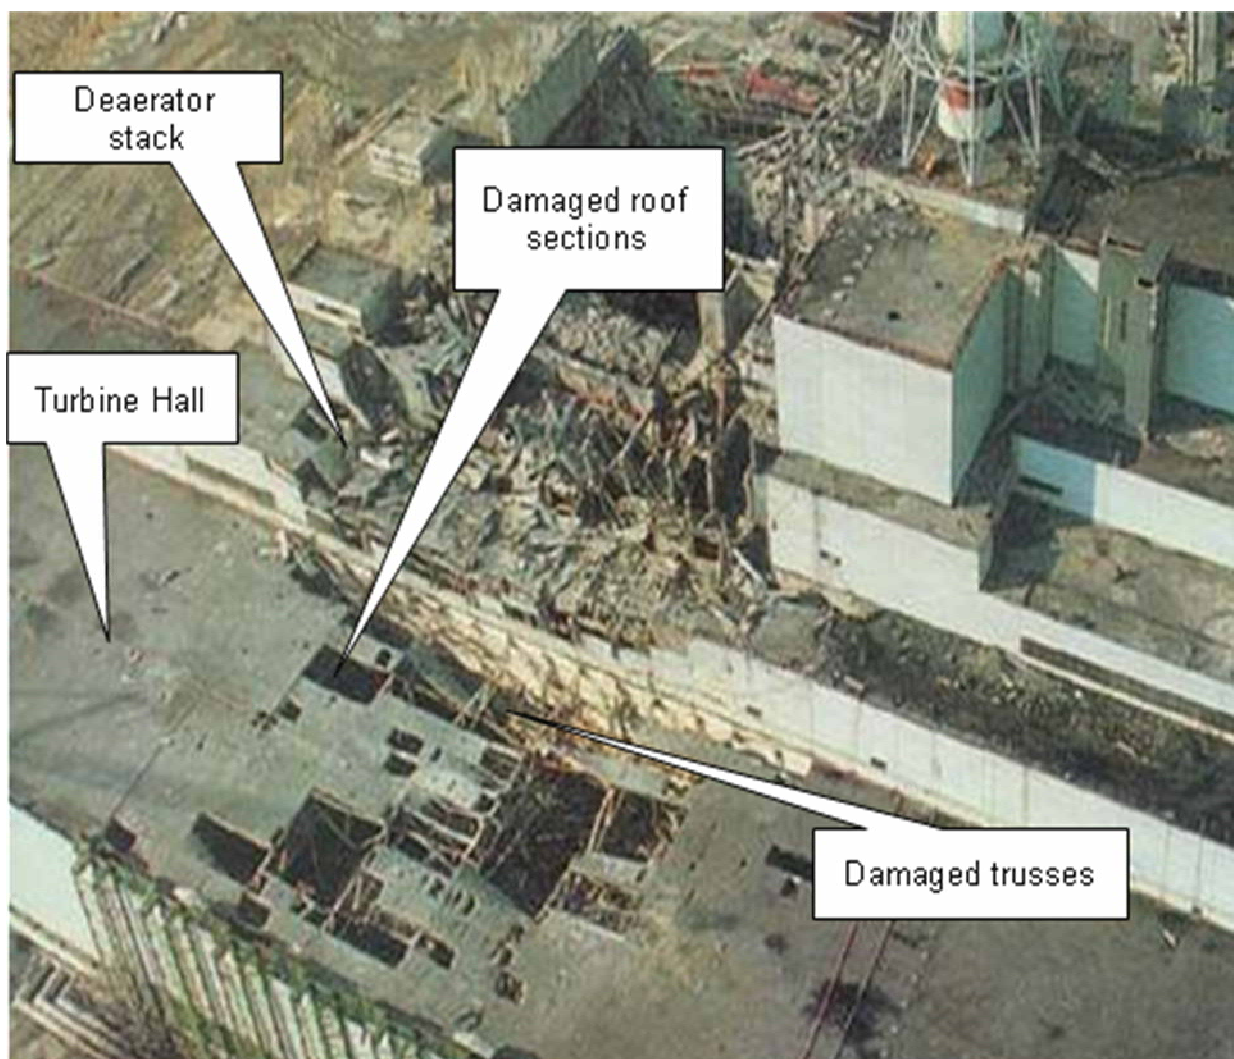
Figure 7 Damages to ChNPP generation II structures (Units 3 and 4) as a result of the accident

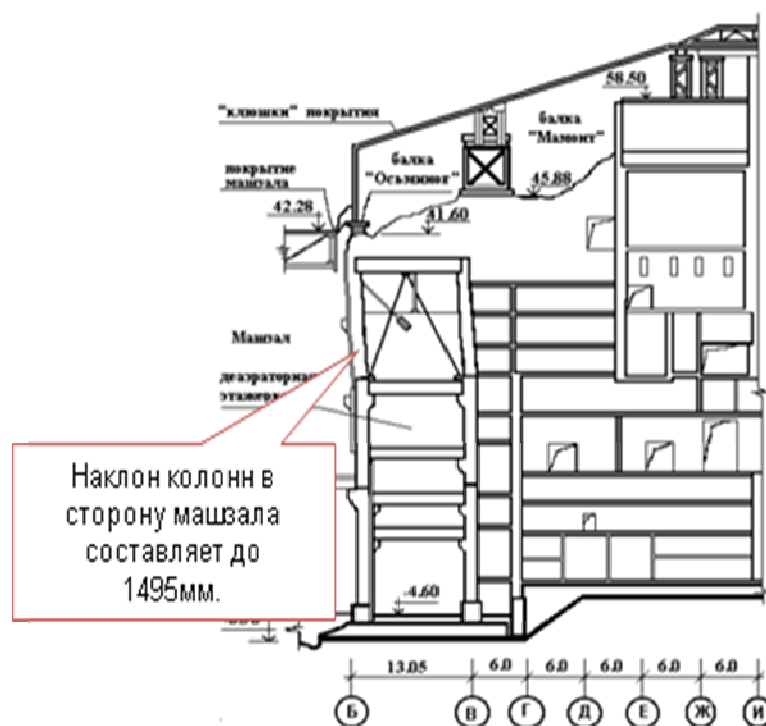
Figure 8 Deaerator stack structure damages

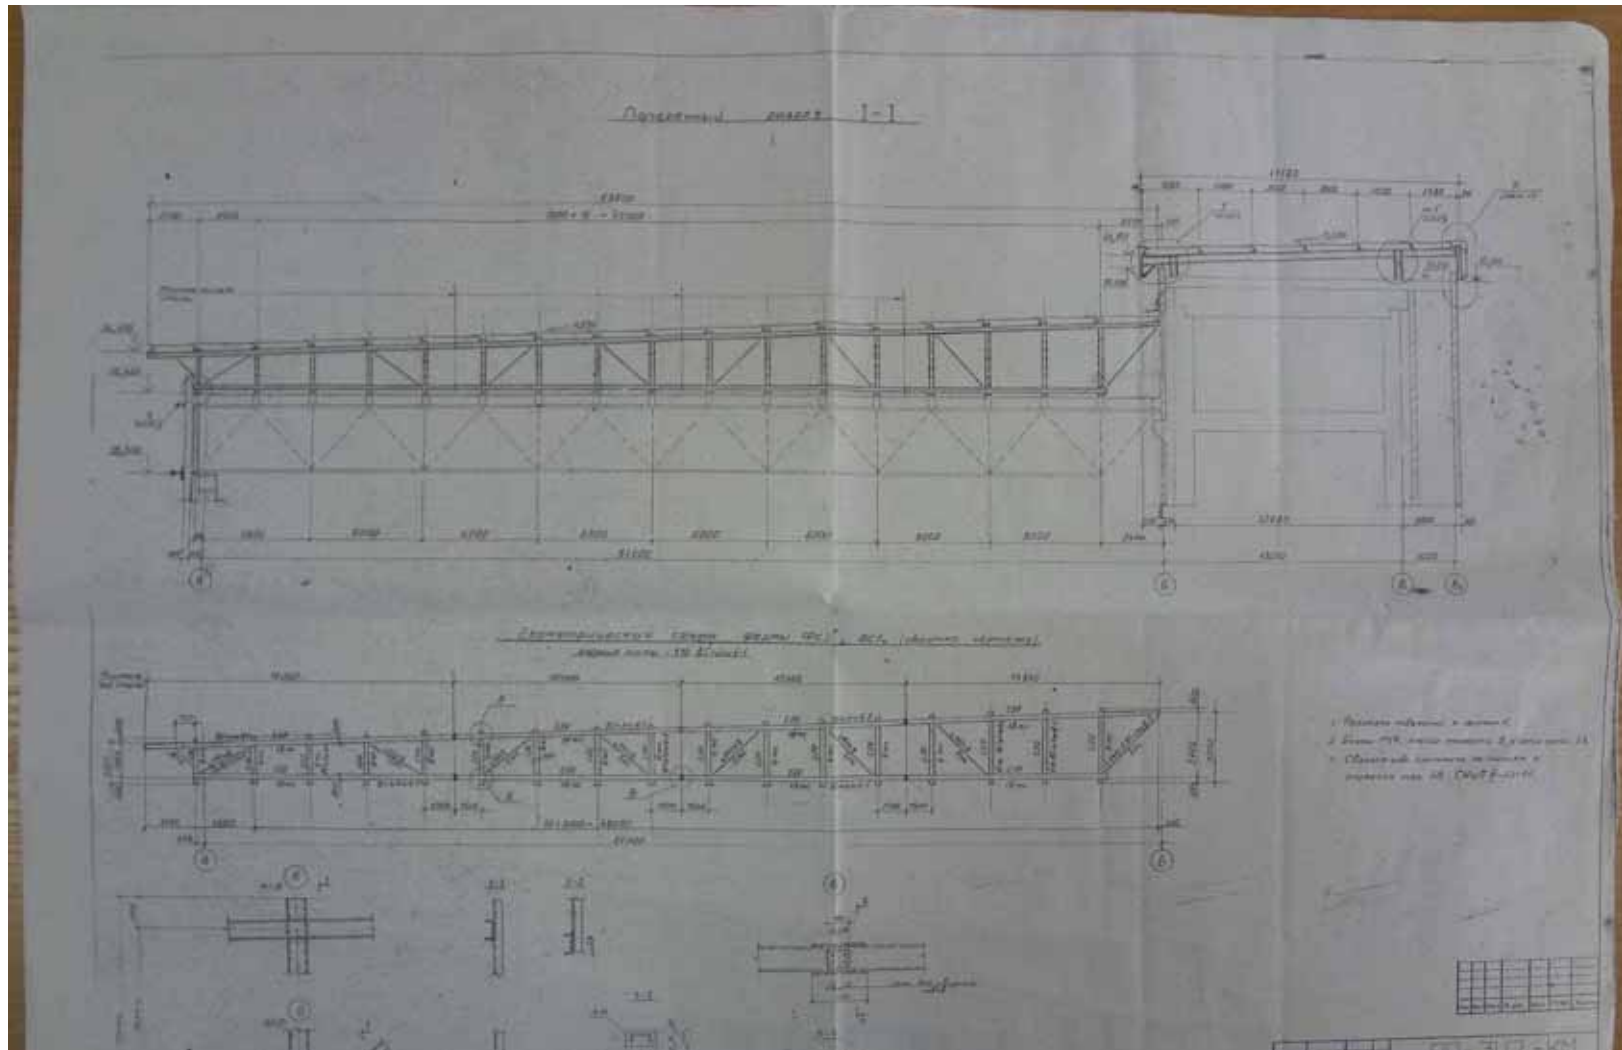
Figure 9 Transverse section of second roof structure in “low” roof area

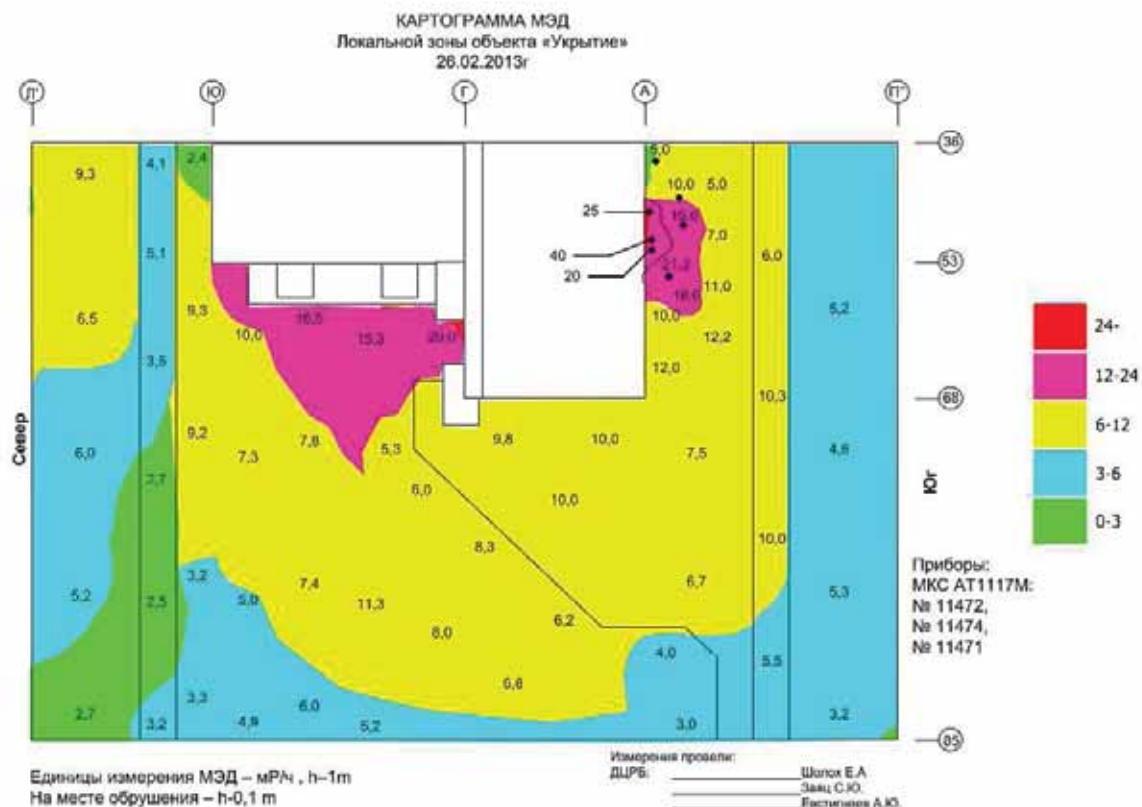
- The monitoring program is being performed every day controlling the dose rate, surface contamination and air contamination.
- Dose rate measurements were performed during the walk through and good agreement was found with the results of the monitoring team.

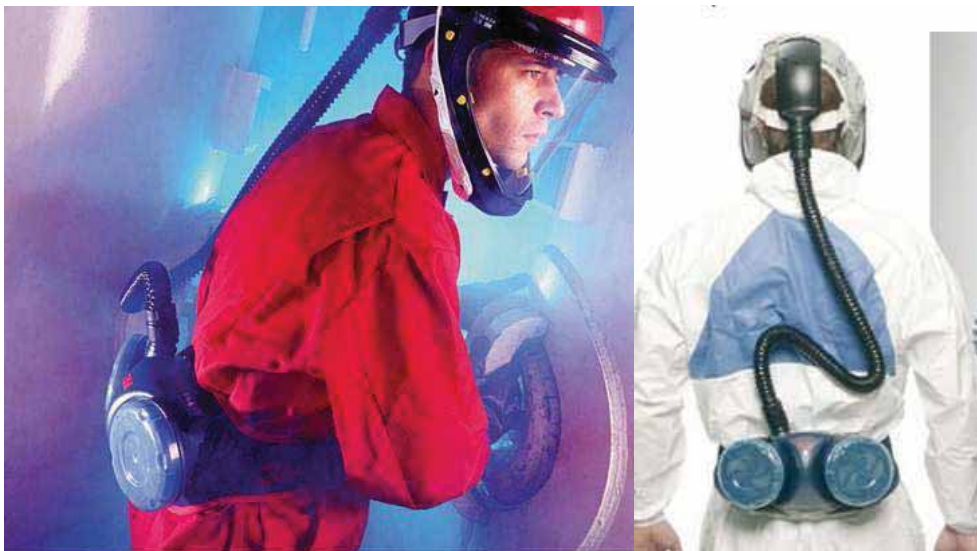
Figure 11 Example of ventilated masks
