# Occupational Radiation Protection during High Exposure Operations

Lessons Learnt from Occupational Radiation Protection  
in Past Accidents

Radiological Accidents – Goiânia Accident

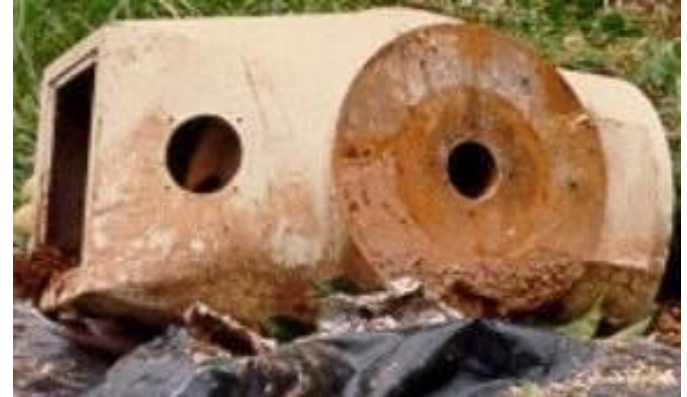
Sept 10 – 13: Source assembly was removed from the device and taken away

Sept 18: CsCl capsule was punctured in junkyard and sold

Sept 21: CsCl was removed from the capsule and distributed to several families

Sept 25: Rest of source assembly was sold for scrap

Sept 28: A number of people were already physically ill.

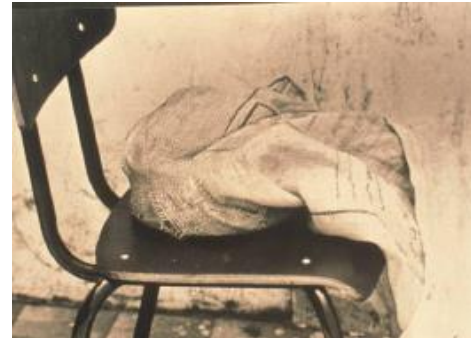
The remains of the  $^{137}\text{Cs}$  teletherapy source wrapped in a cloth bag on a chair in the "Vigilancia Sanitaria"

Sept 28: The remnants in a bag was transported to the Sanitary Service Office by the junkyard manager's wife who was convinced that the glowing powder from the source assembly was causing the sickness.

Sept 29: A medical physicist who happened to be visiting Goiânia was called and confirmed the presence of a huge amount of radioactive material using a NaI(Tl) scintillation survey-meter

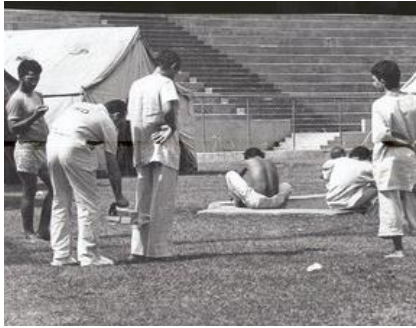
## Survey meters used

Type	Num. of used	Robustness	Resilience in adverse condition	Response	Num. of failures	Failure rate
<b><u>Dose rate monitor</u></b>						
GM tube	27	very good	very good	very good	3	11%
Proportional counter	2	very good	acceptable	excellent	1	50%
Ionization chamber	16	very good	acceptable	poor	1	6%
Teletectors / telescopic	7	very good	acceptable	excellent	1	14%
Teletectors / articulated	3	very good	very good	good	0	0%
End window GM tube	11	very good	very good	excellent	3	27%
<b><u>Contamination monitor</u></b>						
Proportional counter	7	poor	good	excellent	5	71%
Side window dose GM tube	2	very good	very good	adequate	0	0%
Scintillation detector	3	very good	very good	very good	0	0%

- It is necessary to have confidence in the radiation detection equipment. Before use the equipment should be switched on and passed through a functional test. If no check source is available, the background reading should be noted. If there is no background or if the detector goes off scale, then the detector should be rejected or the batteries changed. Ideally the first responder will be familiar with the dose rate measuring equipment he or she is using.
- External decontamination of patients should take priority over environmental contamination considerations. Any personnel decontamination actions will not significantly increase the already existing environmental contamination.
- A major population center should have at least 10 electronic personal dosimeters available to civil defense workers that can be used immediately in the case of a large scale emergency response

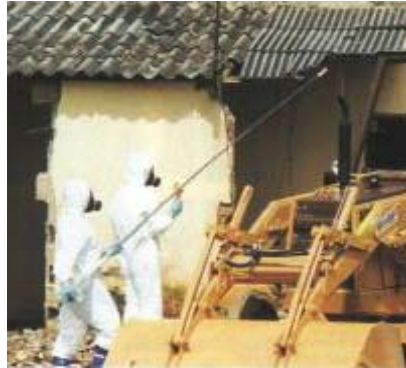
Surface monitoring at Olympic stadium

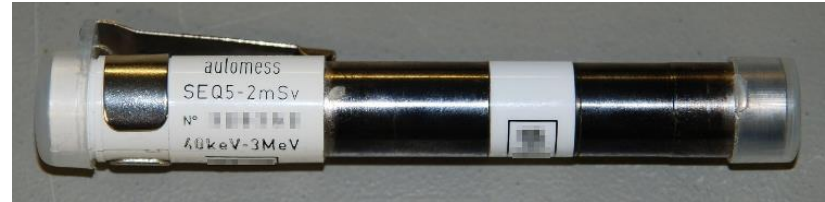
- Daily dose control of workers was mainly made using Quartz Fibre Electrometers (QFE).
- 450 QFE pens were used.
- Each worker used two QFEs (0 – 2 mGy and 0 – 50 mGy range).
- 8 of the QFEs were chosen at random for overnight calibration by  $^{137}\text{Cs}$ .
- QFEs with calibration factors above 1.2 or below 0.8 were not used.

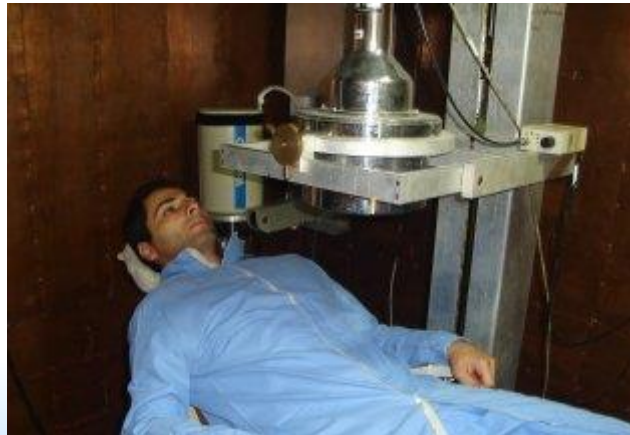
IRD's whole body counter

- 194 occupationally exposed persons were monitored for internal contamination at the IRD's whole body counter.
- 38 workers exceeded the MDA (74 Bq for a 30 min measurement).
- The maximum internal contamination was  $2.0 \pm 0.3$  kBq, corresponding to a committed effective dose of about 2  $\mu$ Sv.

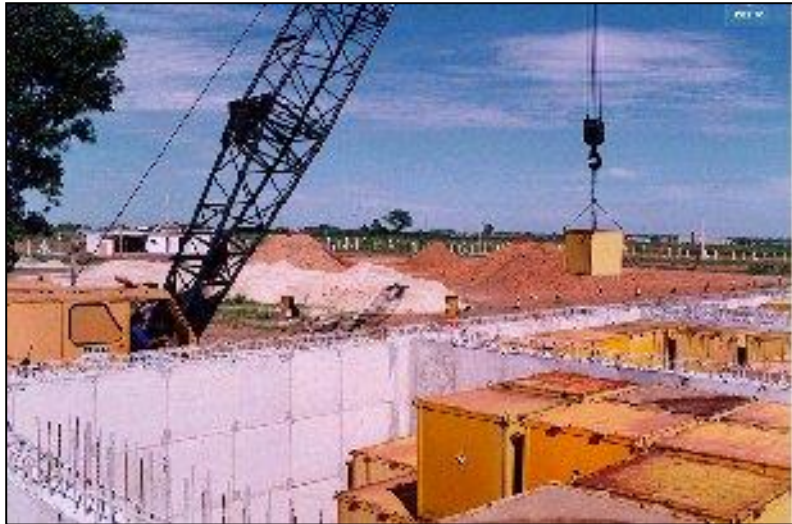
# Final waste deposit – City of Abadia, Goiania

Around 3,500 m<sup>3</sup> of contaminated waste

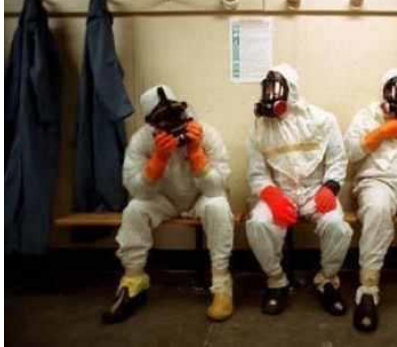
- The public responded to the workers in protective suits with suspicion, fear, and in some cases, even physical threats.
  - Workers were instructed to accept offers of drinking water and food from people's houses to increase public confidence.

- The image shows three individuals in full-body white protective suits, including hoods and respirators, sitting on a wooden bench in what appears to be a locker room. They are wearing orange gloves and various colored boots (yellow, black, and yellow). The room has lockers in the background with blue coats hanging on them.

- Considering the climatic conditions, a certain number of powered & supplied air respirators should be made available for heavy duty decontamination work. Disposable respirators are useful to avoid ingestion of radioactive material, but the protection factor is too low for most decontamination operations
- The cost of PPEs can represent a large part of the emergency budget, a line of credit with sufficient funds is necessary to be able to immediately buy the PPEs required
- Establish the dosimeter exchange frequency to be not longer than a month but at least for a period of time where the expected recorded dose will be above 1 mSv. In areas where the dose rate may increase rapidly, active dosimeters with alarms must be worn
- Ensure that all dosimeters are placed in a plastic outer protective covering before entering a contaminated area.

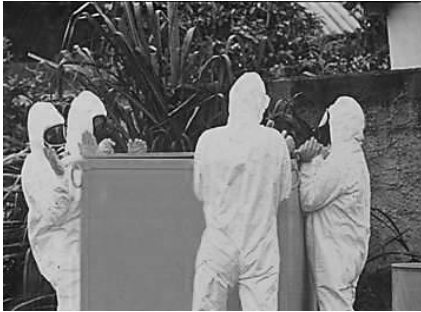
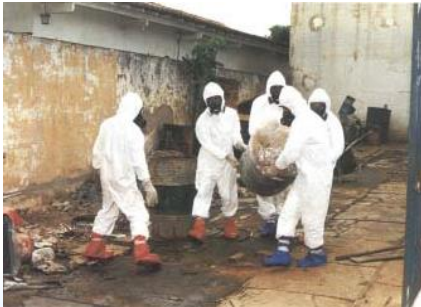
### Situation of workers during emergency operations

- Extreme environmental conditions increased the workers psychological stress. Teams often worked for 15 hour shifts in 40° C.
- Personnel had to wear protective clothes and perform strenuous manual work while giving moral and psychological support to the population.
- The teams were constantly surrounded by people asking for reassurance and information.
- Over time, many responders started manifesting psychosomatic symptoms resembling acute radiation syndrome.
