Occupational Radiation Protection during High Exposure Operations

Lessons Learnt from Occupational Radiation Protection in Past Accidents

Nuclear Accidents – Fukushima Accident –

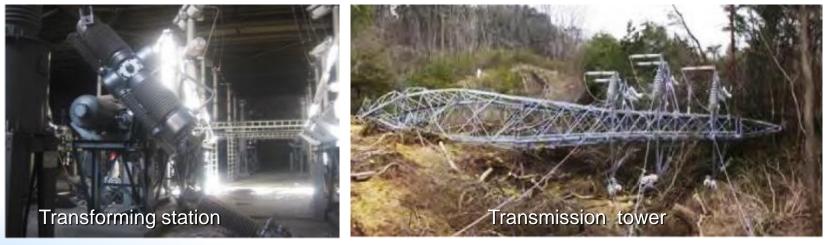
- All reactors in operation were automatically shut down by the earthquake
- At same time, all off-site electric power supply to FDNPS were lost due to the destruction of transforming stations and a transmission tower

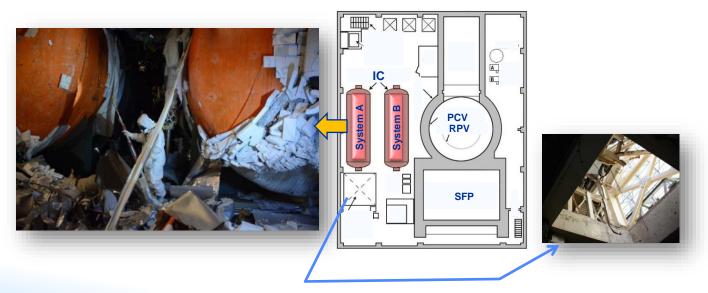
<u>ICs</u>

- One of the cause of this disaster is thought that the Motor Operated (MO) valves of the Isolation Condenser (IC) in the Unit 1 were closed from the beginning.
- Design policy of the Unit 1 was "Enclose radioactive substance in emergency", so IC valves were designed to close in case of piping rupture
- In this accident MO valves were closed automatically by a false signal of "Piping rupture" because of DC power loss
- Owing to SBO (Station Black Out) and DC power loss operators could not recognize the malfunction of the IC and believed that the Unit 1 was kept cooling.

IC is a duplex heat exchanger in which condensed water falls by weight of gravity back into the reactor without using powered feed-water pumps
