# Occupational Radiation Protection during High Exposure Operations

Lessons Learnt from Occupational Radiation Protection  
in Past Accidents

Nuclear Accidents – Fukushima Accident –

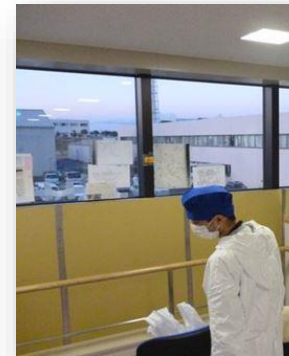
Lead board to shield  
glass windows

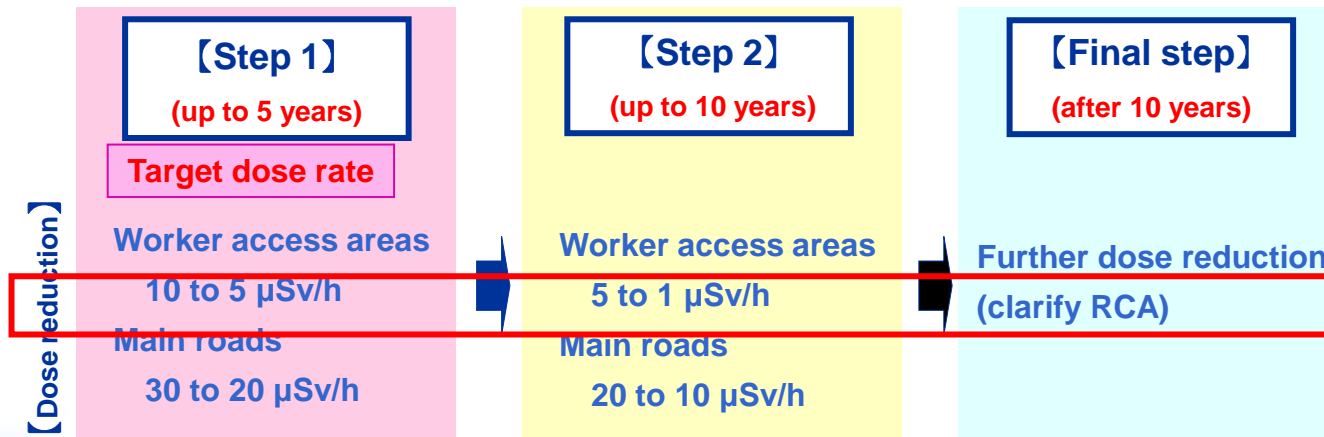
- On-site decontamination has proceeded for the purpose of reducing doses in area where many workers enter, the locations subject to decontamination are selected and target dose rates are set for each step.

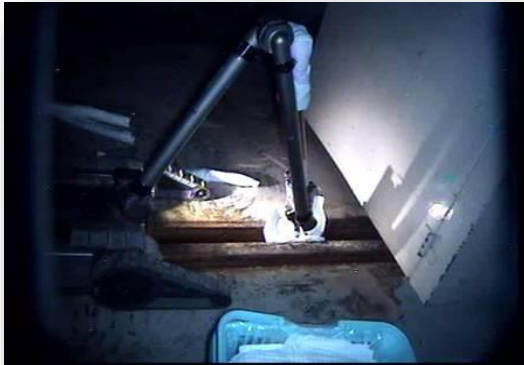
Wiping work with a robot

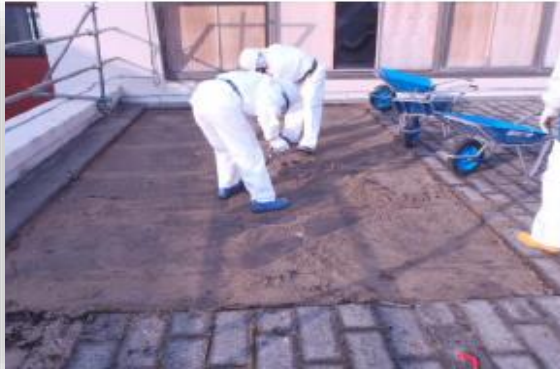
Removal of concrete  
on admin. building

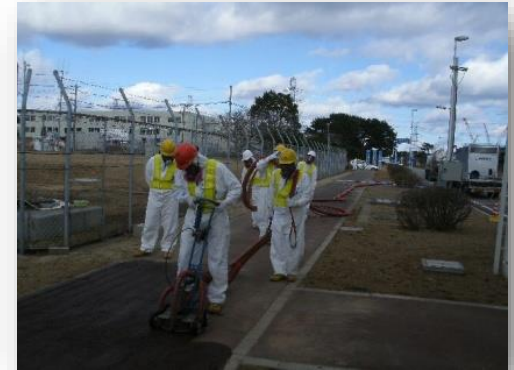
Ultra high pressure  
water peeling

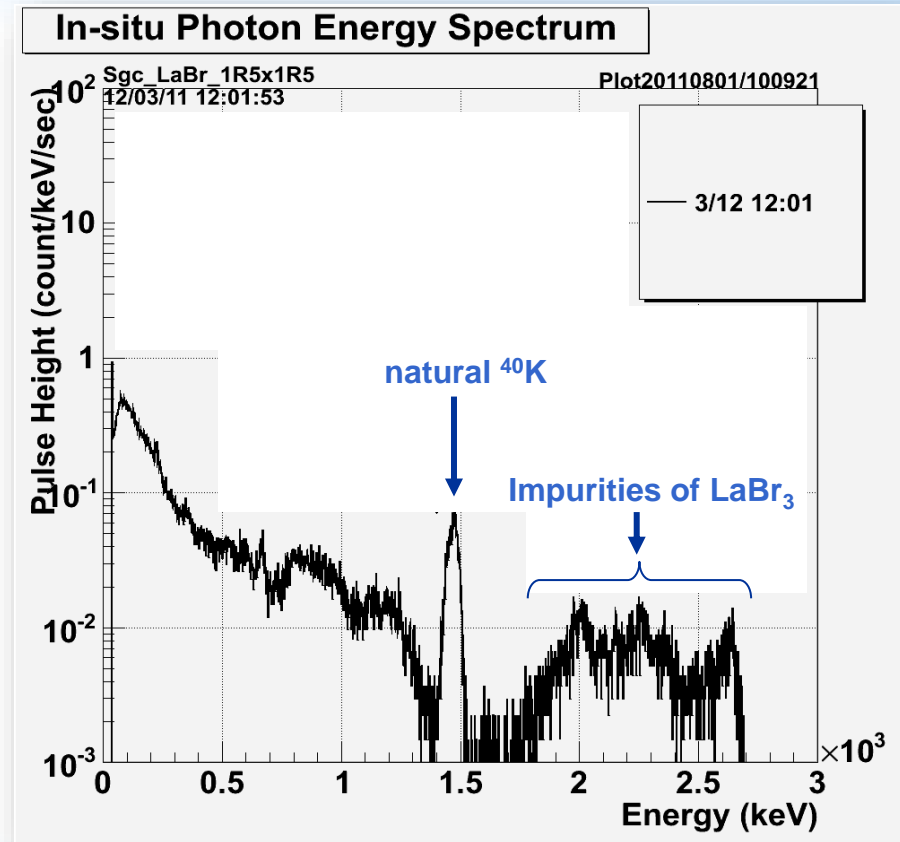
[γ-ray spectrum measured by LaBr3 spectrometer at Okuma off-site center](#)

- It was calm, and the background was around  $0.06\mu\text{Sv/h}$  at Okuma Off-Site center at noon on 12 March, 2011
- However, plume had not yet reached this measuring point

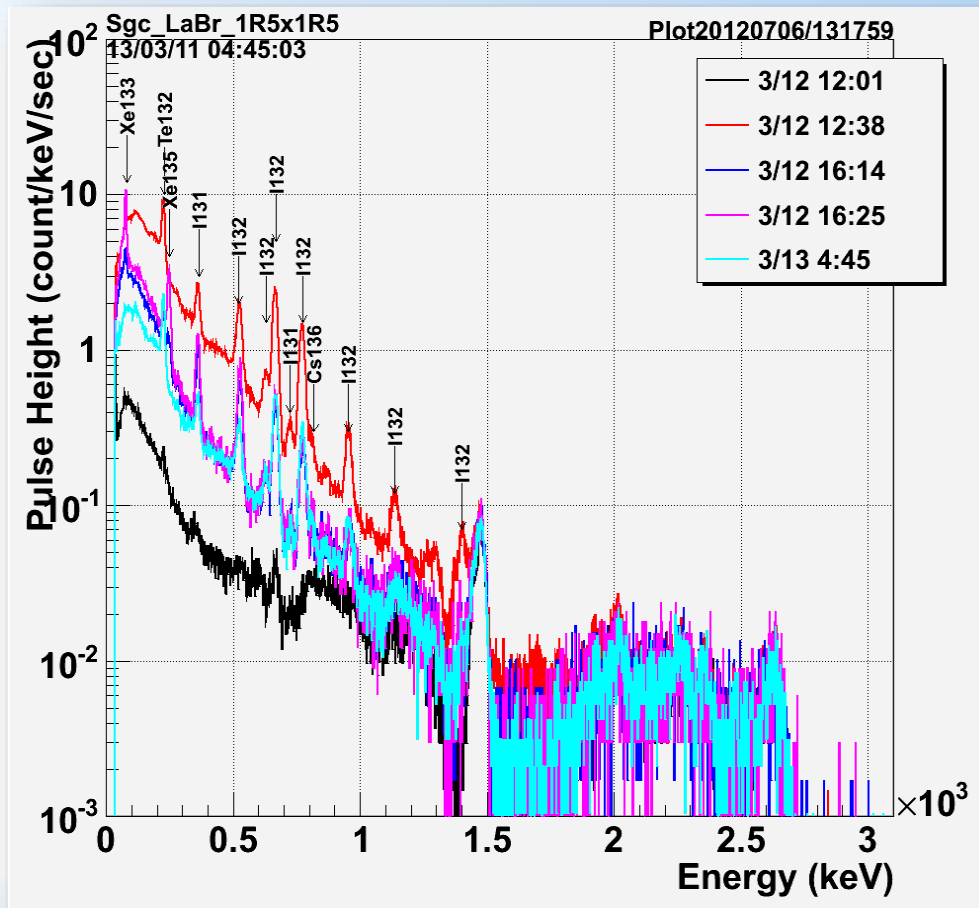
### [γ-ray spectrum](#)

- 30 minutes later, radioactive plume had come just above the center
- Xe-133, Te-132, I-131, I-132, I-133 were mainly observed

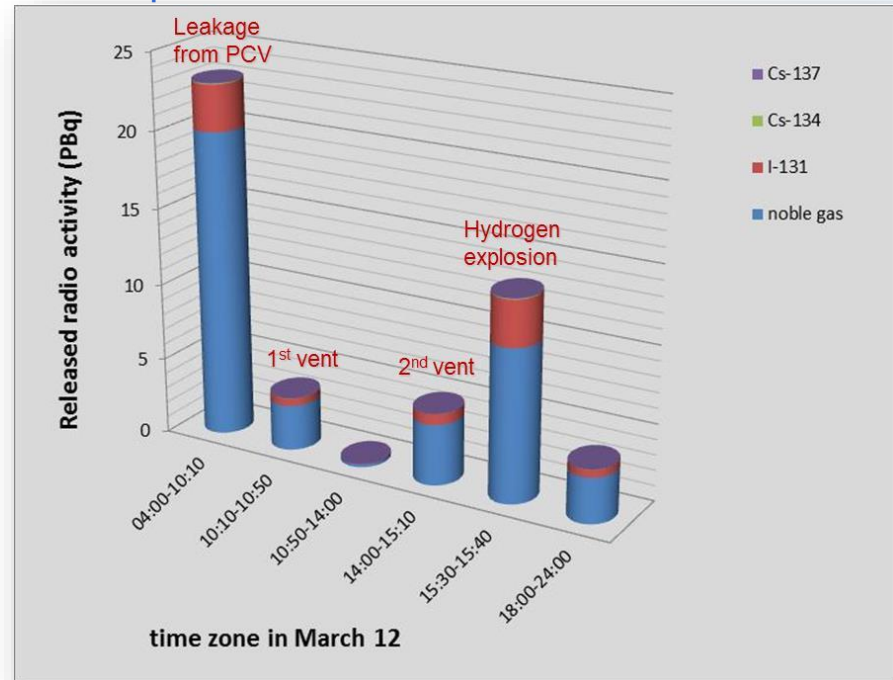
### The first release of the radioactive material

- The origin of this plume must be the wet-well vent operation in unit 1 at 10:17 on March 12 and continuous leakage from the PCV
- Window direction had changed from north to southwest during this 30 minutes at a velocity of 2m/sec, then the plume was coming above the off-site center.
- According to TEPCO's announcement dated in Sep. 2012, 3.5PBq including noble gas, Iodine and Cesium released at this vent.

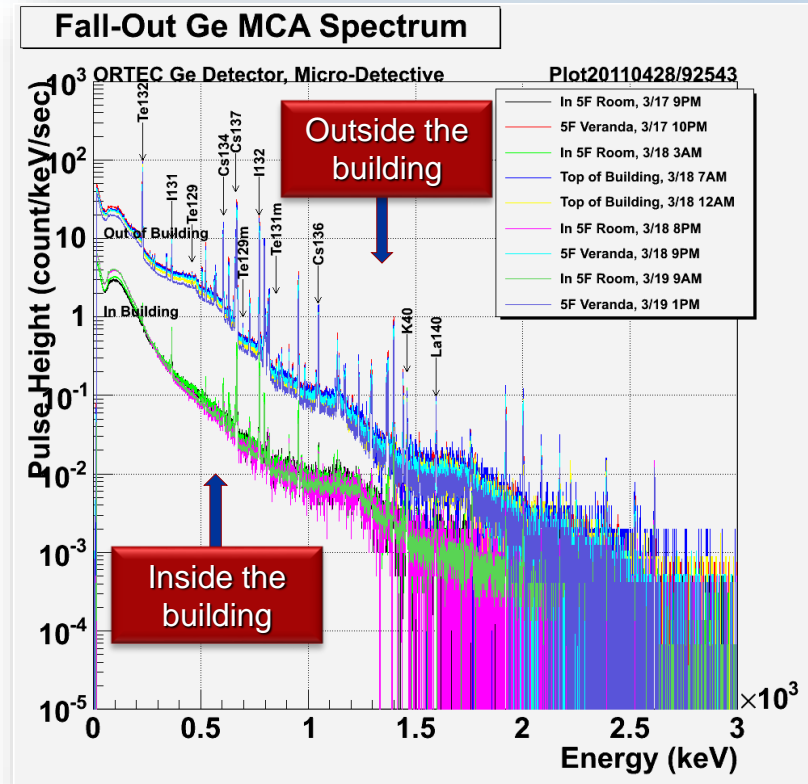
### $\gamma$ -ray spectrum

- Early phase photon spectrum measured by portable Ge spectrometer from 17-19 March, 2011
- Approx. one order of magnitude of shielding effect by concrete building was confirmed

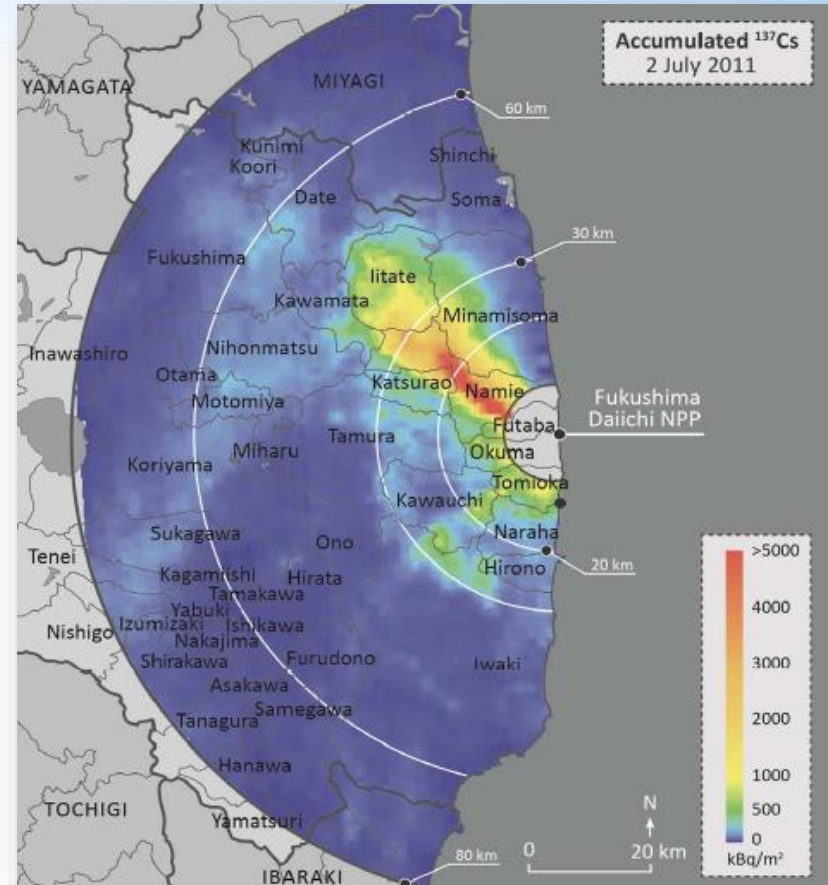
- The contamination map of the Fukushima prefecture was made by an actual soil radioactivity analysis in addition to the aircraft survey and the car survey
- The prime cause that the strong distribution's being seen on the north-northwest side was raining when a radioactive plume reached the area
