Analysis of the TEPCO Fukushima Daiichi NPS Accident

Interim Report
(Provisional Translation)

October 2014

Nuclear Regulation Authority, Japan

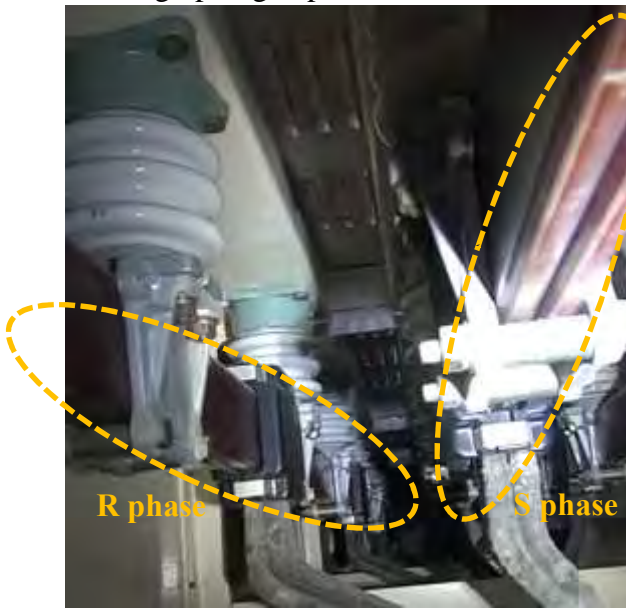
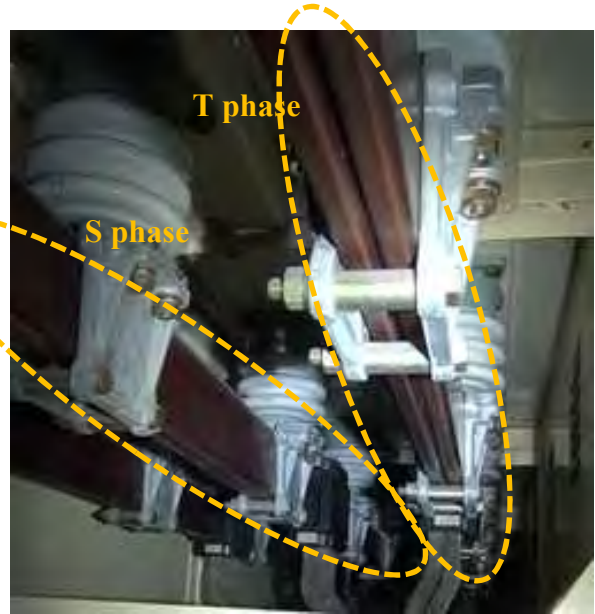
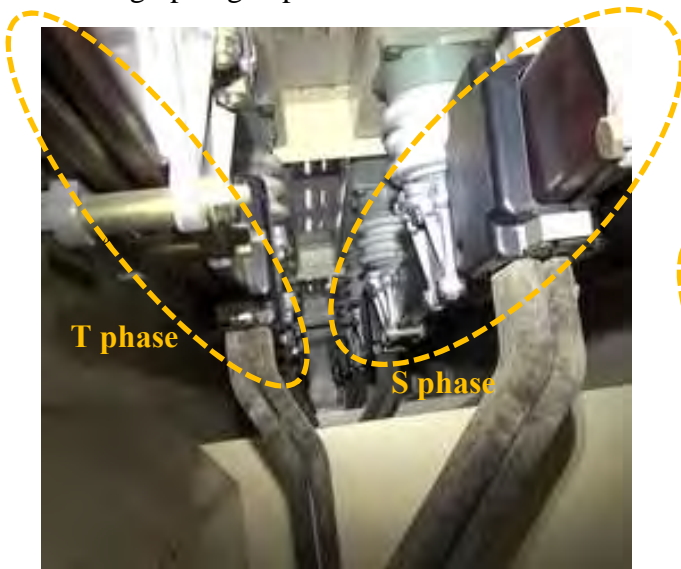
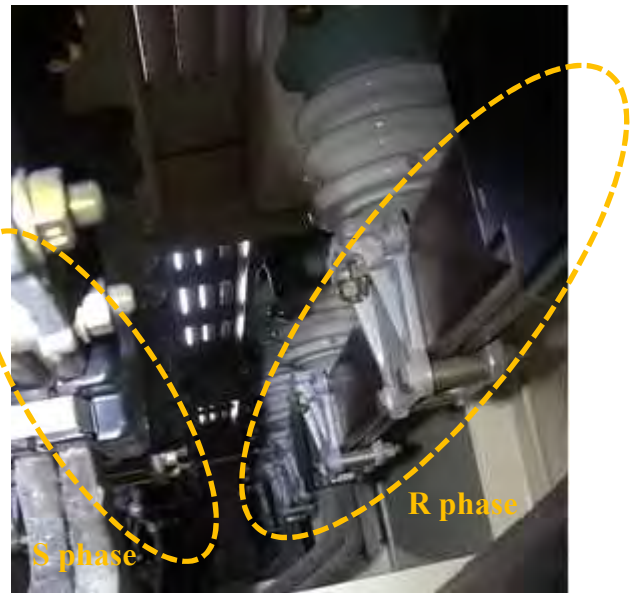
Figure 2.8 Buses and Bus-supporting Insulators inside M/C1C

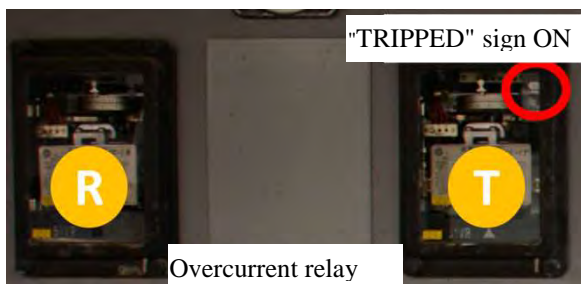
For Condition (g), overcurrent relays for the R and T phases (i.e. apparatus for detecting excessive current) were located near D/G1A side of the D/G1A power receiving circuit breaker ("1" in Fig. 2.11). In the site investigation, the NRA found no "TRIPPED" sign (indicating the relay had been tripped) on the R-phase overcurrent relay, but found one on the T-phase overcurrent relay (Fig. 2.12). However, the NRA estimated that the overcurrent relay did not actually trip, because this sign fell down and was improperly activated by the effects of the earthquake because M/C1C was not consequently damaged and with no short-circuiting or ground fault, based on the results of the analyses below (see 2)).²²

²² The "TRIPPED" sign may be inadvertently activated due to the swaying motion of earthquakes. In such case, the system protection control circuit and other protective circuits will not work because relays do not actually trip (in cases where only the sign was turned on).

Figure 2.12 "TRIPPED" Sign of M/C1C Overcurrent Relay (Cabinet 1)

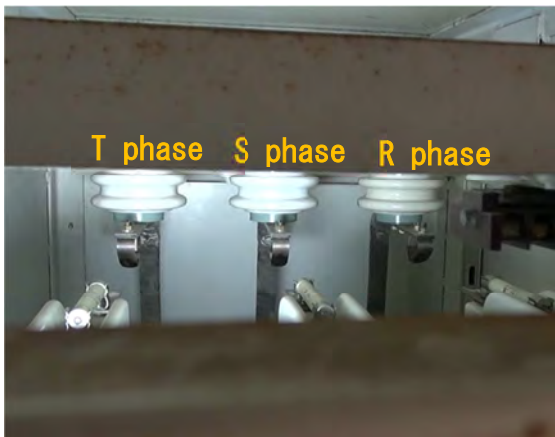
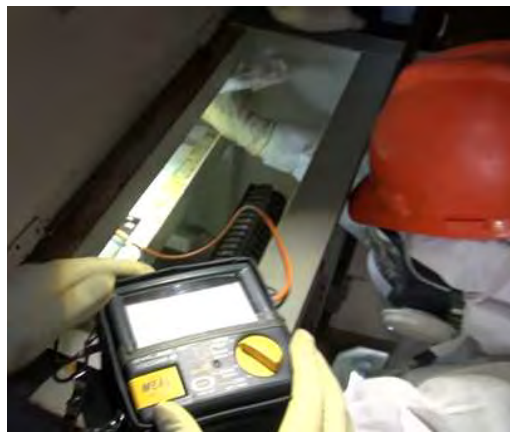
In the site investigation, the NRA measured the interphase insulating resistances of the R, S, and T phases of the buses to examine whether the bus in M/C1C was short-circuited or grounded by the effects of the earthquake.²³ The measured interphase insulating resistances were 2.8 MΩ between the R and S phases, 1.9 MΩ between the S and T phases, and 2.7 MΩ between the T and R phases²⁴ (Figs. 2.14 and 2.15). The NRA staff opened the M/C1C cabinet and visually investigated the condition of the bus. The NRA could not find any thermal or physical damage of buses and bus supporting insulators (Fig. 2.8). Judging from the above, the NRA estimated that the R, S, and T phases of the bus were completely insulated from each other without any electrical contact, and that

Insulating resistance measuring points on top of Cabinet 5

Figure 2.14 Insulating Resistance Measuring Points

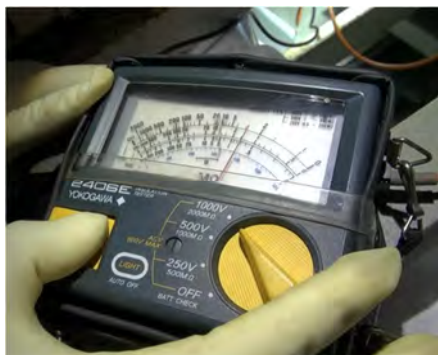
2.8 MΩ between R and S phases

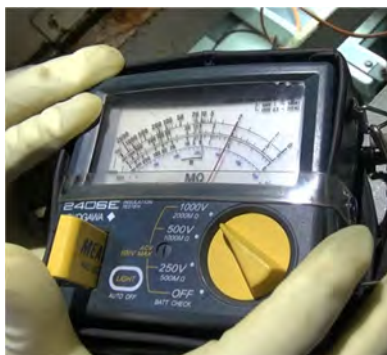
1.9 MΩ between S and T phases

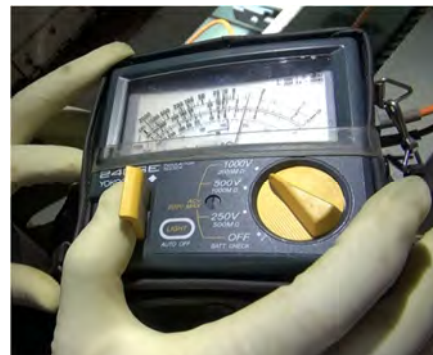
the bus in M/C1C was not short-circuited.

2.7 MΩ between T and R phases

Figure 2.15 Measured Interphase Insulating Resistances

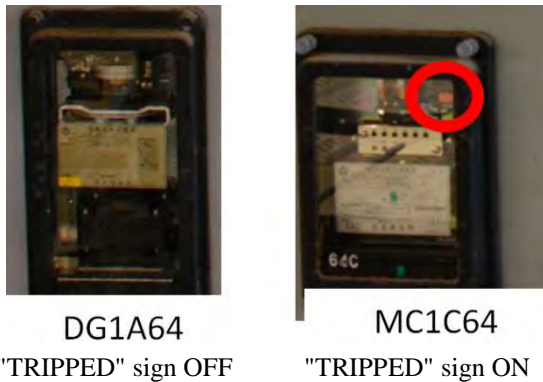
lost power supply to the bus and did not have ground fault overvoltage. Therefore, the NRA could not presume that only MC1C64 tripped. Judging from these findings, the NRA estimated that MC1C64 did not actually trip, and that the "TRIPPED" sign was turned on after being dropped due to the earthquake. Therefore, the NRA estimated that ground fault did not occur in M/C1C.

Figure 2.17 "TRIPPED" Sign of M/C1C Overvoltage Relay

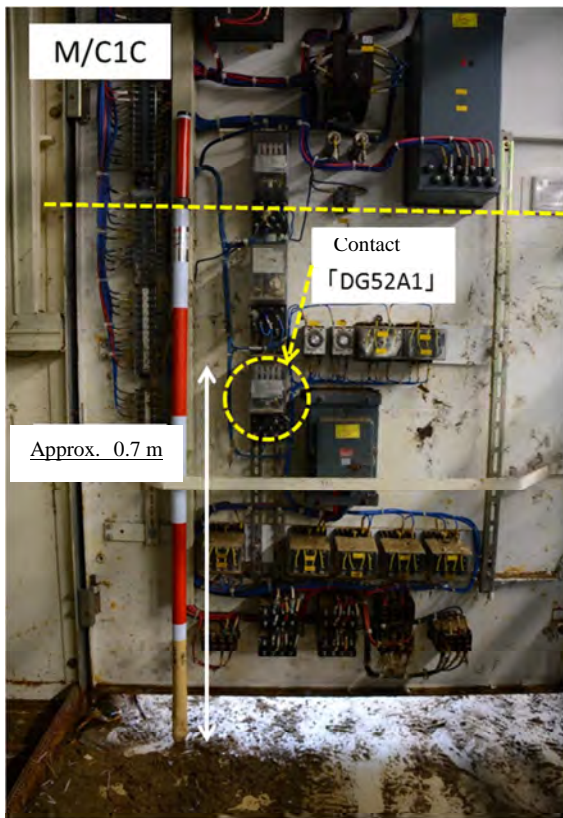
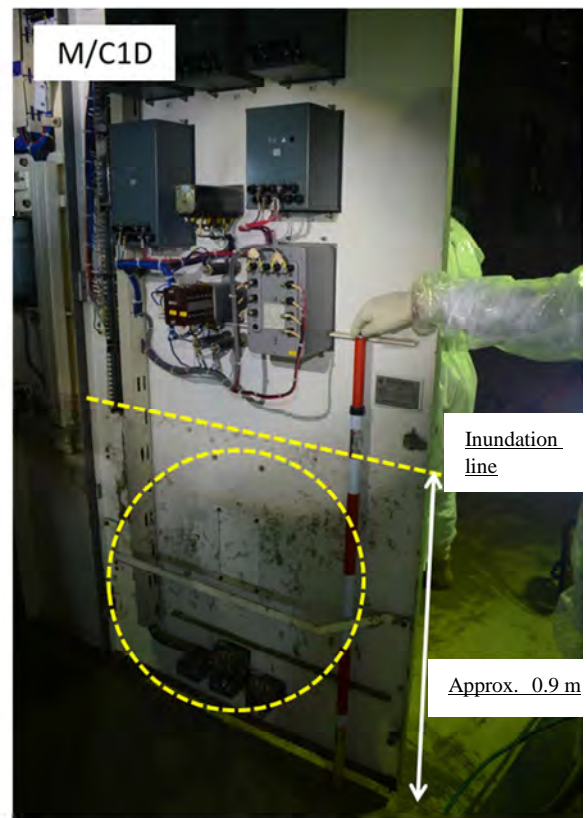
The contact "DG52A1" (1) is usually opened and no current flows, but when this contact is flooded by seawater, this contact is assumed to pass current through the seawater. In the site investigation, the NRA checked its location and the possibility of flooding. The contact of M/C1C was located at a height of about 0.7 meter behind the front door of M/C1C. The height of flooding relative to M/C1C was about 1.0 meter. Accordingly, the NRA estimated that the contact was completely submerged in seawater by tsunami (Fig. 2.19).

Figure 2.19 Location of Control Circuit in the D/G Power Receiving Circuit Breaker, and Inundation Height

heights of inundation differed to open their D/G power receiving circuit breakers. M/C1C had contacts located at a height of about 0.7 m behind the cabinet's front door, and lost its voltage when the contacts were flooded and the D/G1A power receiving circuit breaker opened (see (2) 3)). Conversely, M/C1D had similar contacts on the upper part of the cabinet (at 1.0 m or higher) (Fig. 2.19). Therefore, M/C1D did not trigger the D/G1B power receiving circuit breaker until the water level reached a height of about 0.9 m and submerged the bus of the closed circuit breaker.

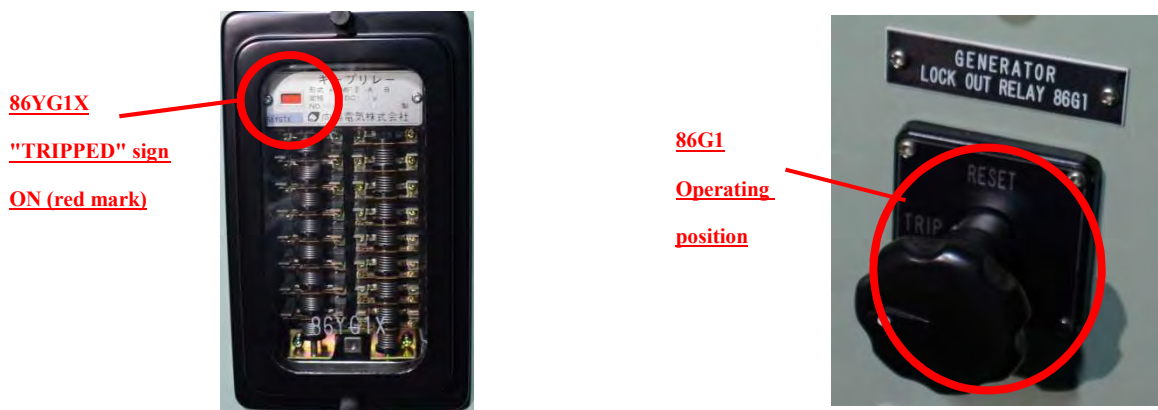
The contact "86YG1X" (2) was closed and passed current when a turbine trip signal was output in connection mode and activated the main generator lockout relay "86G1."^{26,27} In the site investigation for confirming the these relay' operational condition, the NRA confirmed this relay was activated and the contact indicated its "ON" sign (Fig. 2.20).

Figure 2.20 Main Generator Lockout Relay

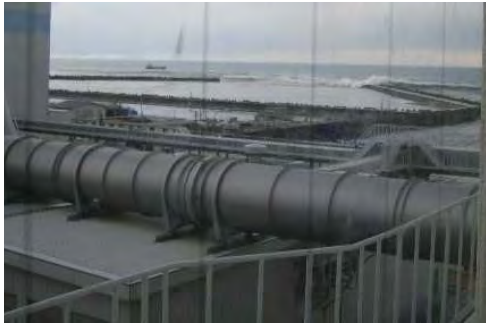
The NRA calculated that Tsunami 2-1 passed over the crook of the south breakwater and was photographed (photo 1)³⁸ between 15:34:34 and 15:34:51, by adding the tsunami propagation time to the above tsunami arrival time recorded by the wave gauge. Similarly, the NRA calculated that Photo 3 [showing the premises (height: O.P. + 10 m) and vast flooding of the main stack of the turbine building's ventilation system] was taken between 15:36:24 and 15:36:41, as Photo 3 was taken about one minute, fifty seconds after Photo 1 was taken.

Photo 1 (Tsunami 2-1 passed over the crook of the south breakwater.)

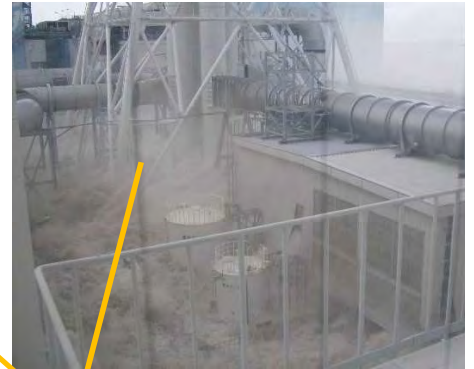
tsunami struck the coastal area near the site at roughly at the same time (without much time lag). Accordingly, the NRA estimated that the height of the Unit 1 turbine building (O.P. + 10 m) was as high as the main stack of the turbine building's ventilation system, with the premises also being flooded at about the same time when Photo 3 was taken (15:36:24 to 15:36:41)³⁹

Photo 3 (Tsunami 2-2 caused large-scale flooding on the premises (height: O.P.+ 10 m).)

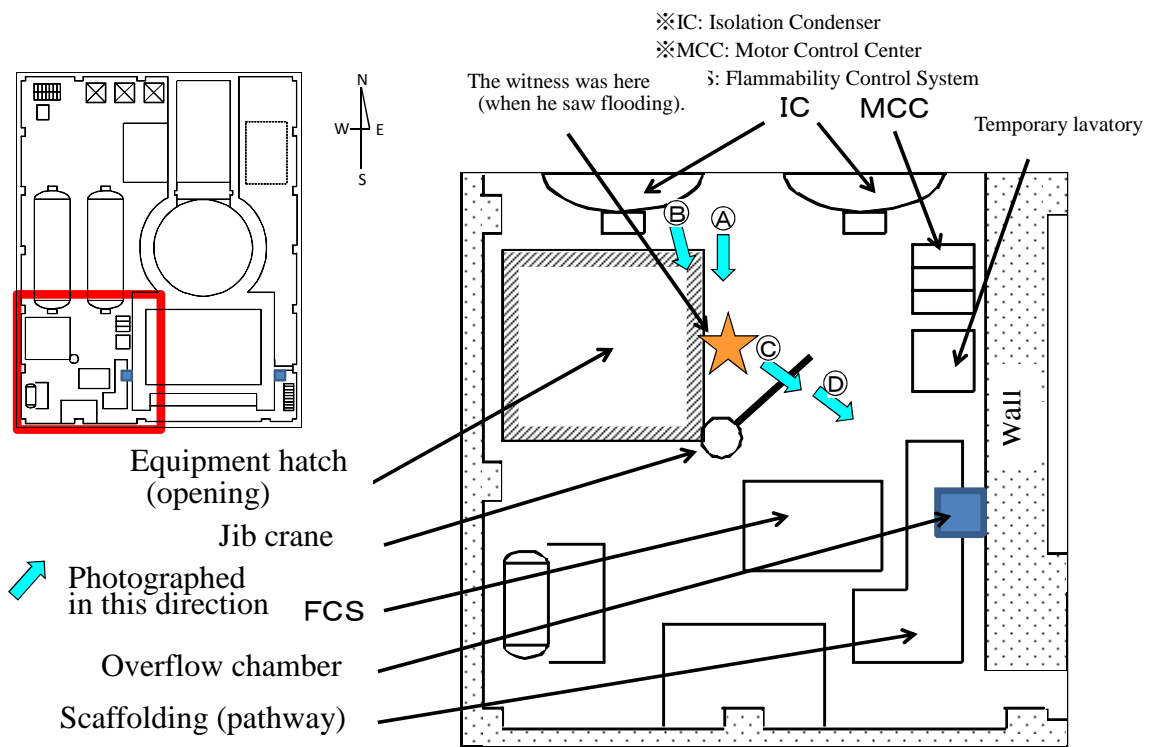
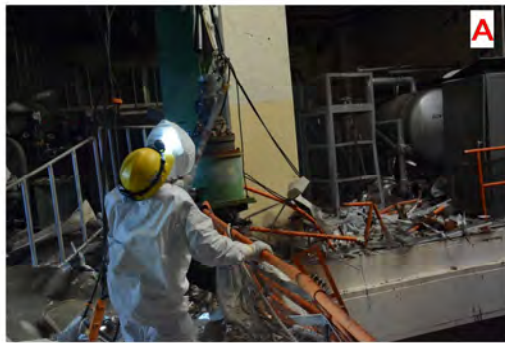
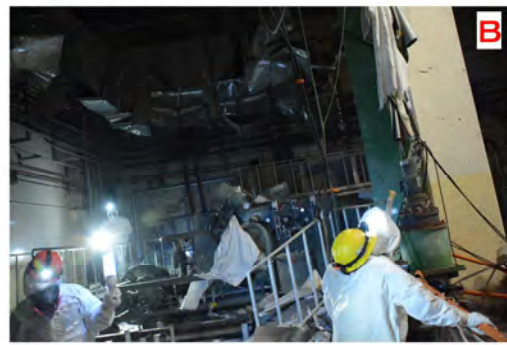
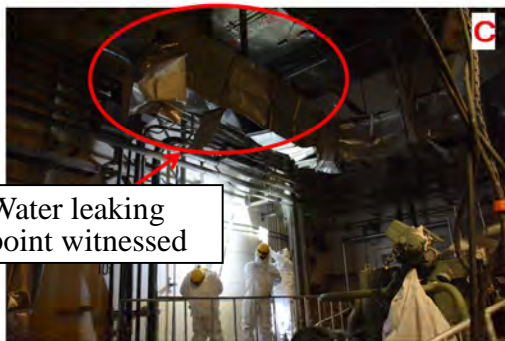
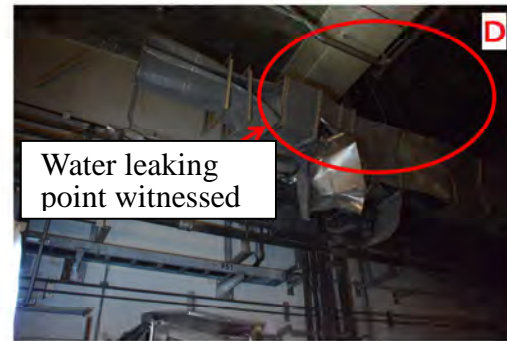
Figure 3.2 Standing Position of Witness when Water Leak came out

As for Issue 1) above, based on the interview, the NRA confirmed the position of the witnesses and the equipment position that could see from the witness's position in the site investigation. As a result, the NRA could identify that witness was standing on the east side (marked "star" in Fig. 3.2) of the equipment hatch (opening) from the positional relationship between the opening, guardrail at the opening and jib crane. Moreover, the NRA estimated that the water leaking point was the vicinity of the overflow chamber above the FCS.

As for the positional relationship between the witness's standing position and the equipment, the NRA confirmed that the actual layout of equipment was almost same the equipment seen by the witness just before and at the time of water leak (i.e. Equipment seen by witnesses just before the water leak: Opening and jib crane; Equipment seen by witnesses at the time of water leak: FCS and pipes above the FCS).

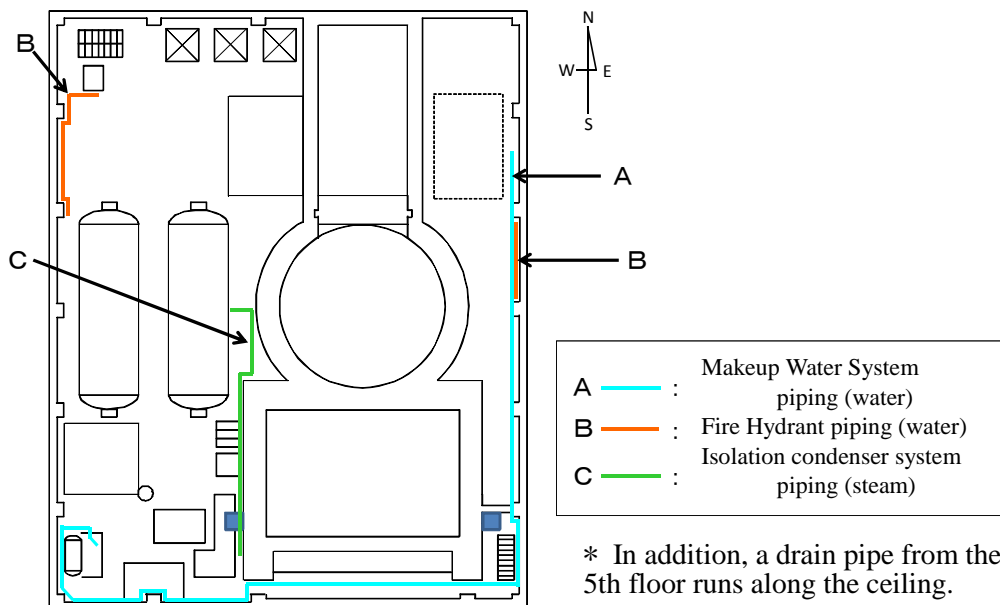
Figure 3.4 Water and Steam Pipes installed on the 4th Floor of the Reactor Building of Unit 1

- Function: Pipe used to feed water to the Standby Liquid Control System (SLC) tank and other equipment
- Location: Running along the south and east walls from the vicinity of the southwest wall (Fig. 3.4)
- Result of assessment: The NRA estimated that this equipment could not be a water leaking point as it is located far from the witnessed water leaking point.

- Function: Pipe used for supplying water to the fire hydrant system
- Location: Located near the northwest wall and east wall (2 places) (Fig. 3.4)
- Result of assessment: The NRA estimated that this equipment could not be a water leaking point as it is located far from the witnessed water leaking point.

- Location: Running from the IC in the west, located near the PCV, and on the west wall of the SFP (Fig. 3.4)
- Result of assessment: The NRA estimated that this equipment could not be a water leaking point although located near the witnessed water leaking point, as this steam discharge pipe never spouts water.

- Location: Running from the floor drain funnel in the cask decontamination area on the 5th floor of the reactor building of Unit 1 to the ceiling near the west wall of the SFP (south of the 4th floor), where water leak was witnessed.

- Result of assessment: TEPCO stated that when the main shock of the earthquake occurred, no decontamination work was done and the floor of the cask decontamination area containing equipment and materials was covered with plastic sheets. However, the NRA estimated that overflowing water due to the sloshing of water in the SFP could possibly flood the 5th floor of the reactor building of Unit 1, and enter the drain pipe through the floor drain funnel. In such case, it is the possibility that the drain pipe from the 5th floor might run the water. The NRA's site investigation found no pipe damage or breaks in this drain pipe. Therefore, the NRA estimated that this drain pipe could not be a water leaking point.

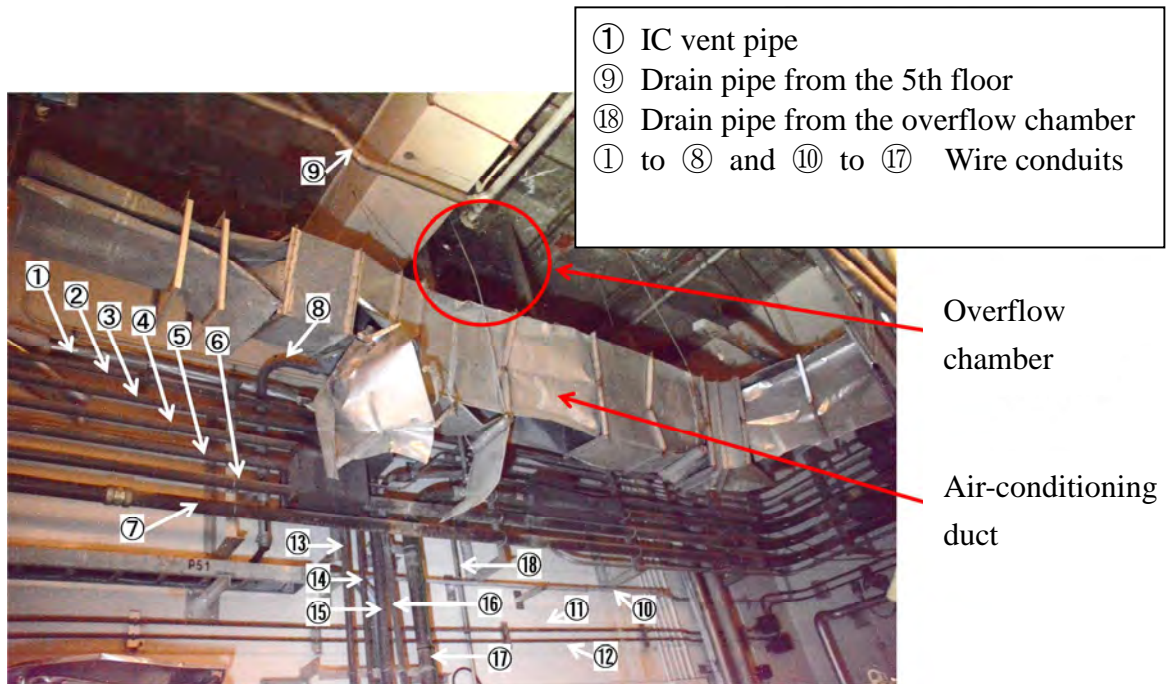
Figure 3.6 Pipe Layout near a Location where Water was seen coming out

chamber were also designed to allow the possible flow of water. However, the NRA estimated that these drain pipes cannot be a water leaking point, as the NRA found no damage or breaks on those pipes in the site investigation.

The NRA therefore estimated that only the "overflow chamber" could have water leaked.

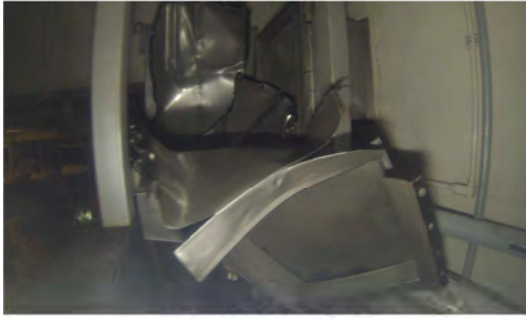
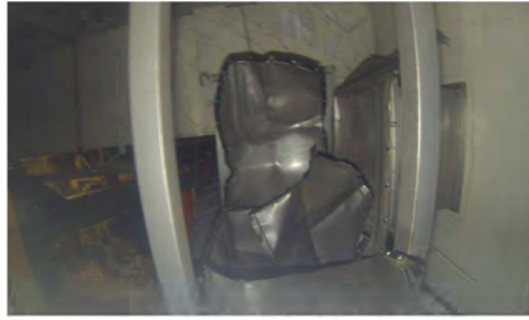
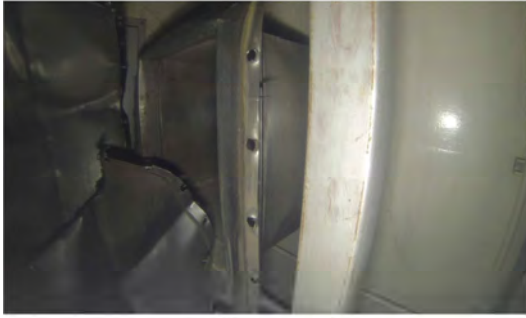
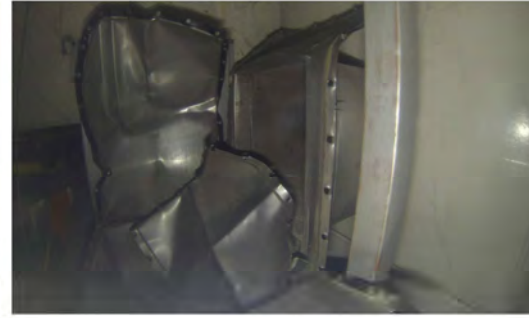
Figure 3.8 Views of Overflow Chamber Surfaces (1)

- The upper portion of the overflow chamber was blown off, as if subject to an internal explosion.
- As far as the site investigation, all bolts of the upper portion were gone. (Nuts and bolts are typically used to couple the overflow chamber to the duct embedded in the concrete wall of the SFP. (Fig. 3.8))

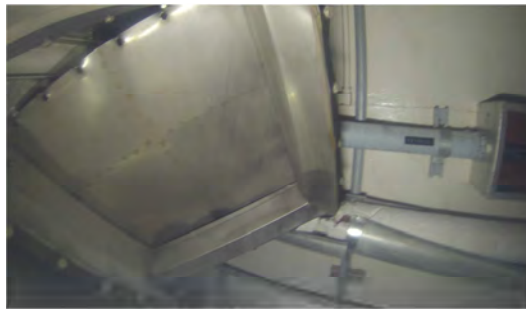
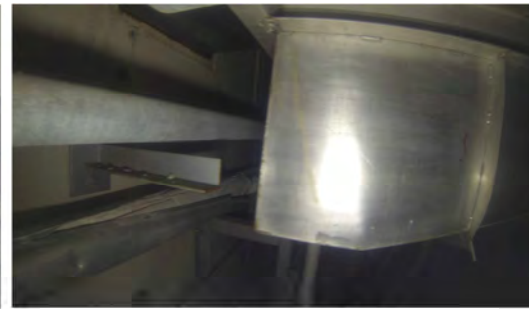
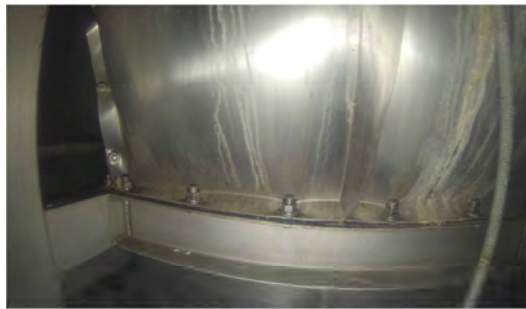
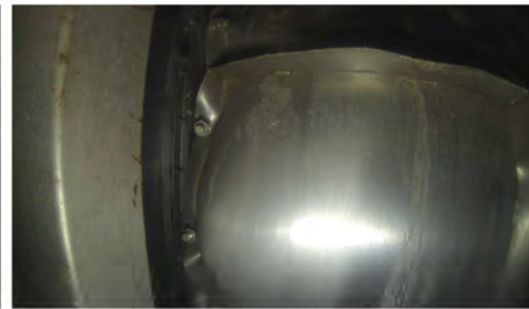
Figure 3.9 Views of Overflow Chamber Surfaces (2)

- The NRA could find no fractured bolts, but found traces of an internal explosion on parts at the side and bottom portions left clinging to the overflow chamber. (Fig. 3.9)

The NRA estimated the gas explosion, not by water pressure, caused the overflow chamber to break (as confirmed in the site investigation), based on the above findings. In other words, the hydrogen explosion that occurred in the reactor building on March 12, 2011 is assumed to be this gas explosion.

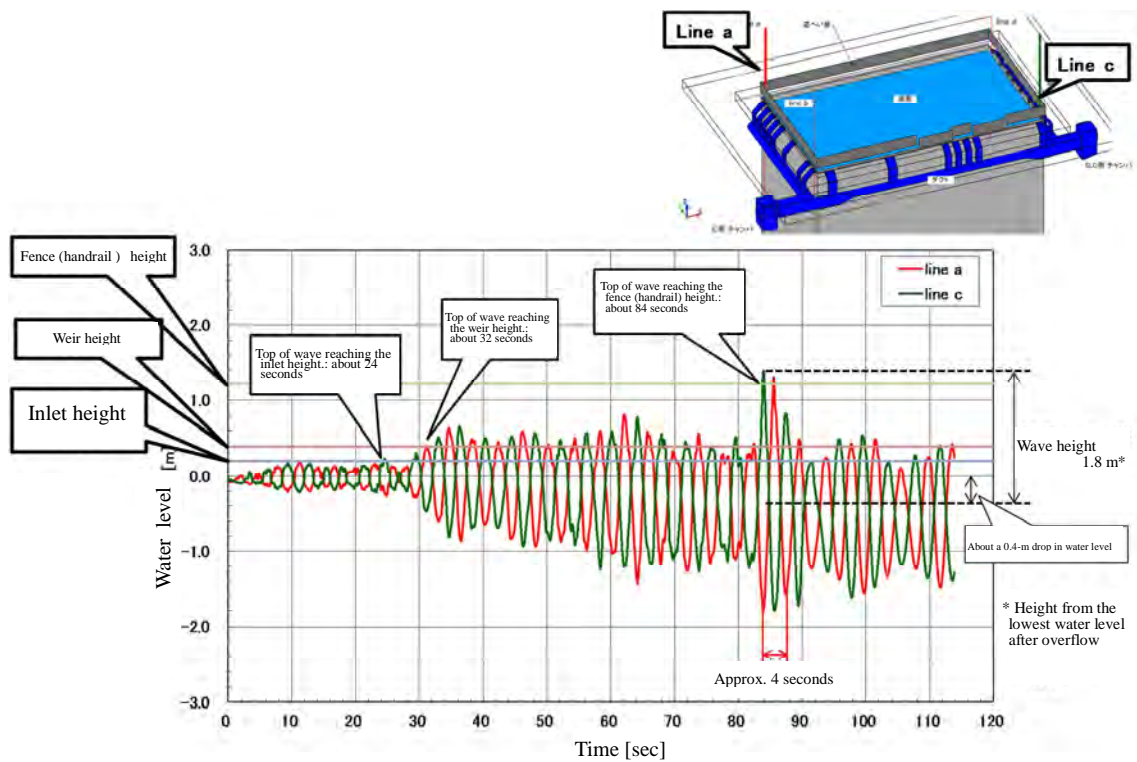
Figure 3.12 Behavior of the SFP Water Level due to Slushing

- It was evaluated that water in the SFP reached at the level 1.0 m above the top of the SFP weir (maximum), and thus reached the top of the fence (0.8 m above the top of the SFP weir. (Fig. 3.12))

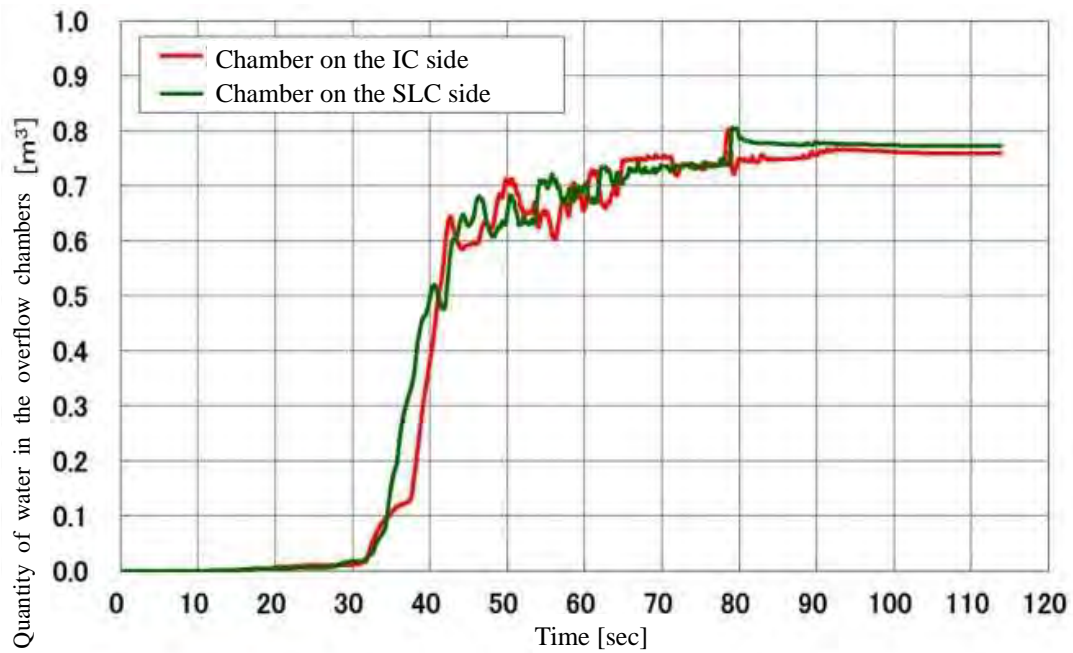
Figure 3.13 Behavior of Water Quantity in the Overflow Chambers

- About 30 seconds after the main shock of the earthquake, the water in the SFP started flooding into the air-conditioning duct embedded in the side concrete wall of the SFP, and flooded into the overflow chamber placed near the ceiling of the 4th floor. The NRA evaluated that approx. 0.6 m³ of water flowed there about 40 seconds later, and about 0.8 m³ of water flowed about 80 seconds later. (Fig. 3.13)

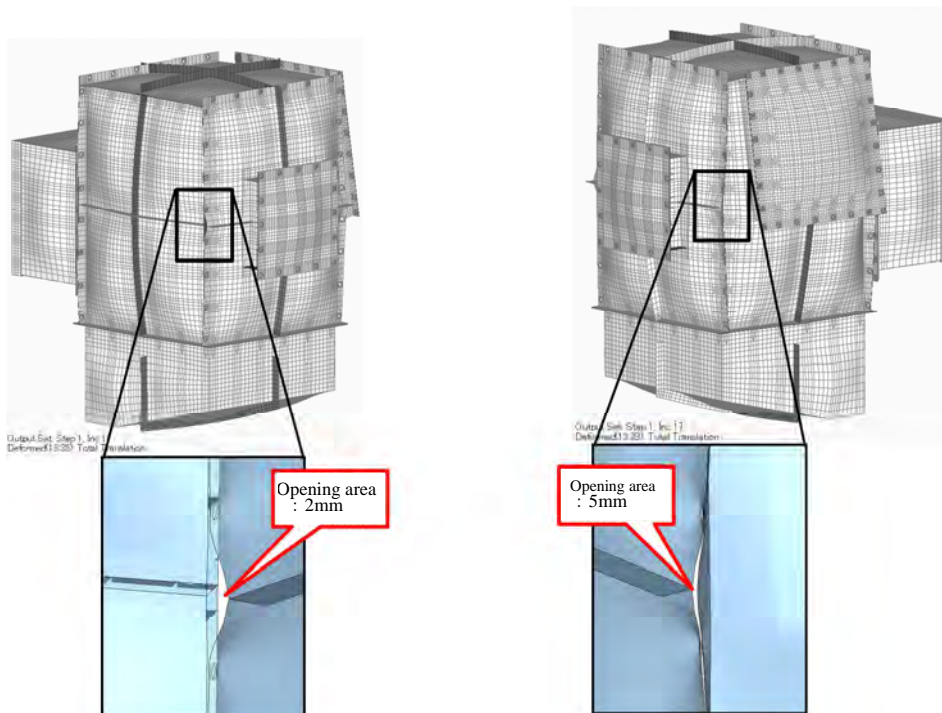
Figure 3.17 Analysis of Overflow Chamber Deformation (example: at 43.2 s (at peak pressure))

The NRA evaluated the overflow chamber deformation caused by the pressure of water ("hydrodynamic pressure" including earthquake force) that flooded from the SFP due to sloshing. From this evaluation, the NRA estimated that some panel joints of the overflow chamber were possibly broken about 40 seconds after the main shock began, followed by water spouting through the gap.

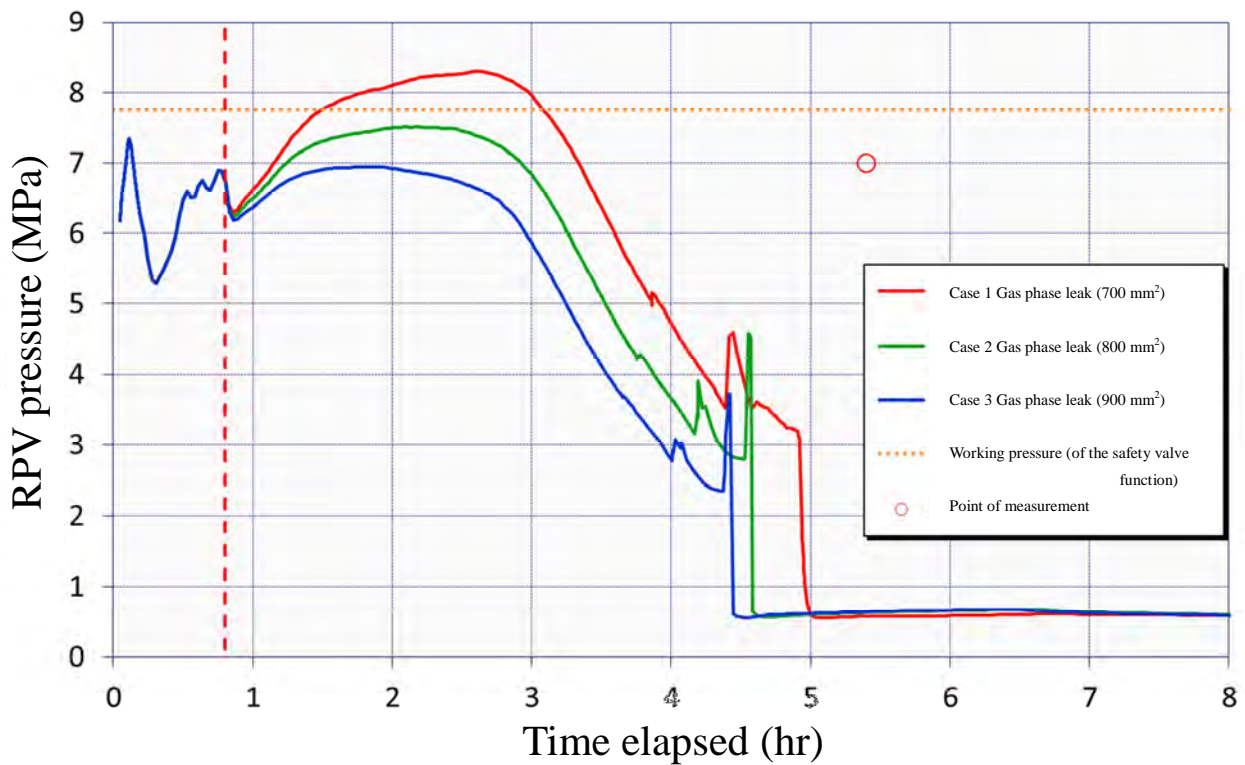
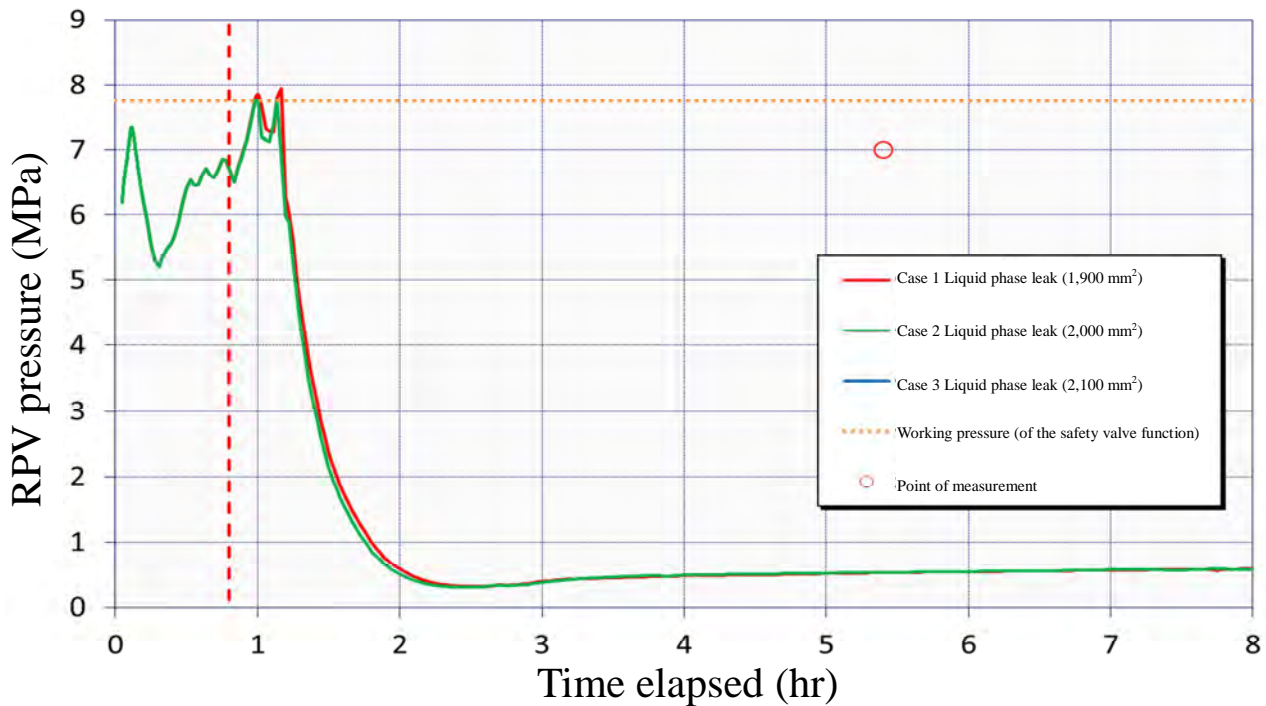
In the case having the smallest leak area (Analysis Case1), the maximum calculated RPV pressure (for leaks from both gas and liquid phases) exceeded the working pressure of the safety valve function of the SRV. If such a leak continued for five hours, however, RPV pressure would become much lower than the measured pressure value (about 7.0 MPa (abs) about 5.4 hours after the earthquake occurrence). Although this analysis assumes that the safety valve function of all installed SRVs are disabled (inoperative), it is highly unlikely that all safety valve function of four SRVs became inoperative. The NRA therefore estimated that the SRVs would actuate when RPV pressure exceeds the working pressure of their safety valve function of the SRV.

Note that the maximum calculated RPV pressure in Analysis Case 2 and 3 did not reach the working pressure of the safety valve function of the SRV, but dropped quickly and widely diverged from the measured pressure value. Though the measured pressure value includes a certain amount of error as only one measured value, the NRA estimated that the prerequisites for Analysis Cases 1 to 3 are not rational as the calculated value is very divergent from the measured pressure value.

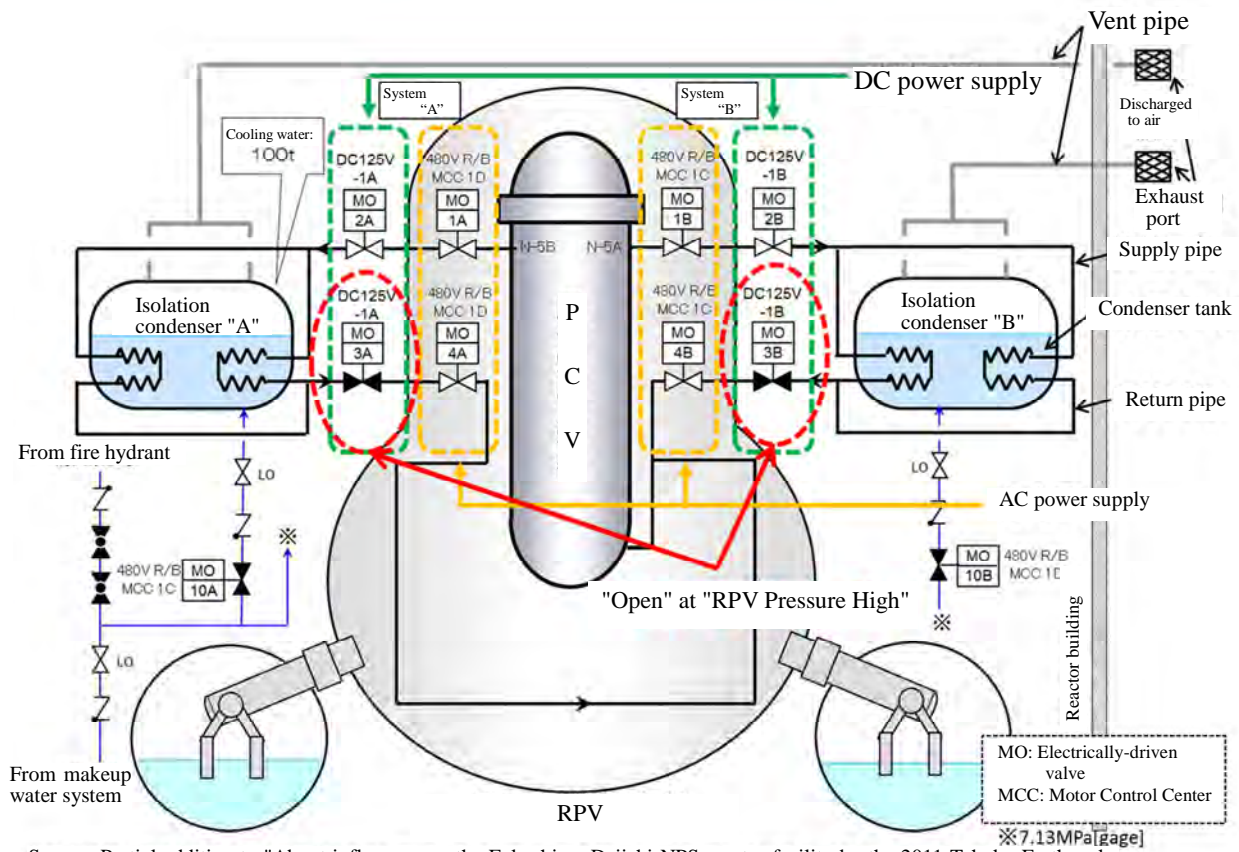
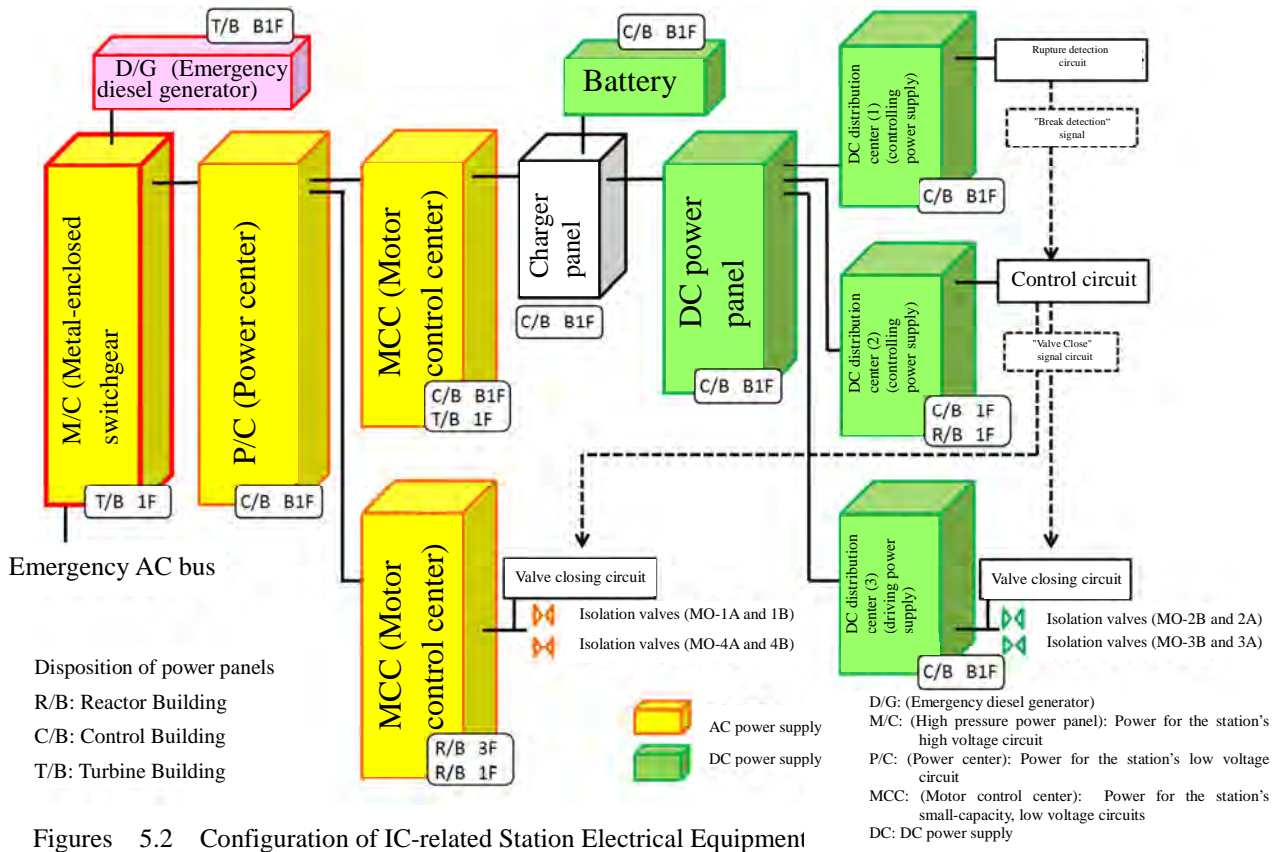
Note that AC power is supplied to the DC power through a charger. In case the DC power panel was flooded and lost its function, the DC power supply system would be disabled even if the AC power supply systems remain operable (Figs. 5.2 and 5.3). Therefore, "as long as there is sufficient AC power, DC power will be available" stated by the National Diet Investigation Commission is not true.

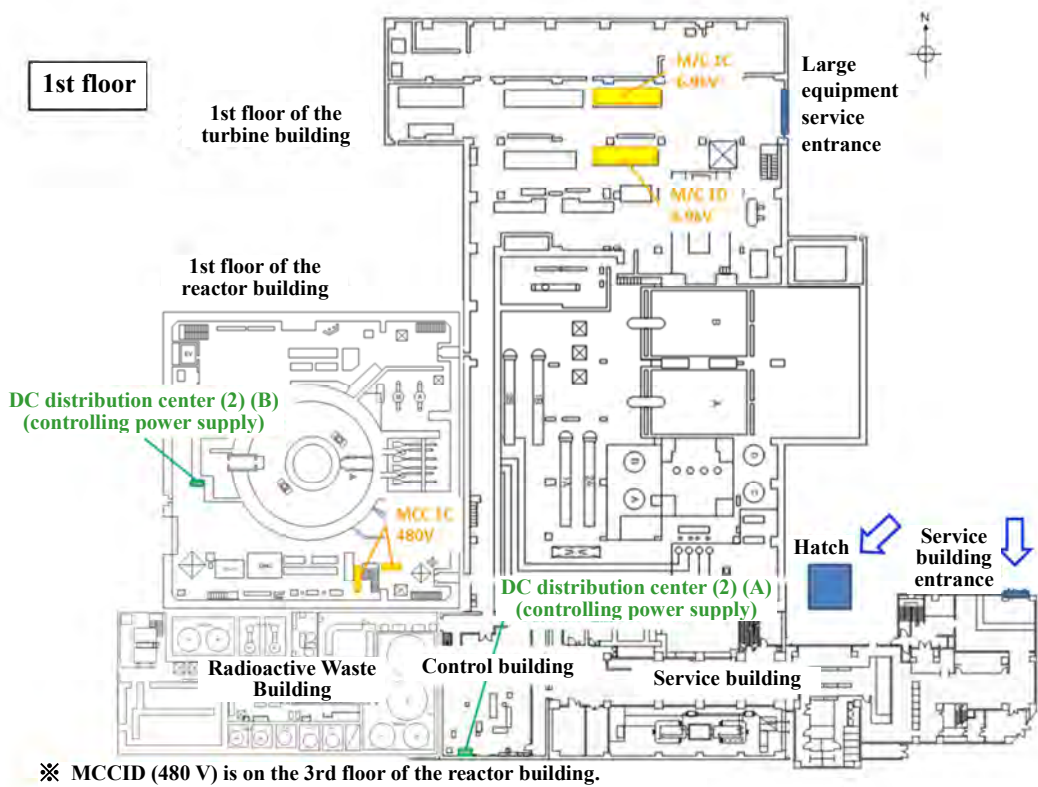
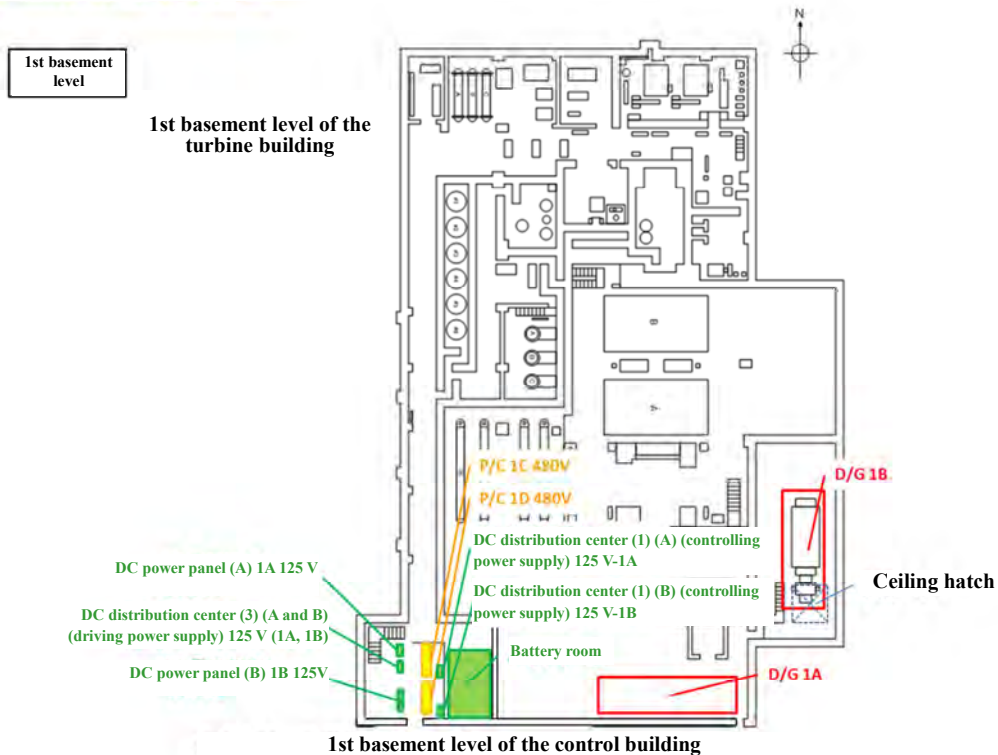
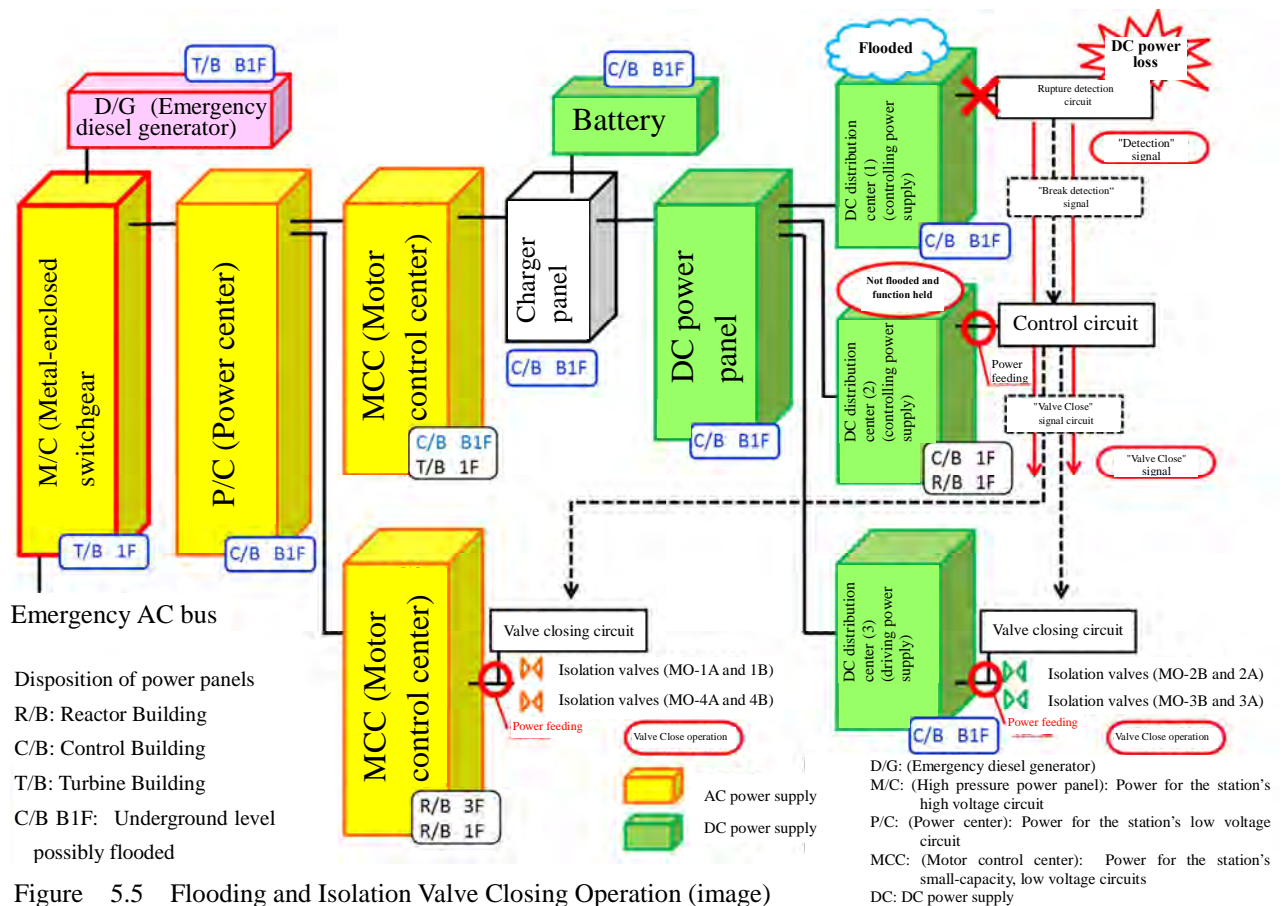
Figure 5.4 Layout of IC-related Station Electrical Equipment (on the 1st floor and 1st basement level)

The station electrical equipment related to the isolation valves of IC consists of distribution centers and other apparatus and these equipment are located on the 1st floor and basement level of the reactor building, the control building and the turbine building (see Fig. 5.4).

As for DC-related power supply panel, the NRA found that the DC distribution center (2) (controlling power supply)⁵² was installed in the cable vault room on the 1st floor of the control building, and that there is no traces of flooding in this room. Judging from these findings, the NRA estimated that DC distribution center (2) (controlling power supply) on the 1st floor of the control building had maintained its function without being flooded.

TEPCO also checked the situation in the control building's basement at about 18:00 on March 11, 2011, and found that the electrical room (containing DC distribution centers (1) and (3)) was flooded up to the upper portion of the weir (0.3 to 0.4 meter high). Therefore, it is highly possible that DC distribution centers (1) (controlling power supply) and (3) (driving power supply) on the first basement level of the control building lost their functions due to flooding. At present, the basement of the control building is full of contaminated water and no one could go there to investigate. Accordingly, the NRA could not determine the exact time when DC distribution centers (1) and (3) lost power in detailed.

As for AC-related power panel, the transient phenomena recorder data showed that M/C1C lost its function earlier than M/C1D. In the site investigation, the NRA confirmed that M/C1D near the equipment hatch was further on the south side by about 4 meters than M/C1C on the 1st floor of the turbine building, or further inside from the equipment hatch (through which the tsunami entered), and that flooding heights of 1 meter and 0.9 meter were found for M/C1C and M/C1D, respectively. These findings are consistent with the function loss time obtained from the data. The NRA estimated that it is highly possible that AC power supply systems "C" and "D" lost their functions at different time.

From the layout of the station electrical equipment and the flooding situation, the NRA could presume a scenario of operation as follows: In case DC distribution center (1) (controlling power supply) in the room that was found to be flooded shipped water and lost its function, DC power for the rupture detection circuit would also be lost. At the same time, a signal to close the isolation valves would be sent via a control circuit (receiving its control power from DC distribution center (2) located in a room that was not flooding). Although it is possible that DC distribution center (3) (driving power supply) shipped water and lost its function, the time of its function loss was later than that of DC distribution center (1) (controlling power supply), and thus the DC-driven isolation valves were possibly closed. The AC-driven isolation valves were operated in a similar manner. (Operating status of the isolation valves described in Item (2))

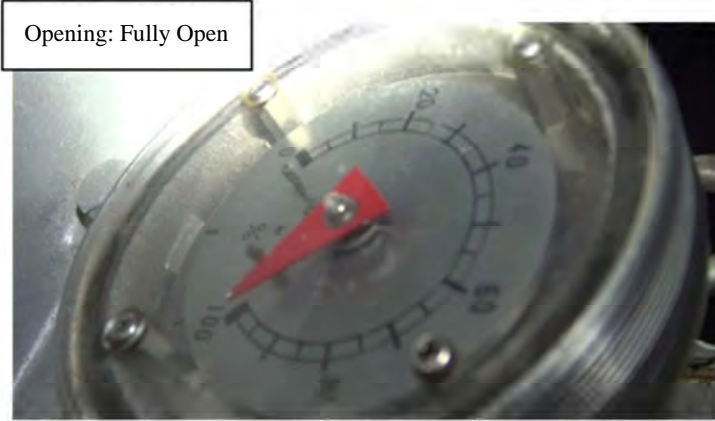
<IC system "A" (2A) opening meter>

Opening: Fully Open

Photographed by the NRA on May 31, 2013.

Figure 5.6 Opening Meter for Isolation Valves (2A and 2B) of IC (Photographed in the NRA's site investigation conducted on May 31, 2013, and February 26, 2014.)

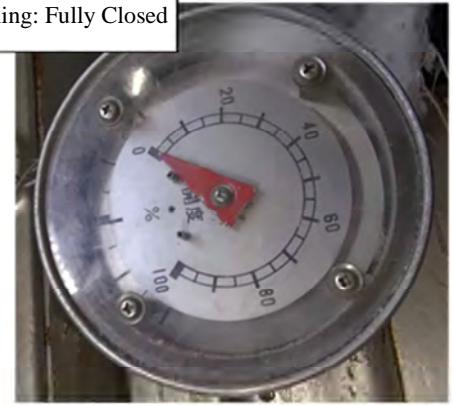
<IC system "B" (2B) opening meter>

The NRA confirmed that the isolation valve (2B) outside the PCV in the IC system “B”, driven by the DC power supply, was "Fully Closed" in the site investigation (see Fig. 5.6).

Opening: Fully Closed

Photographed by the NRA on February 26, 2014.
