Analysis of the TEPCO Fukushima Daiichi NPS Accident

Interim Report
(Provisional Translation)

October 2014

Nuclear Regulation Authority, Japan

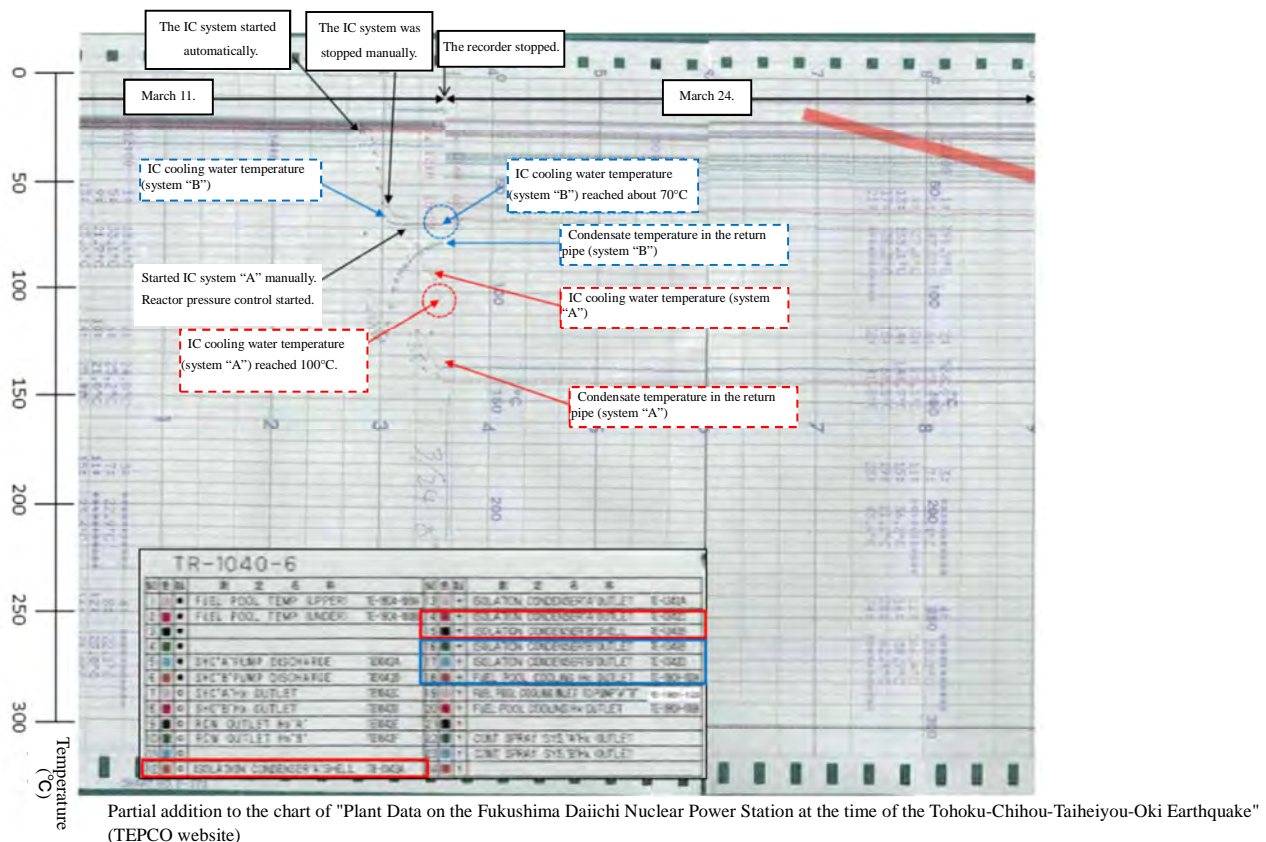
Figure 5.9 IC System-related Temperatures in Unit 1

It has been confirmed that the additional data⁵⁵ of the transient phenomena recorder includes one-minute intervals data including the behavior of the emergency power system before the loss of all power. From this data until 15:36:59 (data collecting time just before data measurement stopped), the NRA can confirm the following: (See Fig. 5.9.)

Since the DC-driven isolation valves (2A and 2B) of IC were "Open" until 15:36:59, the NRA estimated that it is highly possible⁵⁷ that a close signal was not sent due to the loss of DC-controlling power supplied to the rupture detection circuit or control circuit by at least this time.

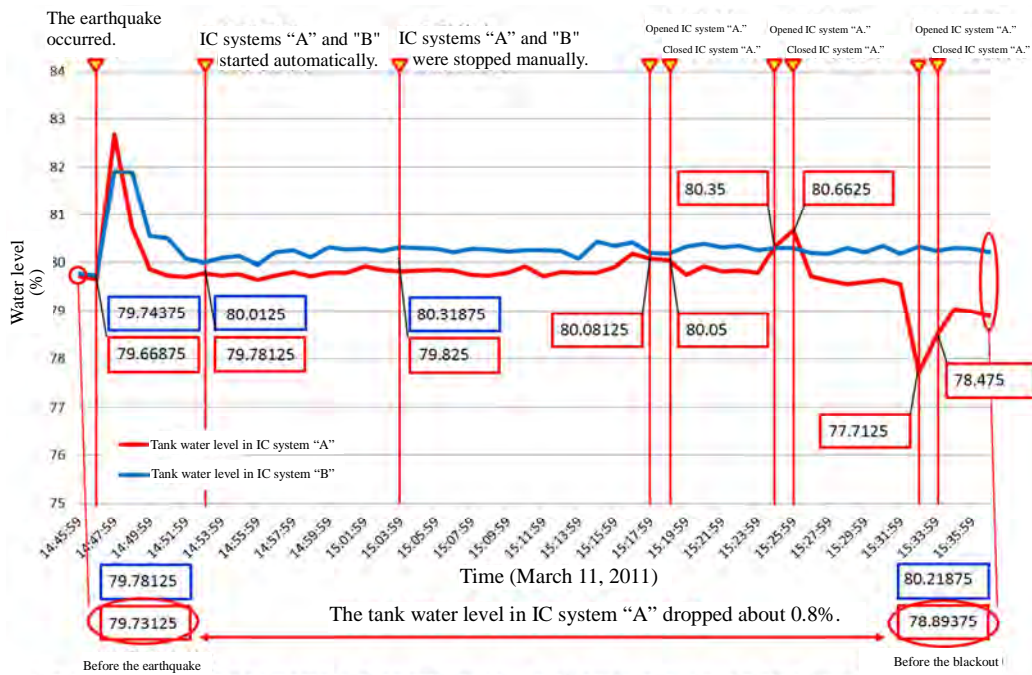
Figure 5.10 Transient Phenomena Recorder Data on Condenser Tank Water Levels in IC Systems "A" and "B"

"Analysis of reactor behavior while ICs were in operation"⁶³ conducted by JNES also reported that the water levels of the condenser tanks dropped very little during the periods above (when the IC systems were in operation). This apparently implies that heat energy was used to increase the temperature of cooling water in the condenser tanks for a certain period after the IC systems actuated. And from the condenser tank cooling water temperature data (chart), the NRA can confirm that it took some time for the temperature of cooling water in IC system "A" to reach 100°C after the IC systems actuated" (see Fig. 5.10).

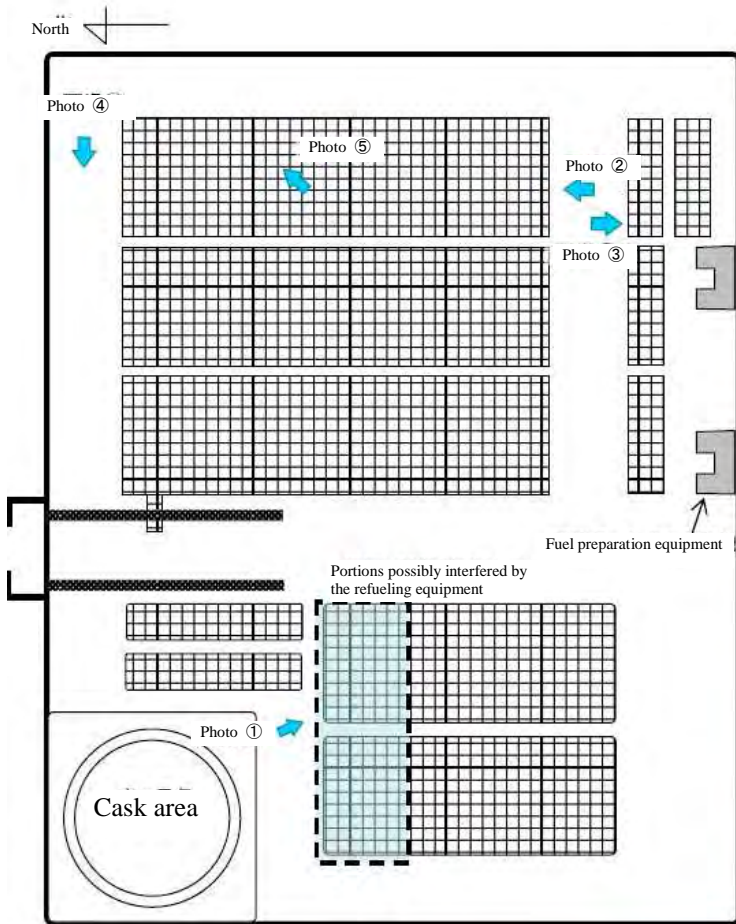
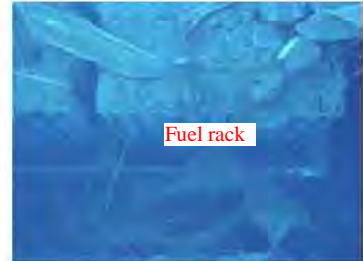
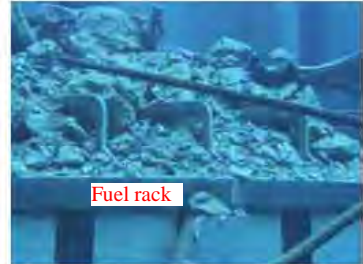
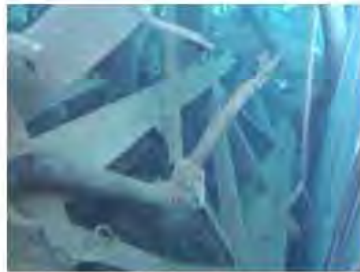
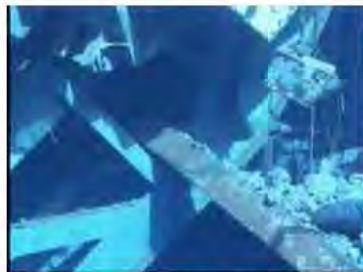
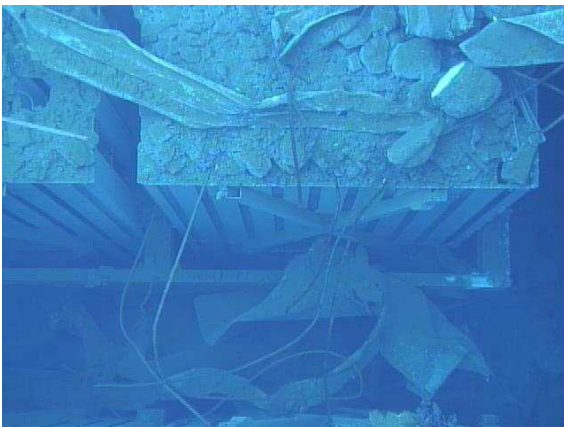
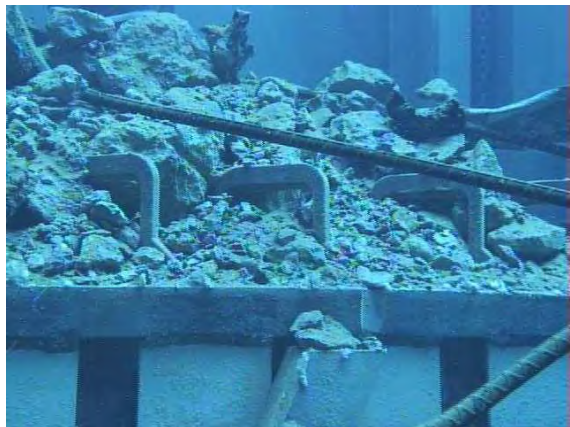
Figure 6.1 Inside Views in the SFP of Unit 3

In the underwater photos taken by TEPCO (in Fig. 6.1) in the SFP of Unit 3 (after the National Diet Investigation Commission report was disclosed), the NRA confirmed concrete, steel frame and other debris, but no significant damage to the fuel storage racks and the peripheries of the fuel assemblies. And in the underwater video images that were disclosed together with the photos, the NRA cannot confirm any significant damage to the fuel storage racks and fuel assemblies.

Photo① View of the lower part of the refueling equipment and the fuel storage racks

Photo② View of the fuel storage racks (photographed from above)

Photo③ Deposits on the fuel storage racks

Photo④ View of the refueling equipment corridor

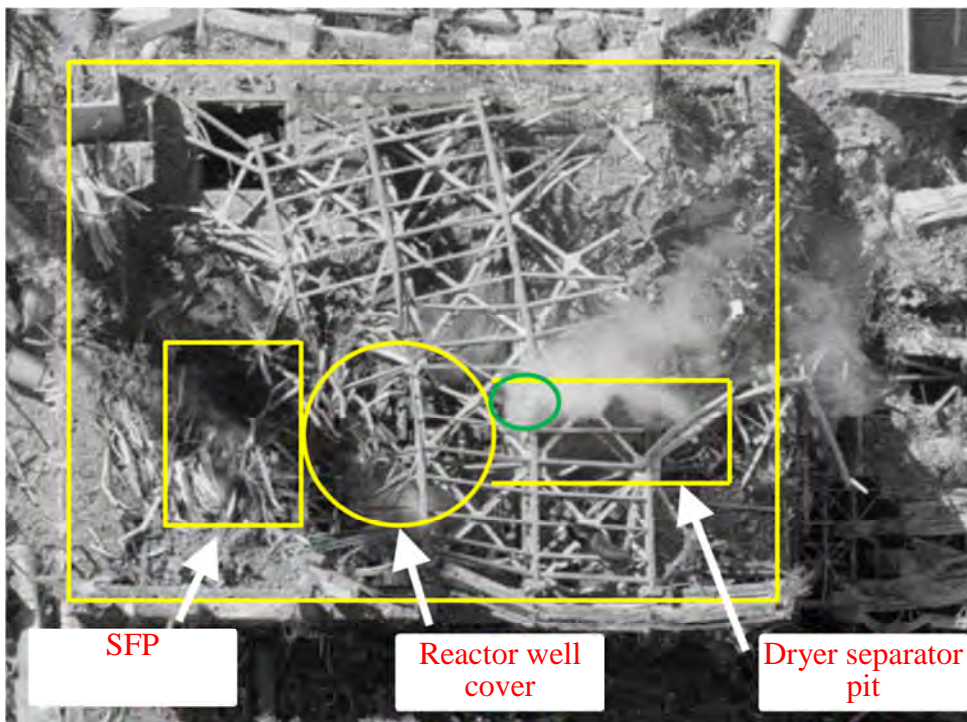
Figure 6.2 Location of White Steam rising from the Reactor Building of Unit 3

The NRA estimated the location of the white smoke from above the reactor building, by precisely overlapping a simplified 5th floor plan of the reactor building of Unit 3 on the smoke-showing aerial photos taken by the Ministry of Defense (see Fig. 6.2). Through such image overlapping, the NRA estimated roughly location of the white smoke shown in the photo quoted by the National Diet Investigation Commission (in Fig. 6.3) came from the adjacent area of the dryer separator pit and reactor well cover, where opposite side to the SFP across the reactor.

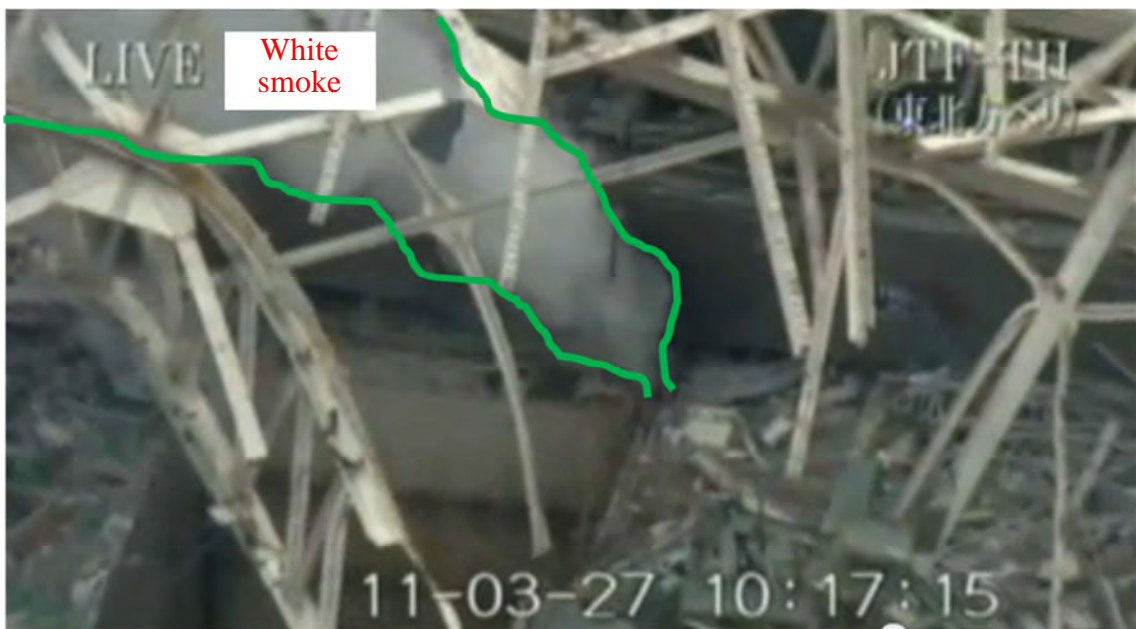
Figure 6.4 White Smoke rising from the Reactor Building of Unit 3 (site 2)

The NRA also confirmed from another image (in Fig. 6.4) taken by the Ministry of Defense that showed white smoke coming from the adjacent area of the dryer separator pit and reactor well cover, where opposite side to the SFP across the reactor.

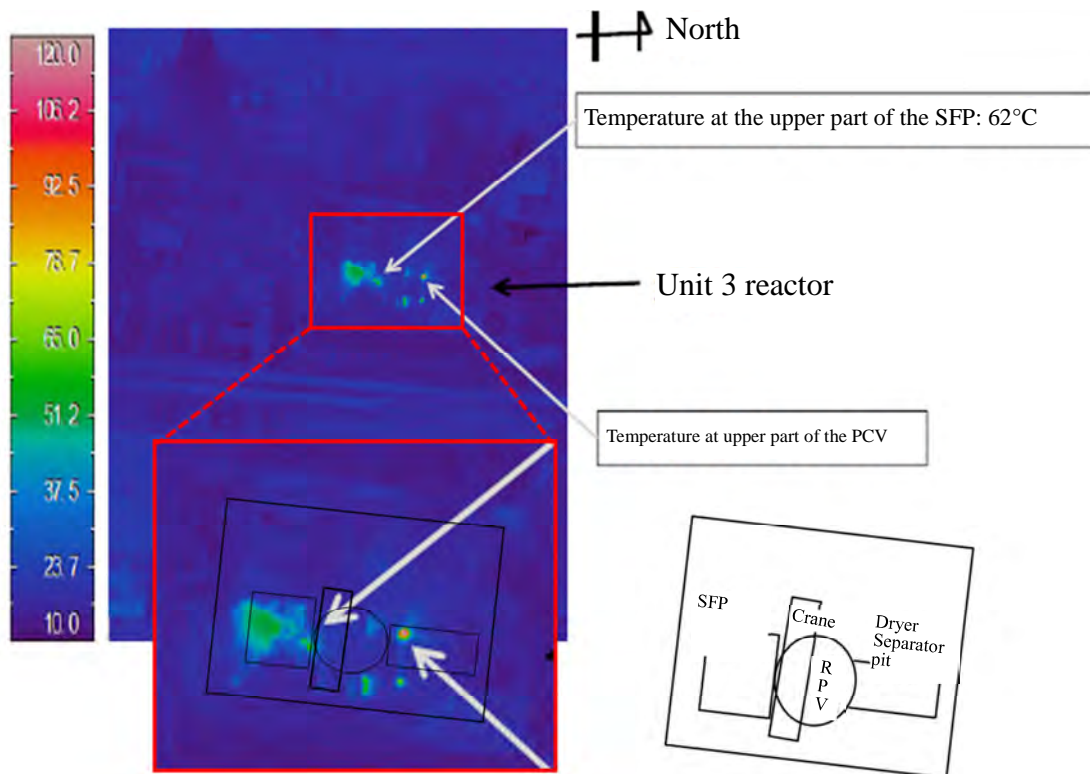
Figure 6.5 Measurement Results of Temperature Distribution in the Reactor Building of Unit 3

By overlapping a simplified floor plan of the 5th floor in Unit 3 with a thermal image made by the Ministry of Defense on March 20, 2011, the NRA confirmed that the temperature of the SFP was about 60°C, which is not so high as to cause white smoke (i.e., plenty of steam). In contrast, the adjacent area of the dryer separator pit and reactor well cover, where opposite side to the SFP across the reactor, was over 100°C, which showed possibility that the white smoke (plenty of steam) generated (see Fig. 6.5).

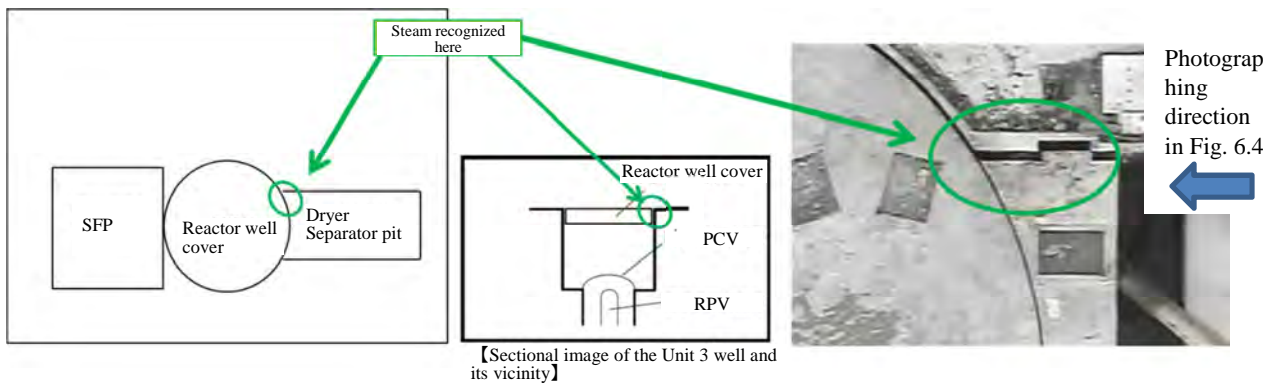
Figure 6.6 Equipment Layout on the Top of the Reactor Building of Unit 3

From Items 1) and 2), the NRA estimated that the white smoke came from the adjacent area of the dryer separator pit and reactor well cover, where opposite side to the SFP across the reactor (see Fig. 6.6).

The NRA can hardly presume that the white smoke (steam) came from such a location even if the SFP generated white smoke. In case the SFP was not a smoke generation source, the NRA estimated that the possible cause of heat generation was the steam coming from inside the reactor through sealed portions deteriorated by heat or the water hosed out from fire engine heated at the outside walls of the PCV. Note that no rain was confirmed.

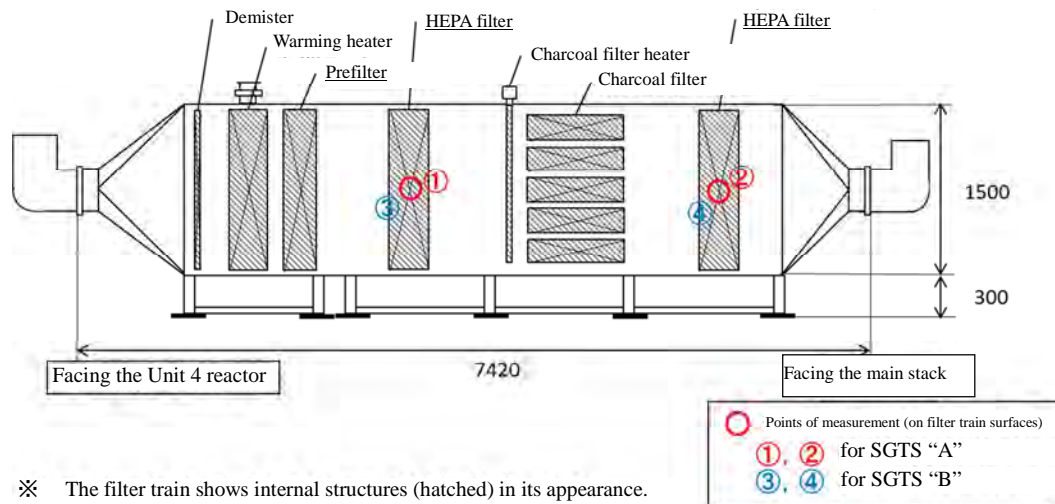
Figure 7.3 Structure of the SGTS Filter Train

To examine this possibility of hydrogen gas backflow from Unit 3, NRA measured the radiation levels of the SGTS filter trains in Unit 4 that consisted of multiple filters to remove radioactive materials, in consideration of TEPCO's site investigation problems noted above⁷⁵(see Fig. 7.3).

Upstream side (facing the Unit 4 reactor building)	Downstream side (facing the main stack)
System "A"	16.7 $\mu\text{Sv/h}$ (Fig. 7.3①)	1500 $\mu\text{Sv/h}$ (Fig. 7.3②)
System "B"	38.0 $\mu\text{Sv/h}$ (Fig. 7.3③)	1220 $\mu\text{Sv/h}$ (Fig. 7.3④)

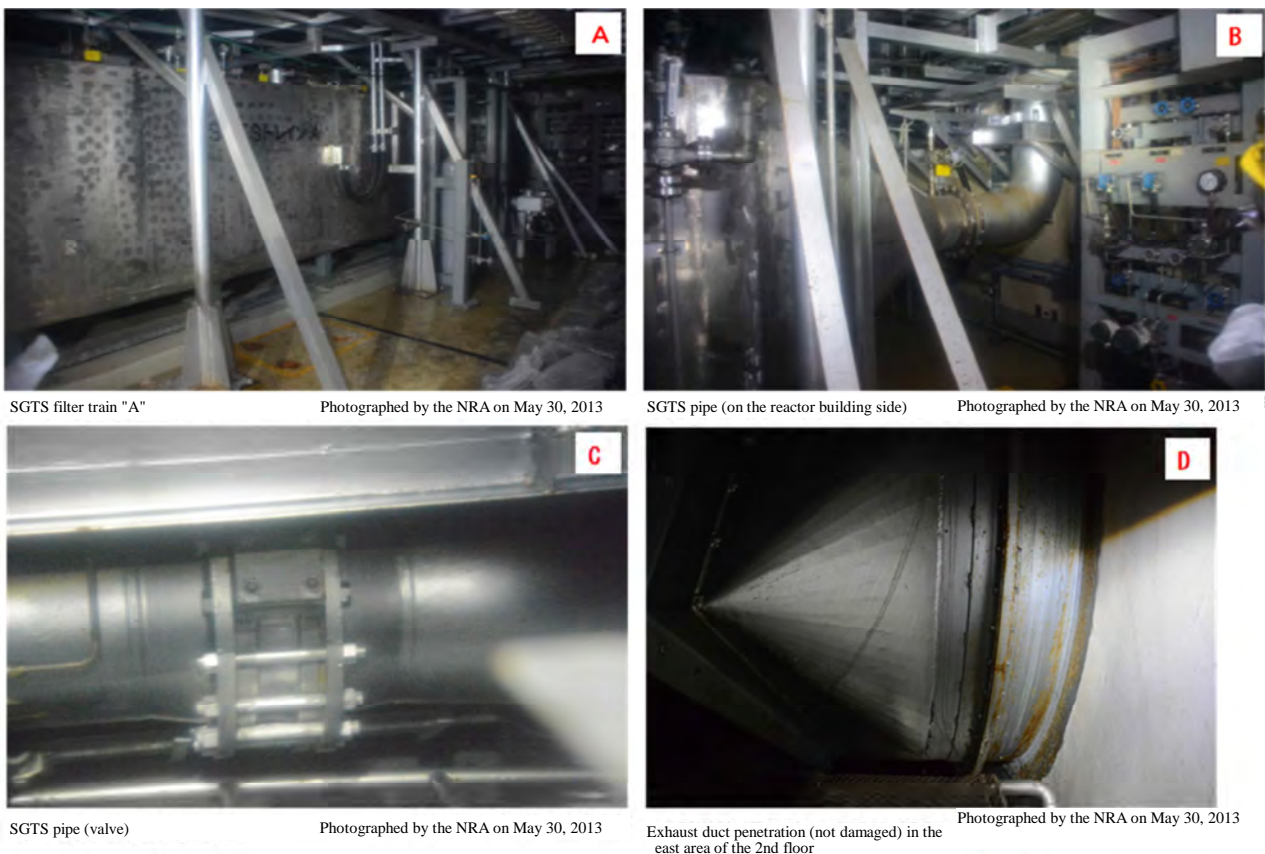
Figure 7.6 Situations of SGTS Filter Trains, Pipes, and Exhaust Duct Penetrations

- No remarkable damage was confirmed in the appearance of the SGTS pipes and filter trains of Unit 4 (see Figs. 7.6 and 7.7).
- As for exhaust ducts running upstairs and downstairs in the east part of the 2nd floor of the reactor building of Unit 4, the NRA confirmed slight damage on the exhaust duct running downstairs to the 1st floor, but severe damage on the exhaust duct running upstairs to the 3rd floor (see Fig. 7.8). The NRA estimated that hydrogen gas flowed upstairs through the exhaust ducts, accumulated there, and then exploded.

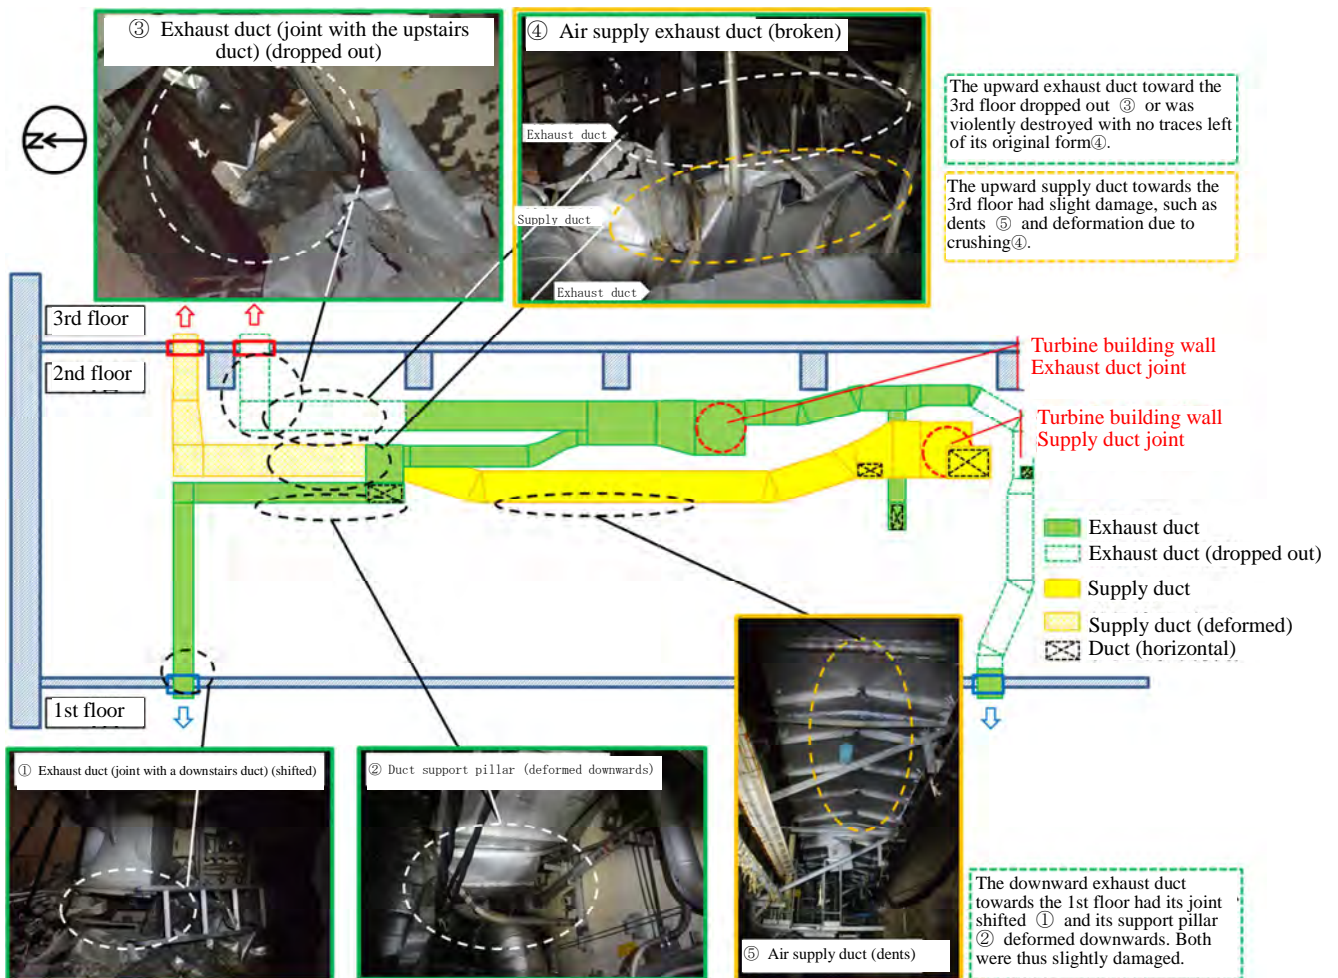
Figure 7.8 Traces of Damages on the Exhaust and Supply Ducts in the East Area of the 2nd floor of the Reactor Building

- Although the NRA confirmed less damage to the supply ducts than to the exhaust ducts, some parts of the upward supply duct line (towards the 3rd floor) were crushed (see Fig. 7.8). The NRA estimated that the explosion in a nearby exhaust duct caused such crushing damage.

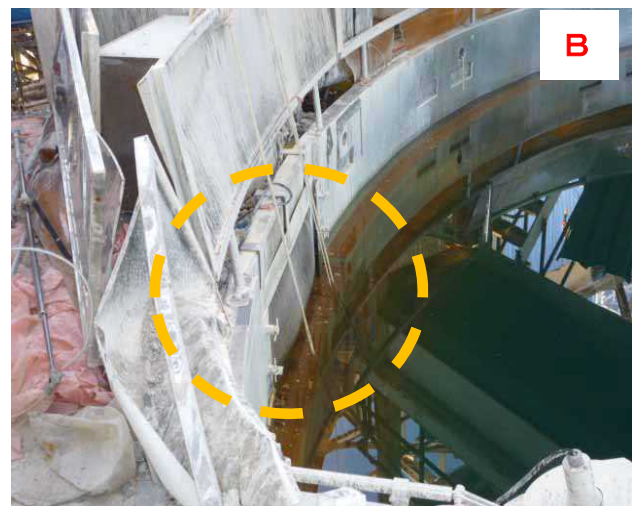
Figure 7.9 Deformed Exhaust Port Net of the Exhaust Ducts

- The NRA confirmed that steel net was deformed outward, which was provided to cover the exhaust ports of exhaust ducts located above the water in the reactor well and the SFP on the 5th floor. (i.e., backward from 4th to 5th floor) (see Figs. 7.9 and 7.10). The NRA estimated that this deformation was caused by a blast burst from the 4th to 5th floors through the exhaust duct.⁷⁸

Deformation of the exhaust port net of the exhaust duct above the reactor well on the 5th floor (deformed outward)
(photographed by TEPCO on November 8, 2011)

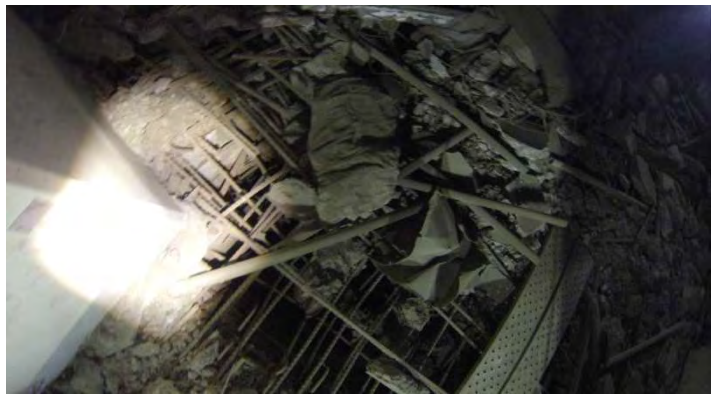
Figure 7.12 Traces of Damages on the Reactor Building (floor and ceiling in the northwest area of the 3rd floor)

Photographed by the NRA on February 6, 2014
 Close-up view (floor surface)

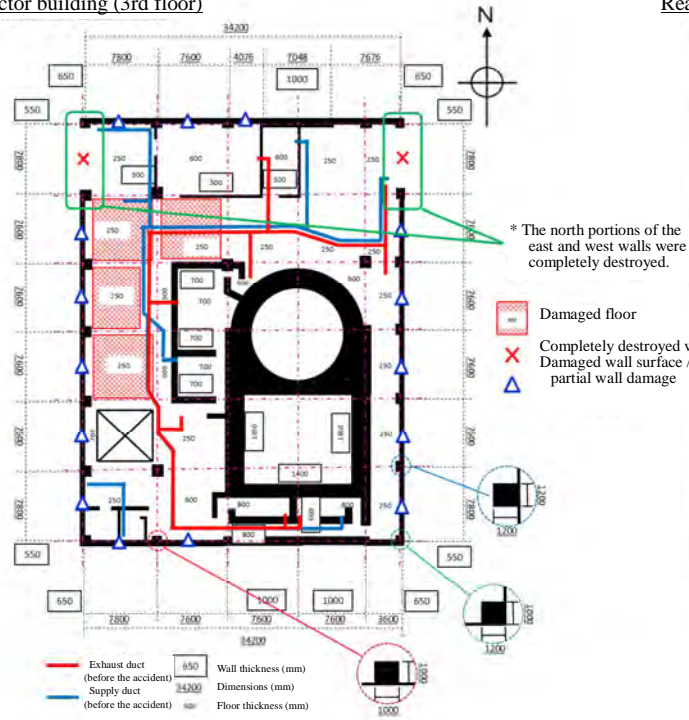
Reactor building (3rd floor)

partially destroyed, but confirmed no damage to the north and south walls (1000-mm thick). The east, west and south walls (250-mm thick) on the 5th floor (excluding the north wall) were also totally or partially destroyed. The NRA also confirmed some damage to beams and pillars near the north and south walls, and the staircase. On the 3rd floor, the NRA confirmed that the walls (550-mm thick) around the north staircase were completely destroyed (see Figs. 7.14 and 7.15).
