**IAEA MISSION TO ONAGAWA
NUCLEAR POWER STATION TO
EXAMINE THE PERFORMANCE OF
SYSTEMS, STRUCTURES AND
COMPONENTS FOLLOWING THE
GREAT EAST JAPANESE
EARTHQUAKE AND TSUNAMI**

Onagawa and Tokyo, Japan

30 July - 11 August 2012

IAEA MISSION REPORT

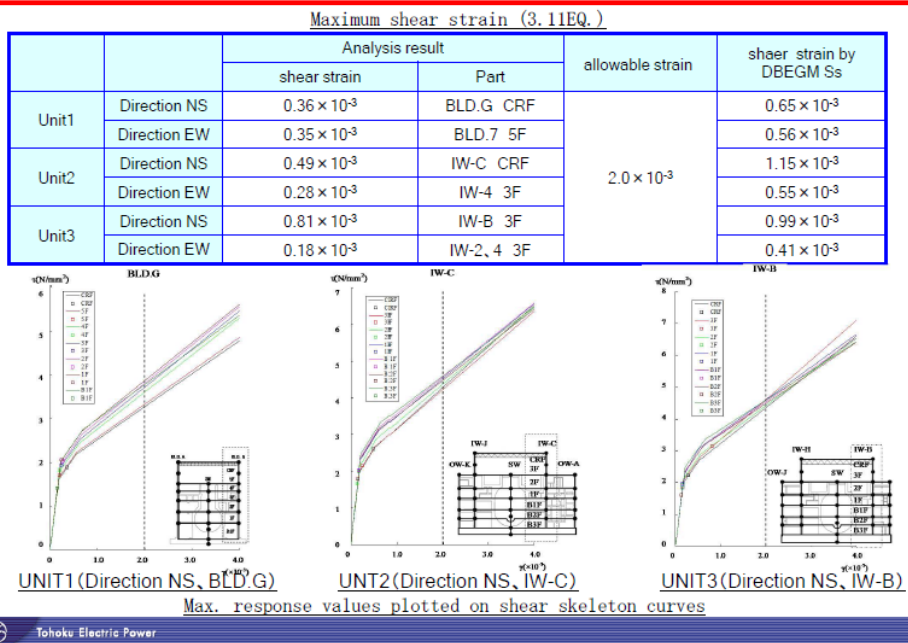
Figure 5-6 Tohoku EPCo' Results from Nonlinear Analysis of the Structural Response of reactor building to GEJ Earthquake

The family of curves in Figure 5-6 is representing the capacity curves for the different floors in the reactor buildings (Unit 1 to 3). We can also see in this figure a few circles representing the results of the nonlinear dynamic time history analysis due to the GEJ earthquake. Most of the circles are within the elastic range of the curves. Some like the CFR data for Unit1 and 2 are slightly beyond the elastic limit. The data for 3f of Unit 3 is significantly beyond the elastic limit.

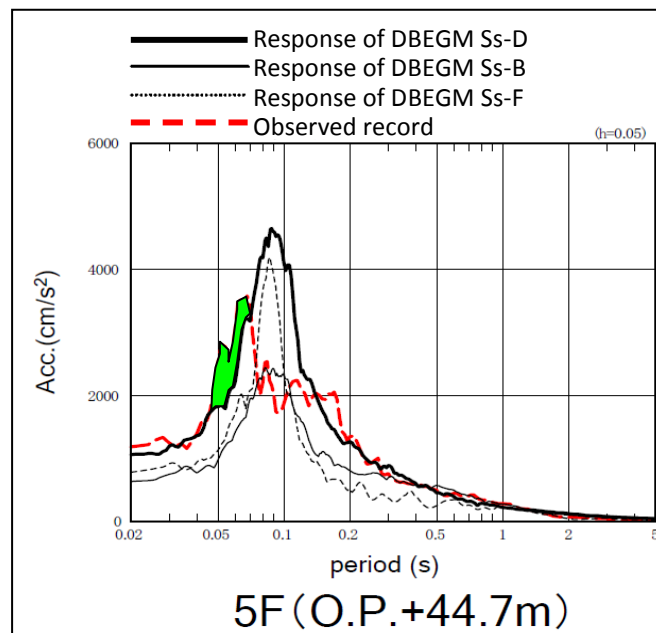
Figure 5-8 Exceedance of Acceleration Floor Response Spectra in R/B Unit 1 due to 3.11 EQ in direction UD - Exceedance in the range 14 to 22 Hz. For example, 1.40-times exceedance (1830 cm/s² vs. 2580 cm/s²) at 20 Hz.²

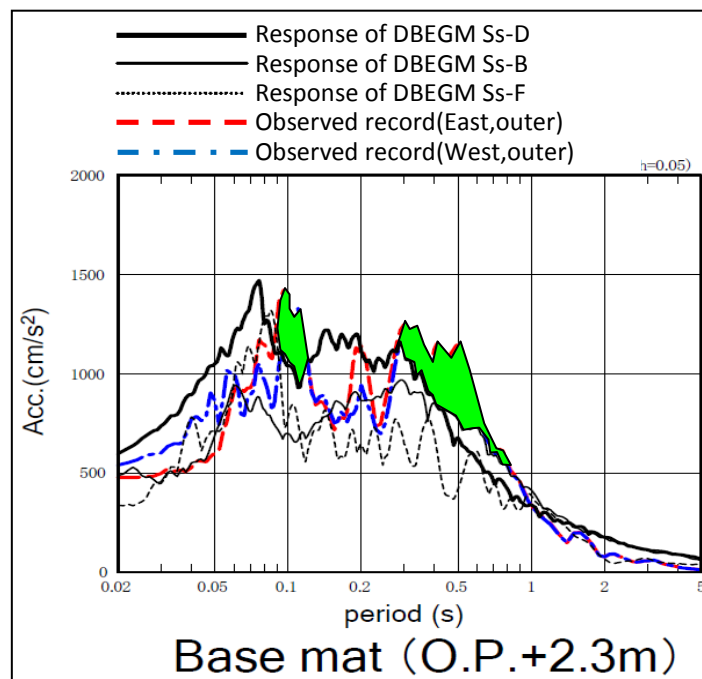
Figure 5-9 Exceedance of Acceleration Floor Response Spectra in R/B Unit 1 due to 3.11 EQ in direction NS – Exceedance in the ranges 8 to 11 Hz and 1.3 to 3.6 Hz. For example, 1.33-times exceedance (1045 cm/s² vs. 1395 cm/s²) at 10 Hz and 1.50-times exceedance (770 cm/s² vs. 1155 cm/s²) at 2 Hz.

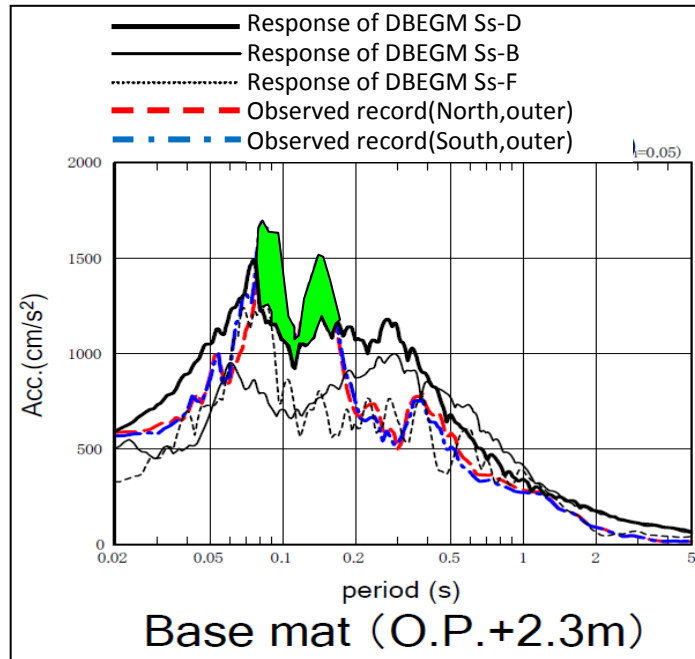
Figure 5-10 Exceedance of Acceleration Floor Response Spectra in R/B Unit 1 due to 3.11 EQ in direction EW – Exceedance in the ranges 6 to 13 Hz. For example, 1.37-times exceedance (1230 cm/s² vs. 1690 cm/s²) at 12.5 Hz and 1.25-times exceedance (1155 cm/s² vs. 1450 cm/s²) at 6.7 Hz.

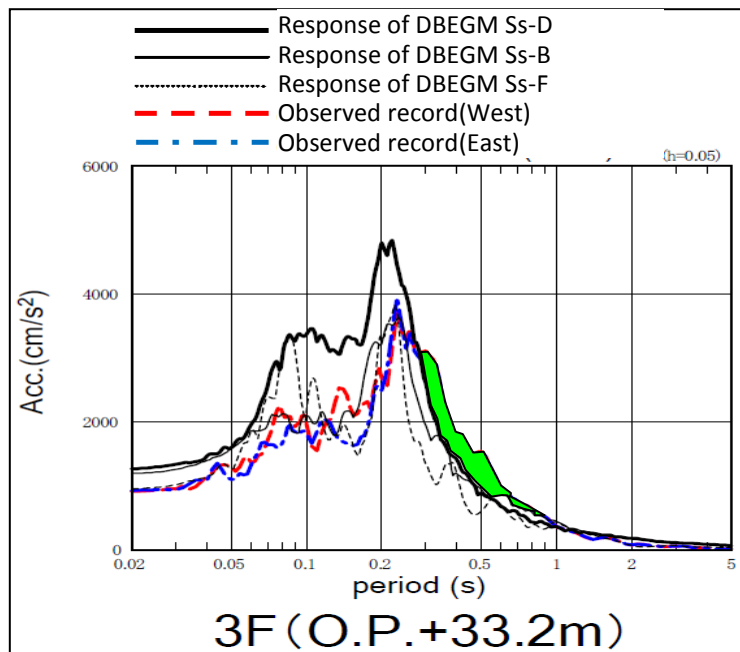
Figure 5-11 Exceedance of Acceleration Floor Response Spectra in R/B Unit 2 due to 3.11 EQ in direction NS – Exceedance in the ranges 1.1 to 3.5 Hz. For example, 1.63-times exceedance (950 cm/s² vs. 1550 cm/s²) at 2.0 Hz and 1.20-times exceedance (2575 cm/s² vs. 3100 cm/s²) at 3.3 Hz

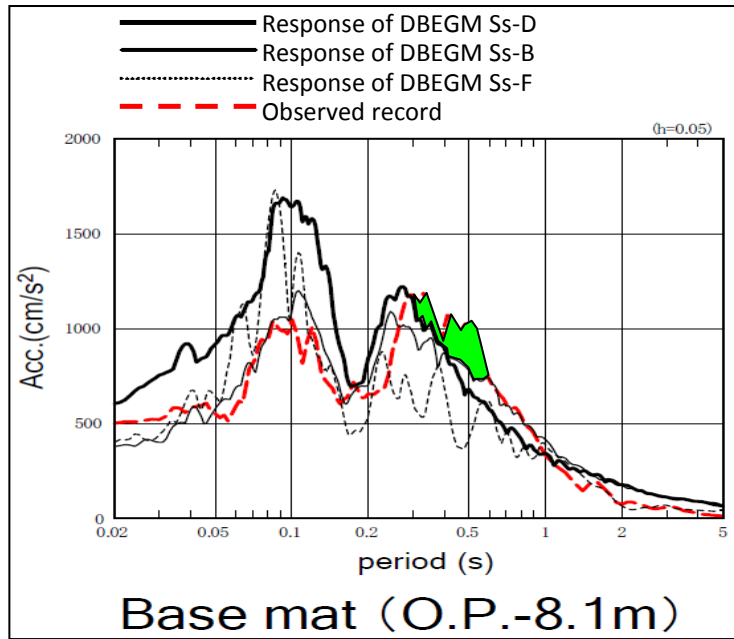
Figure 5-12 Exceedance of Acceleration Floor Response Spectra in R/B Unit 2 due to 3.11 EQ in direction NS – Exceedance in the ranges 1.7 to 3.3 Hz. For example, 1.32-times exceedance (775 cm/s² vs. 1030 cm/s²) at 2.0 Hz

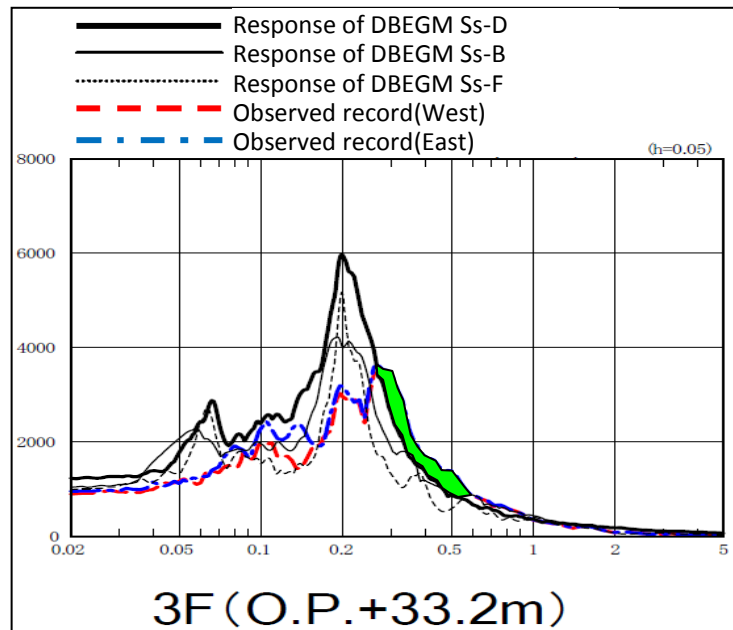
Figure 5-13 Exceedance of Acceleration Floor Response Spectra in R/B Unit 3 due to 3.11 EQ in direction NS – Exceedance in the ranges 1.7 to 3.7 Hz. For example, 1.54-times exceedance (910 cm/s² vs. 1400 cm/s²) at 2.0 Hz

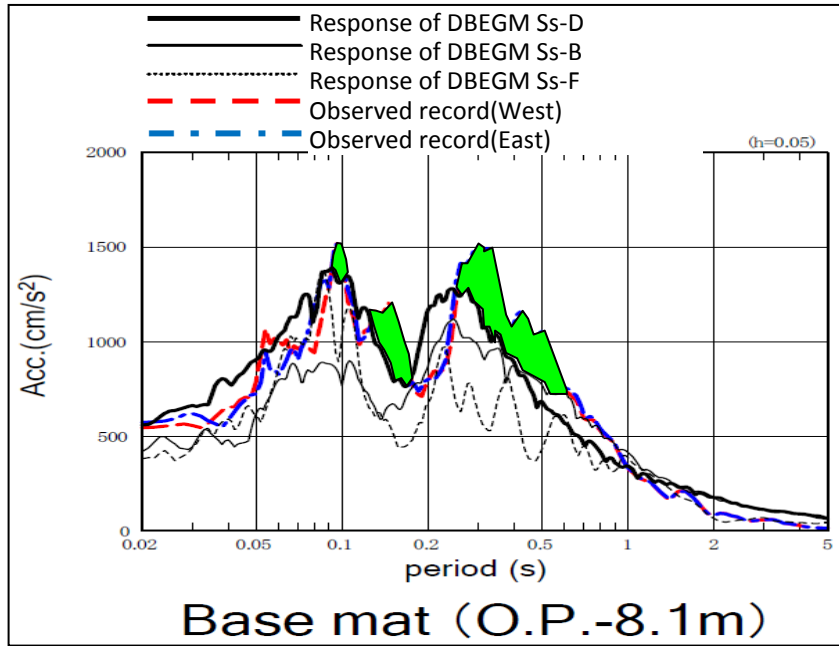
Figure 5-14 Exceedance of Acceleration Floor Response Spectra in R/B Unit 3 due to 3.11 EQ in direction NS – Exceedance in the ranges 1.7 to 11 Hz. For example, 1.40-times exceedance (1060 cm/s² vs. 1495 cm/s²) at 3.0 Hz and 1.40-times exceedance (855 cm/s² vs. 1210 cm/s²) at 6.8 Hz and 1.15-times exceedance (1340 cm/s² vs. 1525 cm/s²) at 10.5 Hz.

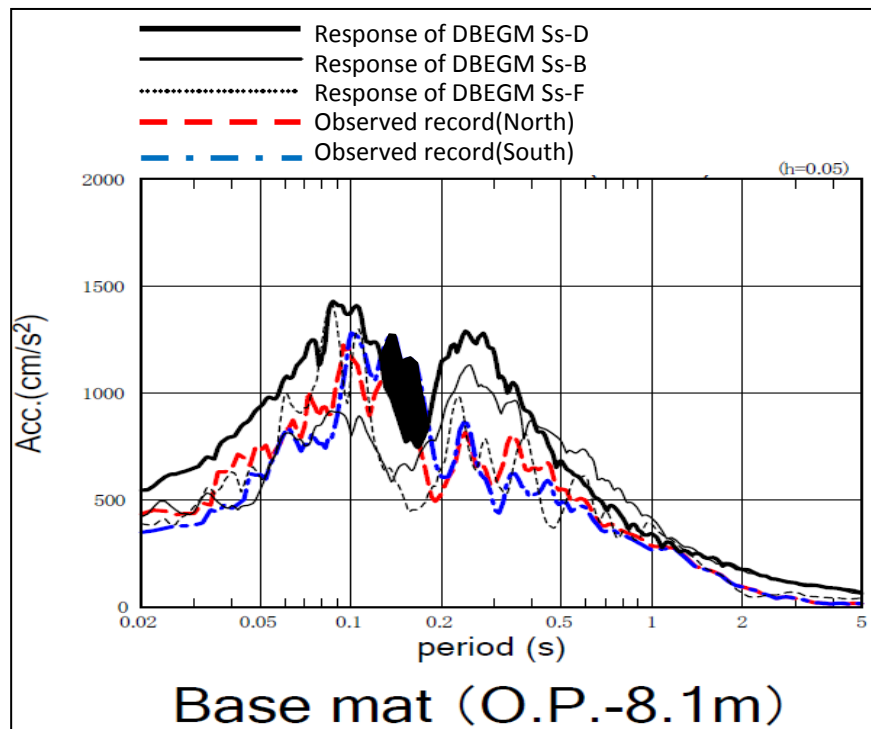
Figure 5-15 Exceedance of Acceleration Floor Response Spectra in R/B Unit 3 due to 3.11 EQ in direction EW – Exceedance in the ranges 5.6 to 8 Hz. For example, 1.46-times exceedance (785 cm/s² vs. 1145 cm/s²) at 6.2 Hz.

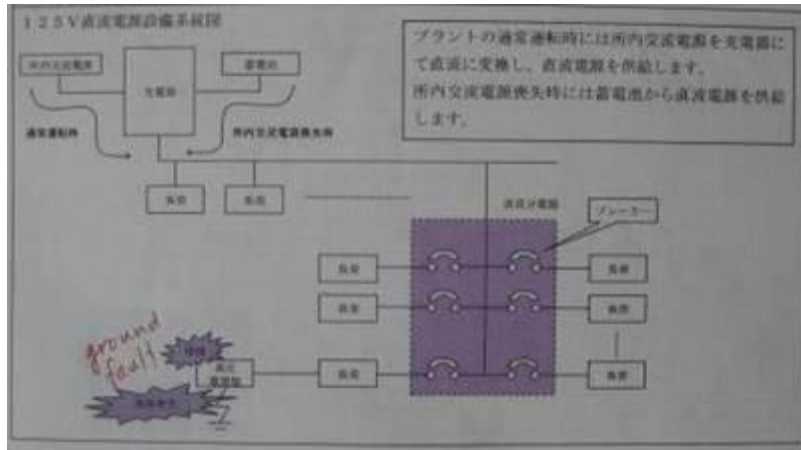
Figure 7-10 The simplified diagram illustrates ground fault failures

Ground faults in certain 125-volt DC circuits caused over-currents, but circuit breakers in DC distribution panels housed in various cabinets in the Unit 1 Control Building, the Unit 2 Control Building and the Unit 3 Reactor Building still connected, that were consistent with breakers' specification. Ground faults were caused by sea water contact with live conductor in various devices that were inundated in the areas flooded by the tsunami. Unit 1 DC ground faults were apparently caused as a secondary effect of the arc and fire in the Train A 6.9-kV switchgear, which contains DC circuits for protective relays.

The simplified diagram illustrates ground fault failures in 125 volt DC panel boards. The apparent cause was contact of sea water with conductor in devices located in the flooded areas of the auxiliary buildings see **Figure 7-10**.

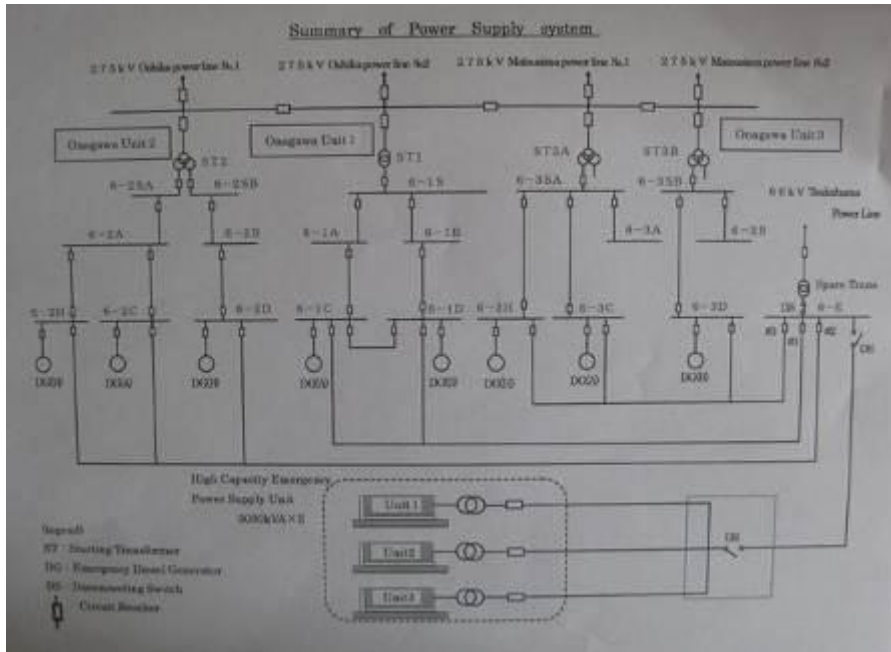
Figure 7-21 Electrical one-line diagram of power flow into the Onagawa Power Plant, including the damaged 6.9-kV Train A on Unit 1

The Unit 1 power train at 6.9-kilovolts (the voltage for large motors) includes five switchgear assemblies (refer to the one-line diagram below for all three units). The Unit 1 non-safety-related power supply Train A consists of vertically-racked circuit breakers, unlike the horizontally-racked breakers in safety-related switchgear. Rocking of a vertically-racked breaker apparently fractured the insulators enclosing the bus clamps at the top of the breaker, allowing bus contact with the cabinet sheet metal. The resulting ground fault and short circuit flash started a small fire in the cabinet, consuming the cable insulation and the few other flammable materials in the cabinet. The arc and fire damage took the A switchgear assembly out of service. The activation of the protecting relay for start-up transformer caused the loss of offsite power in Unit 1 see **Figure 7-21.**, **Figure 7-22.** and **Figure 7-23.**

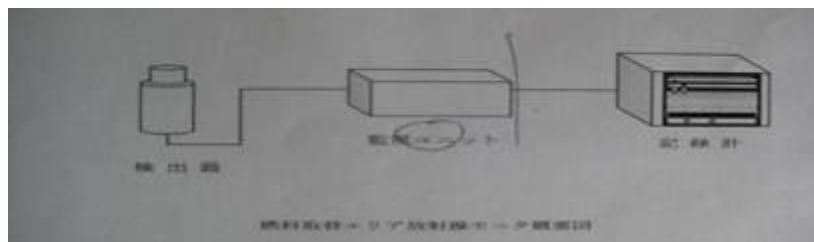
Figure 7-25 The simplified diagram illustrates the refueling floor radiation monitor, signal conditioner and the recorder

In the main control room panel of Unit 3 a strip chart recorder, seismic safety class C, for the refueling floor radiation monitoring system required replacement. The recorder was found to be inoperable after the earthquake for reasons not determined (the recorder was simply replaced without researching the specific component damaged or the apparent cause because this recorder was non-safety related).

The simplified diagram illustrates the refueling floor radiation monitor, signal conditioner and the recorder that required replacement in the main control room of Unit 3 see Figure 7-25.

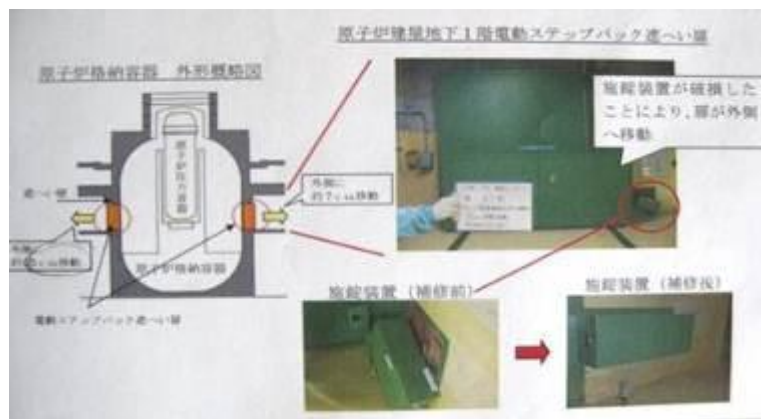
Figure 7-27 Concrete shield plugs

The concrete shield plugs for the equipment hatches of the Unit 2 primary containment vessel dislodged due to the breakage of locking device caused by sliding motion of the hatch on its rails see Figure 7-27.

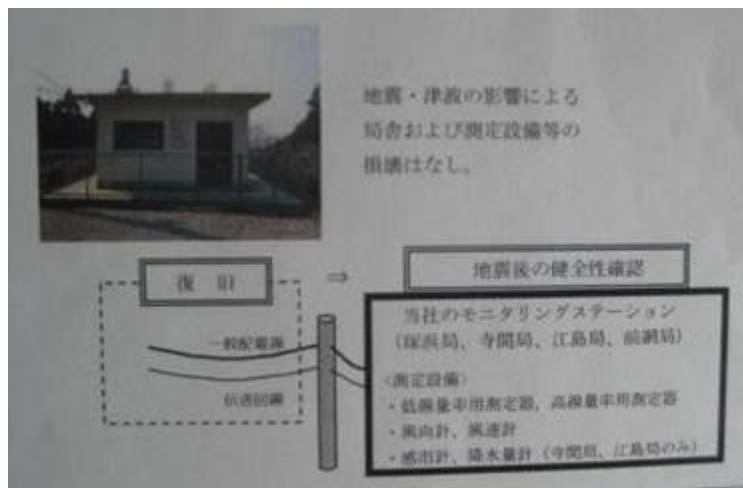
Figure 7-30 Radiation monitoring station

The earthquake and tsunami damaged electricity and signal transmitting lines for all 4 offsite radiation monitoring stations located at diversified points within 8 kilo-meters from the site. In house monitoring facilities for 4 stations were found to be operable, then after the completion of restoration works for electricity and signals the radiation monitoring and data published on homepage were restarted.

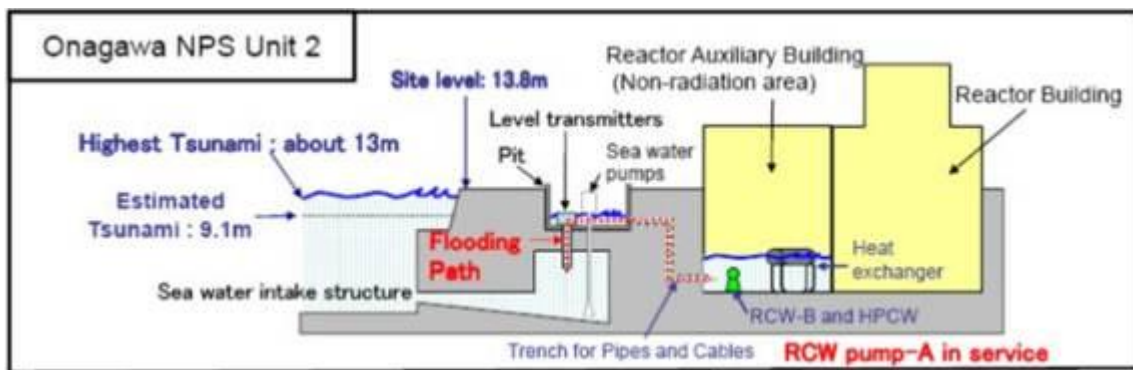
Figure 7-31 Sea water intake structure and sea water pump pit

The Onagawa NPS was subject to a 13.6 m tsunami wave. The tsunami protection due to the plants chosen elevation of 14.8 m was a key to the performance of the plant during the March-11 event. The first tsunami arrived to the NPS site at 15:21, 35 minutes after the earthquake, flooded the concrete pits containing the traveling screens for all three units see Figure 7-31.

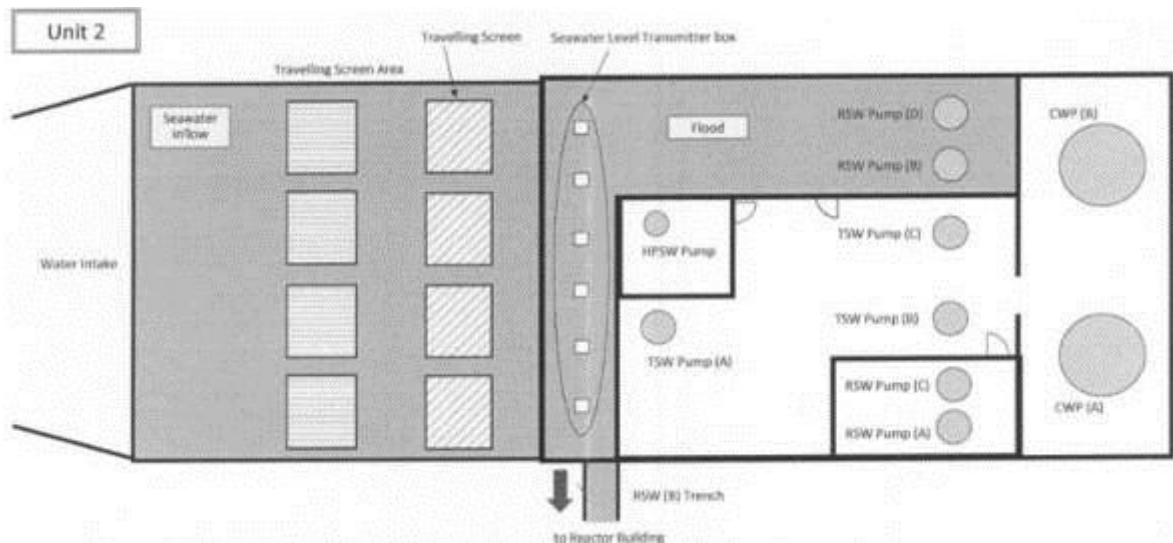
Figure 7-34 Seawater intake pits for Unit 2

During the construction of Unit 3 a new requirement on measurement on water level in the seawater intake structure were passed by the regulator. The purpose was to conserve water in the intake structure for the safety system due to shut down the CWP. To fulfill the new requirements unit 1 and 2 were forced to back fit this installation. One ultrasonic water level measurement point was installed in each intake tunnel. At the end the intake structure is divided in to 6 tunnels. At unit 1 and 3 these installations were made in the pit containing the traveling screens. Due to lack of space in the pit for the traveling screens at unit 2 the installation was made together with the S class equipment of RSW train B, shown in Figure 7-34.

There are penetrations in the wall for the RSW piping and cable trays approximately 1.5 m above the floor. The water traveled through the pipe penetration and cable penetrations in the wall into the RSW (B) trench. These penetrations had a 10 cm gap around the pipe that was a free flow path. In the RSW trench there are sump drains to remove water. This drain is connected to a sump pump located in the RSW room. The hydrostatic pressure and amount of water quickly overwhelmed the sump pump and the sump pit filled up. High level alarms are installed and pump shutoffs are set at approximately 10 cm above the bottom of the sump pits. When the water level reached the high level alarm the sump pumps shut down. Upon inspection after the flooding, the resin sealing of the RSW pipe penetration of the wall into the reactor building was damaged and bent inwards further increasing the area of the flow path see **Figure 7-35**.

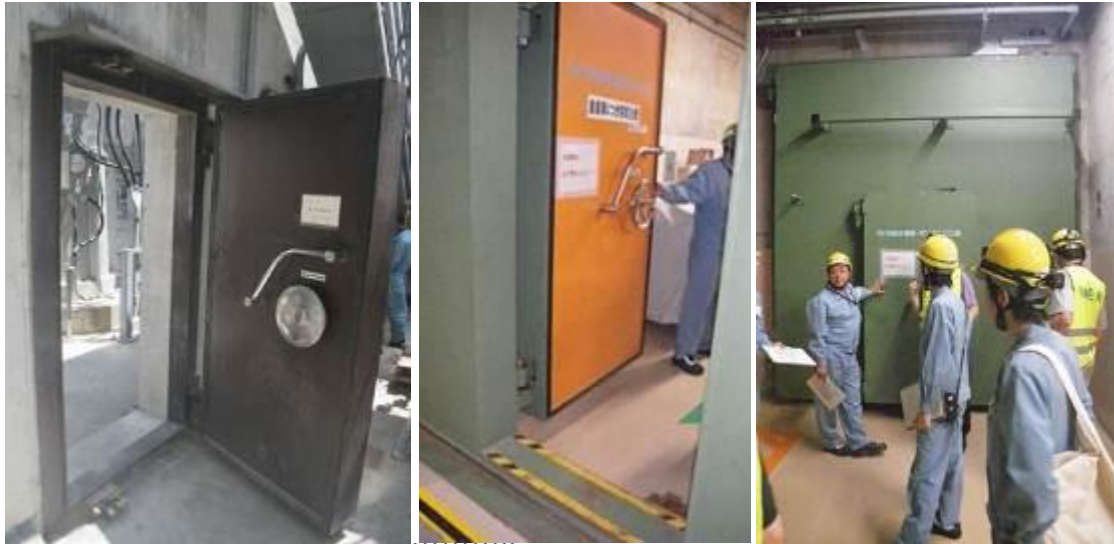
Figure 7-36 Water Tight Door in Seawater Pump Pit (left) and in RCW HX Room (middle and right) at Unit 2

In 9 minutes the water level reached level of 1 m above the floor of the basement where the RCW pumps are located. Despite the water tight door, the water propagated to adjacent room, containing the HPCW. The HPCW rooms sump pumps were shut off on high water level indication. The high water level indication was reached in 4 minutes, after that the sump pumps in the RCW shut down and 5 min before the RCW located at an elevation of 1.5 m above the floor tripped. The door is a vault type with a neoprene lip that a steal rim is supposed to cut into, see Figure 7-36. The plant staff stated that the door was closed at the inspection they conducted 5 days later, when they removed enough water the doors where still closed. They also stated that they needed to adjust the tightness of the door after the event.

This event has proven an inadequate function of a type of watertight door. Both watertight door types only works as watertight in one direction (closing direction), see Figure 7-36. The red door is only for people and the green is a double door with a small door in the center for people (orange coloured on the surface to open) and a big frame about 4x4 m or more for components so it has longer insulation that could leak. The sump drains system piping was also a contributor to the flooding propagated between different rooms and trenches.

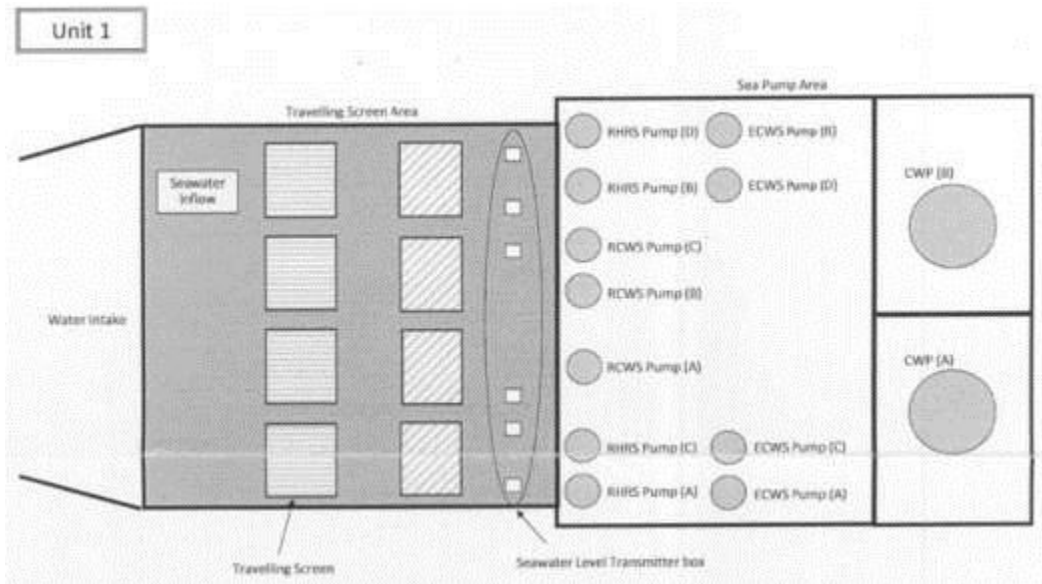
Figure 7-37 Seawater intake pits for Unit 1

At Unit 1 the pit containing traveling screens (the dust screen pit) is submerged. The water flowed through 4 large openings in the pit floor. In Figure 7-37 areas displayed as grey were submerged. The CWP tripped due to the shutdown of startup transformer for unit 1. The CWP could later not be utilized due to loss of offsite power and the shortages in the ultrasonic water level measurement system.

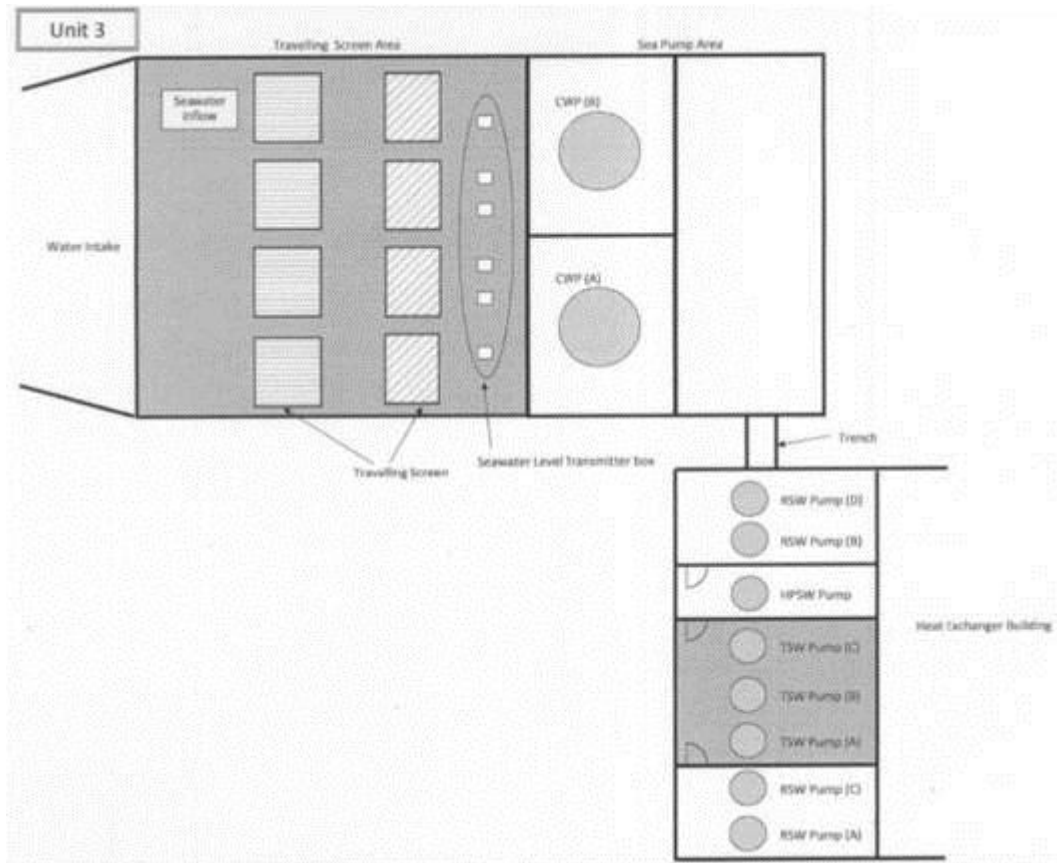
Figure 7-38 Seawater intake pits for unit 3

At Unit 3 the pit containing traveling screens is submerged. The water flowed through 4 large openings in the pit floor, see Figure 7-38. A pit containing the TSW Pump A, B, C was submerged due to an opening. The TSW is a seawater side of turbine cooling components vital for balance of the plant. None of the flooded areas was critical for nuclear safety. In Figure 7-38 areas displayed as grey are submerged. The CWP tripped due to the flooding of the water level measuring in the travelling screen area. The short circuit created a permanent low level alarm preventing the CWP pumps from starting. The CWP could not be restarted due to a second reason since the TSW pumps that supply the cooling for the CWP were submerged and shorted.
