Radon in Slovenia

Experience in radon mitigation

Webinar, 26. 02. 2019

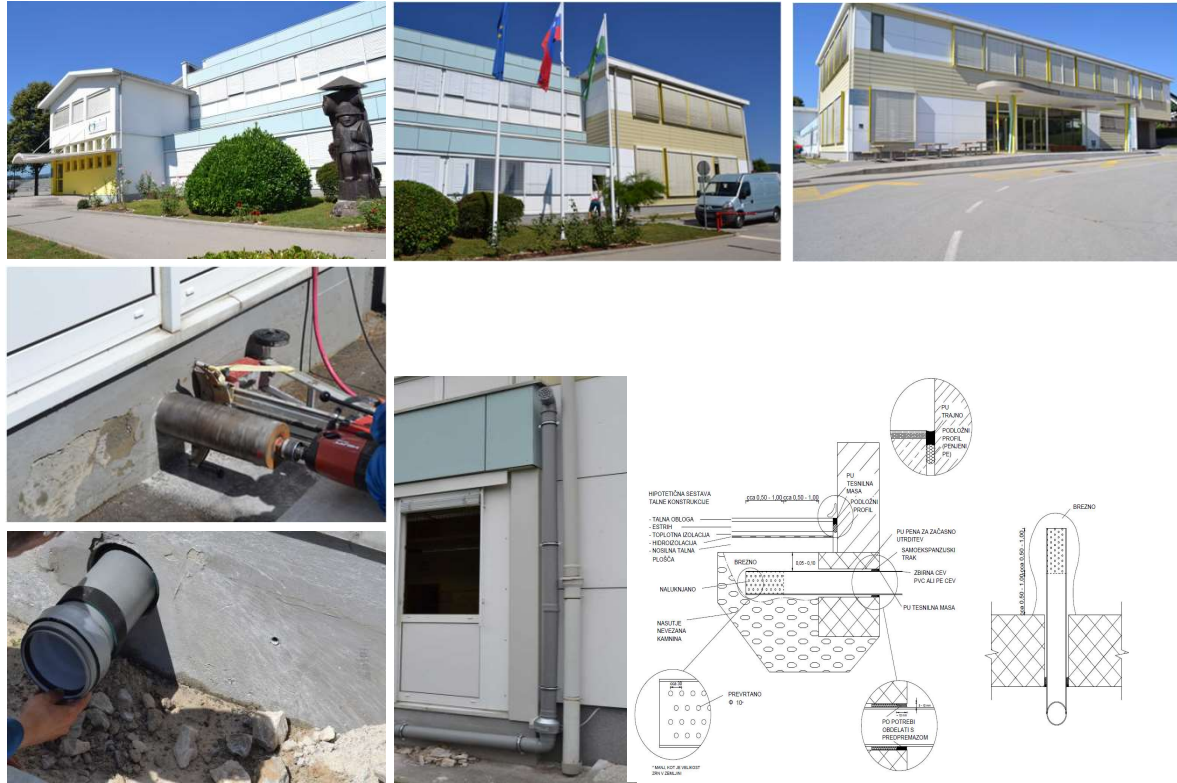
Case study – case 1

- School, new building (less than 20 years old), elevated concentration measured in one room, likely reason – breaking of the floor structure;
- Screening only – no extensive measurements were done;
- Strong public pressure;
- After initial disbelief that anything has to be done the mitigation was simple.

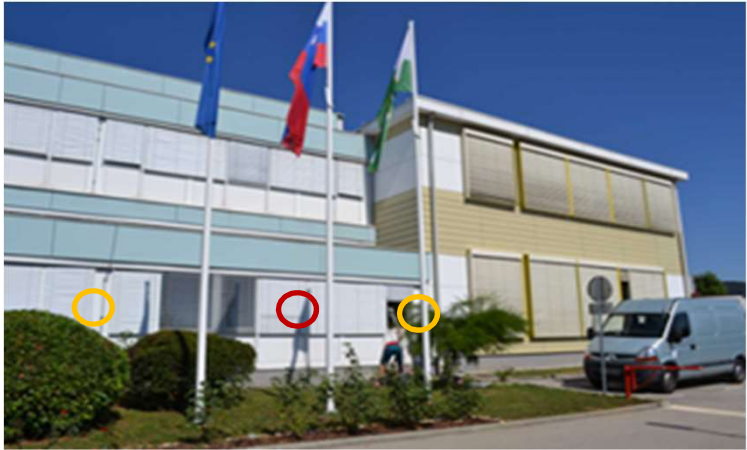
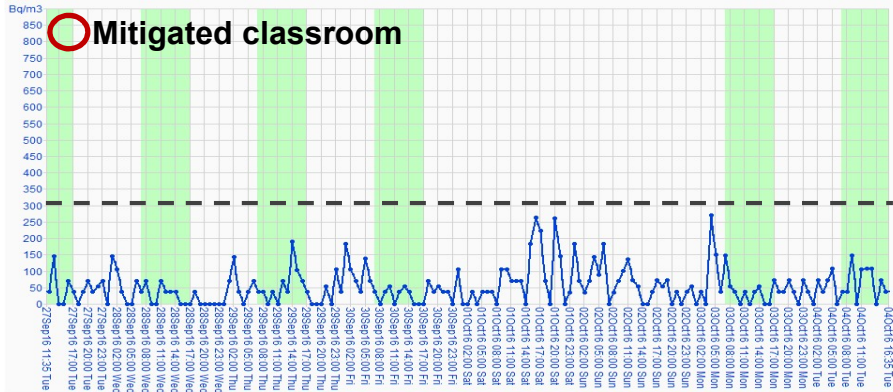
Results close-up

Simple mitigation and almost ideal result.

Because of the exhaust proximity to the window, special care was given to the possibly affected adjacent rooms by taking additional measurements.

No interference was detected.

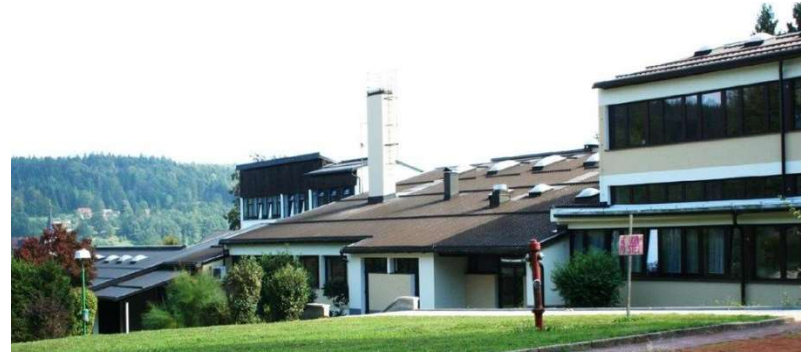
TLORIS

- School, post WWII building, built in the 1950s with additions and reconstructions to the 2000s
- Cascading architecture
- Piping in shafts – three separate branches; possibly large not tightly closed air void
- Blueprints available, but not accurate – verification needed
- Limited cooperation of all parties involved

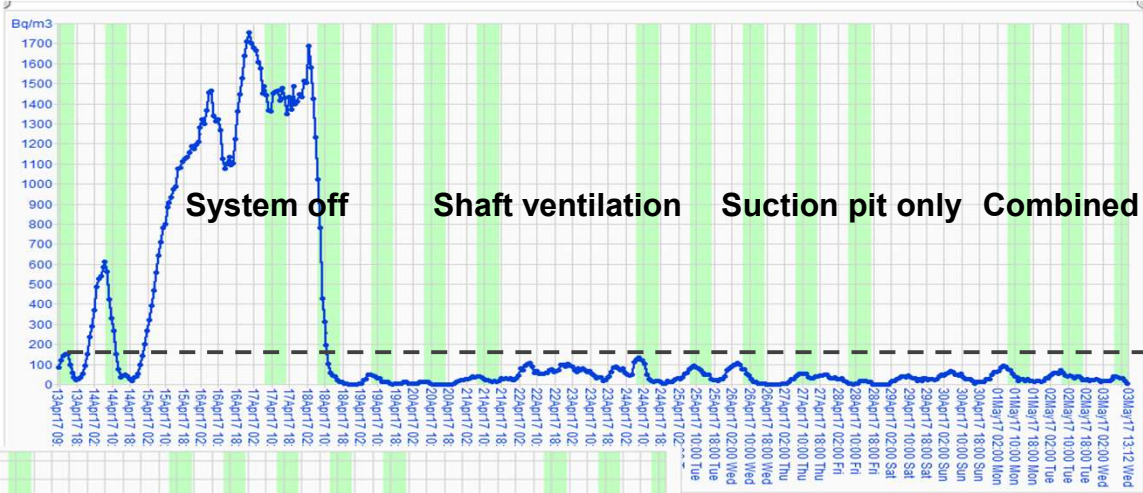
Room with the suction pit

Results (2)

Influence of the foundation walls clearly demonstrated.

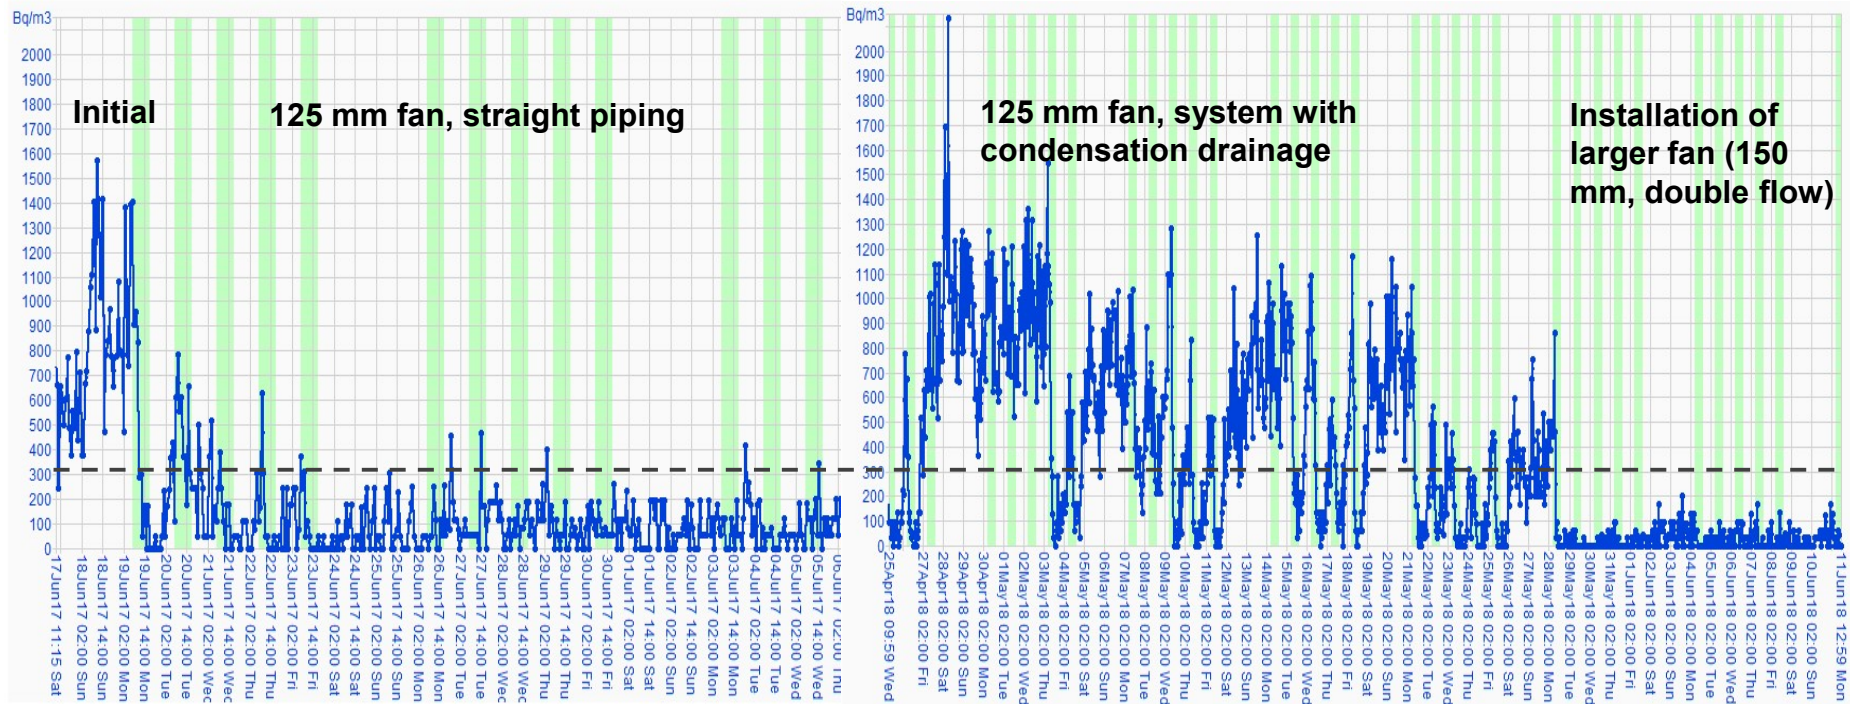
Results

Secondary effects may influence the system's performance.
