Construction Operating Experience: Benefits and Challenges

Lisa Regner

Generic Communications and Operating Experience Branch
Office of Nuclear Reactor Regulation
U.S. Nuclear Regulatory Commission

Vogtle 3

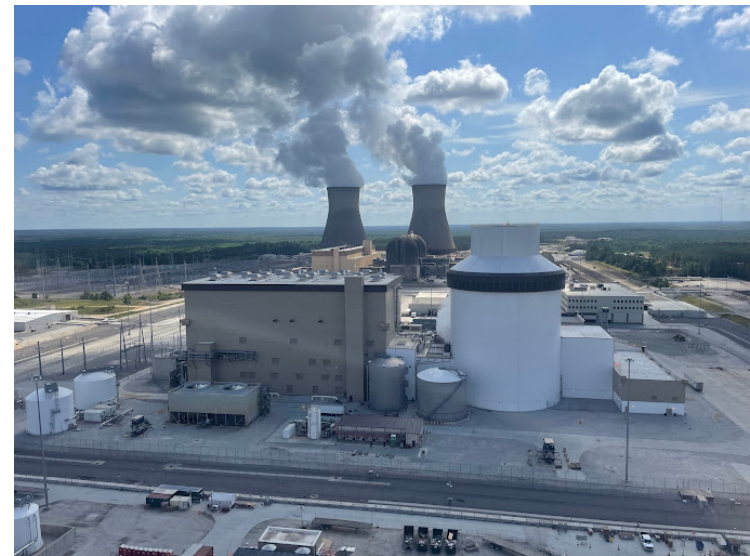
- Westinghouse AP1000 PWR
- Free-standing steel vessel with shield building
- 1,117 MWe
- Located in the State of Georgia
- Scheduled to commence operation in July 2023
