Influence of the Coolant Chemistry on the Structural Materials Surfaces Exposed into the CANDU NPP Primary Circuit

Institute for Nuclear Research, POB 78, Mioveni, Romania, www.nuclear.ro, Poster No. 249

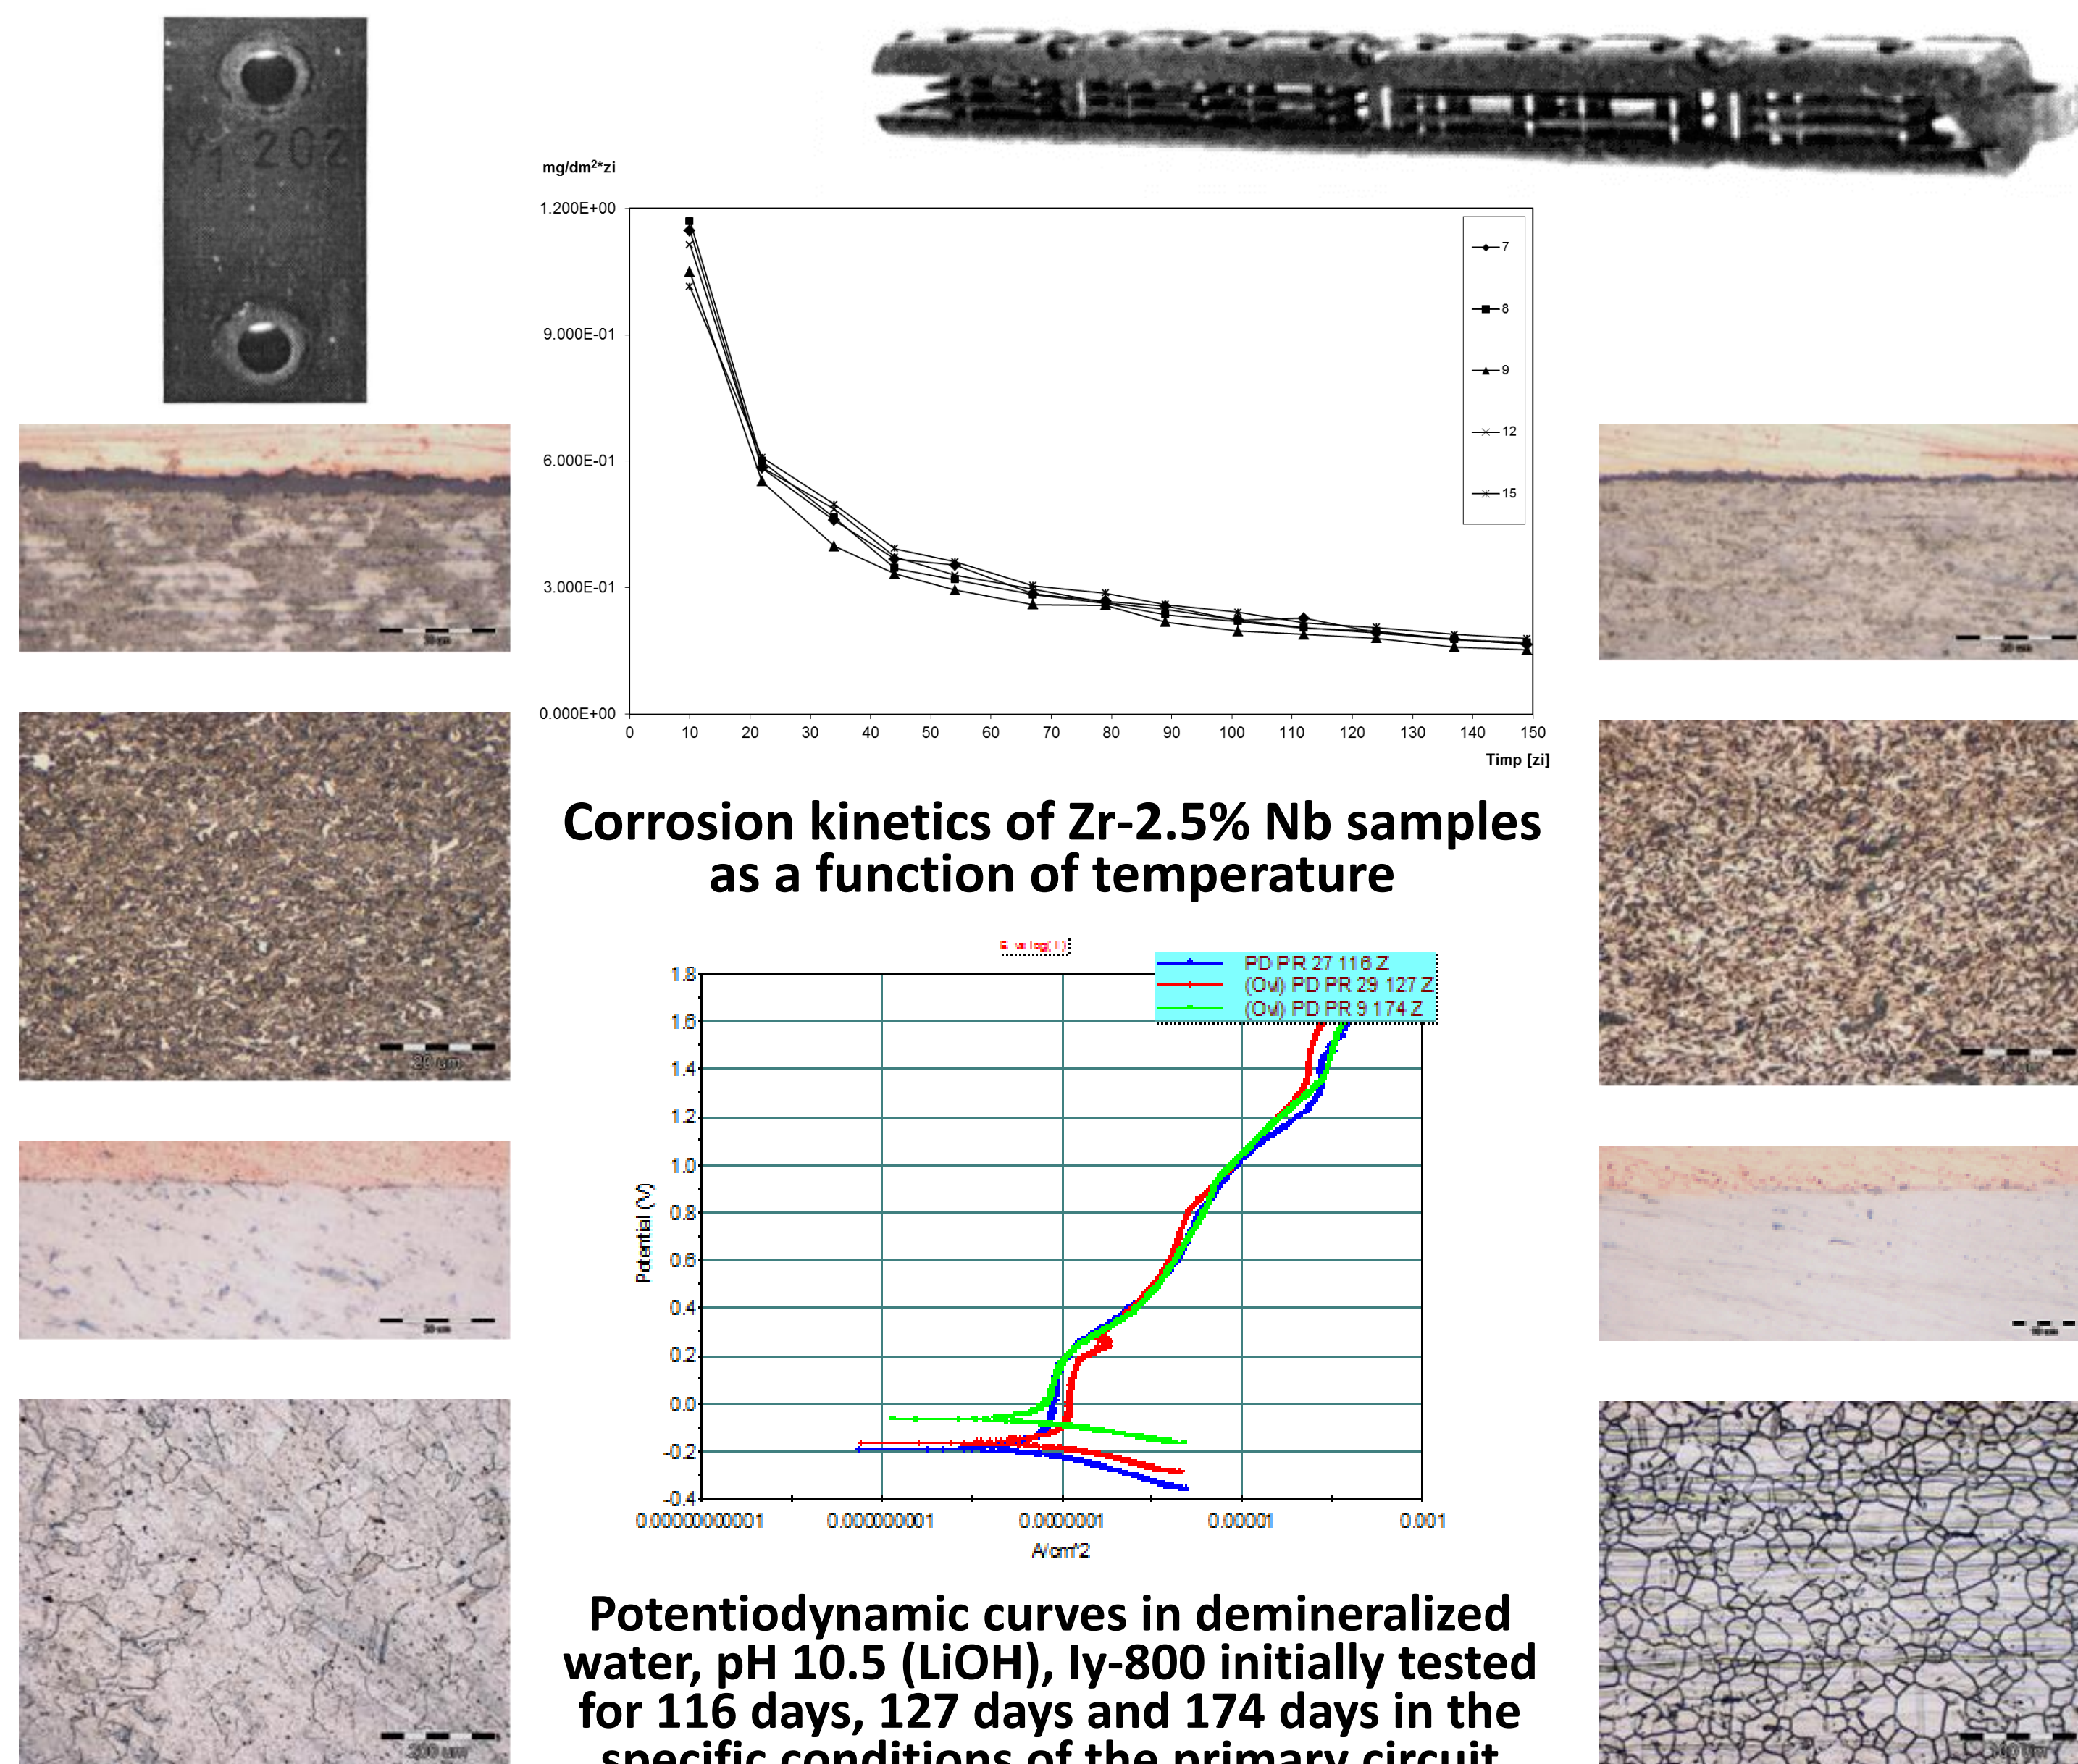
The aspect of the Zr-2.5%Nb and Incoloy 800 oxide films after different testing periods at 310°C, evidenced through metallography

- The oxidation of Zr-2.5%Nb alloys was strong dependent of temperature. Thus the constants of corrosion kinetics at pre and post-transition (k_1 and k_2) increased significantly with temperature. Generally, the formed oxides were continuous and uniform, but, at temperatures more than 310°C increased the porous character of oxides and appeared fissures at exterior surface oxides which increased of time, advancing to oxide/metal interface.

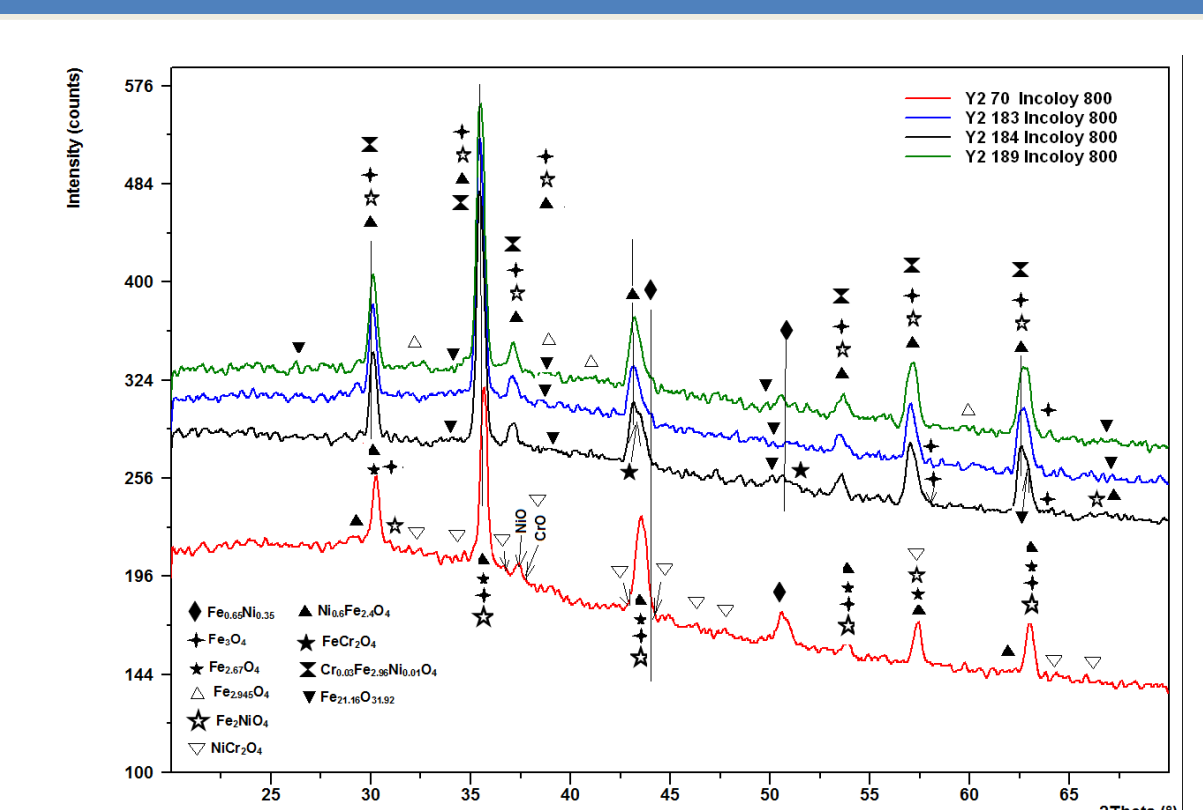
Superposition of diffraction spectra obtained for Incoloy 800 coupons exposed in the Y 2 autoclave
