**ENGINEERING SAFETY REVIEW SERVICES
SEISMIC SAFETY EXPERT MISSION**

**FOLLOW-UP IAEA MISSION IN
RELATION TO THE FINDINGS AND
LESSONS LEARNED FROM THE
16 JULY 2007 EARTHQUAKE AT
KASHIWAZAKI-KARIWA NPP**

Tokyo and Kashiwazaki-Kariwa NPP, Japan
28 January – 1 February 2008

Facility: Kashiwazaki-Kariwa NPP, Units 1 – 7

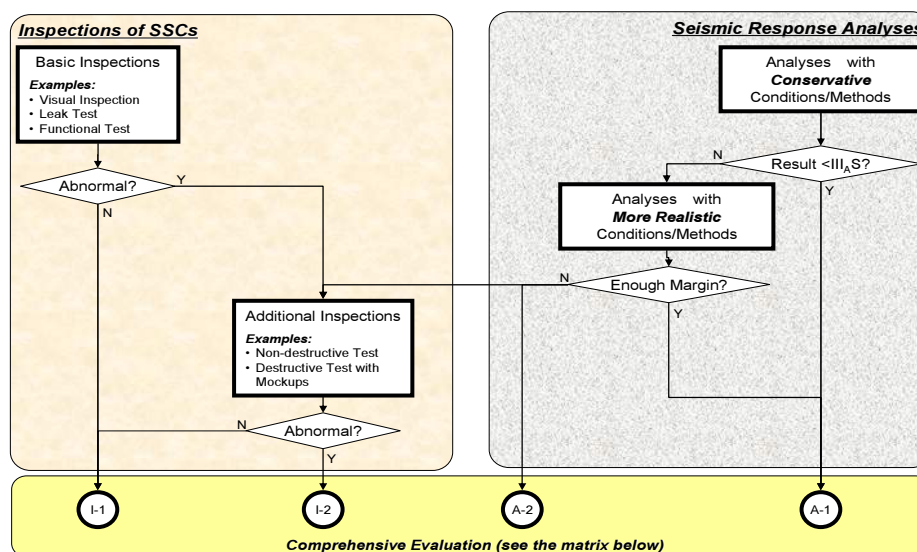
The integrity assessment for systems consists of the following process:

<i>Comprehensive Evaluation Matrix</i>		
Analyses	Inspections	
	No Abnormality (I-1)	Abnormal (I-2)
Enough Margin (A-1)	Judged as Sound	Restoration (Repair/Replacement)
Less Margin (A-2)	Further Analyses and/or Inspections	Restoration (Repair/Replacement)
