### OSART Good Practices MAINTENANCE Conduct of maintenance work

## Mihama 3, Japan

## St. Alban, France

# Flamanville 3, France

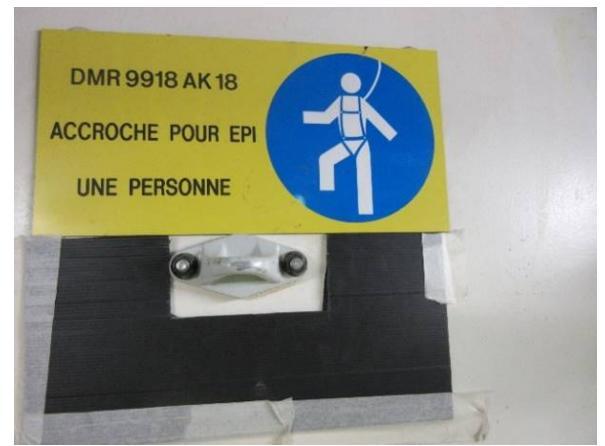
Figure 1: Tie-Off Point

Tie-off points for attaching a safety harness are permanently installed at all potential crash surfaces and floor openings, (see figure 1) to secure a harness or fall arrester. They enable workers to perform their job safely when a risk of fall from a height is present. Their maximum rated load capacity is (10kN). These tie-off points are checked once a year to ensure usability. When their yearly check is due, and/or the tie-off point is damaged, it is tagged out using a tagging device. See Figure 2.

Safe access to locations where there is a risk of fall from a height (floor openings, movable floor gratings, access to cranes and platforms).

Since the implementation of these tie-off points no event due to fall from a height have been recorded.
